**CORRECTIVE ACTION REPORT
CONNECTOR BUILDING DEMOLITION
ST. PAUL ISLAND, ALASKA**

MAY 8, 2006

U.S. DEPARTMENT OF COMMERCE
NATIONAL OCEANIC AND ATMOSPHERIC ADMINISTRATION
PRIBILOF PROJECT OFFICE
7600 SAND POINT WAY N.E.
SEATTLE, WA 98115-0070

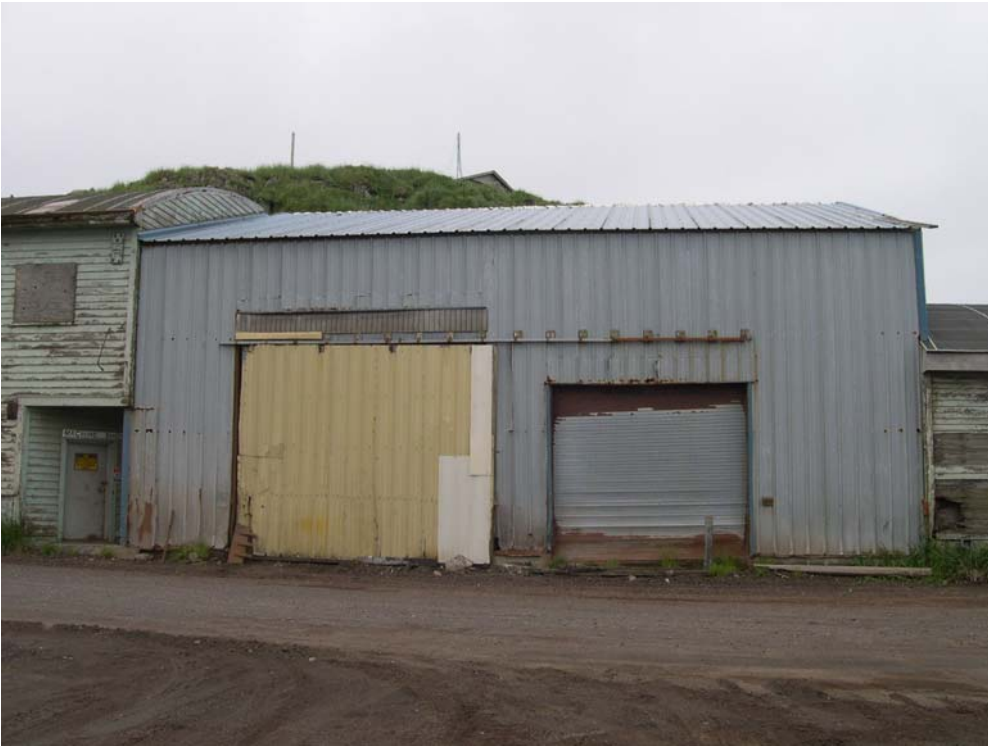
The Connector Building general orientation was north-south, and its dimensions were approximately 50' by 63' (Figure 3). The structure was a sheet metal covered building, steel framed with steel purlins (Figure 4). It was located between and connected to two wooden structures: the Machine Shop and the Equipment Garage (Figure 5). The Connector Building was constructed in the early 1980s. The Machine Shop and Equipment Garage were constructed prior to World War II.

Figure 4. The eastern (front) side of the Connector Building before incurring major damage, July 2004

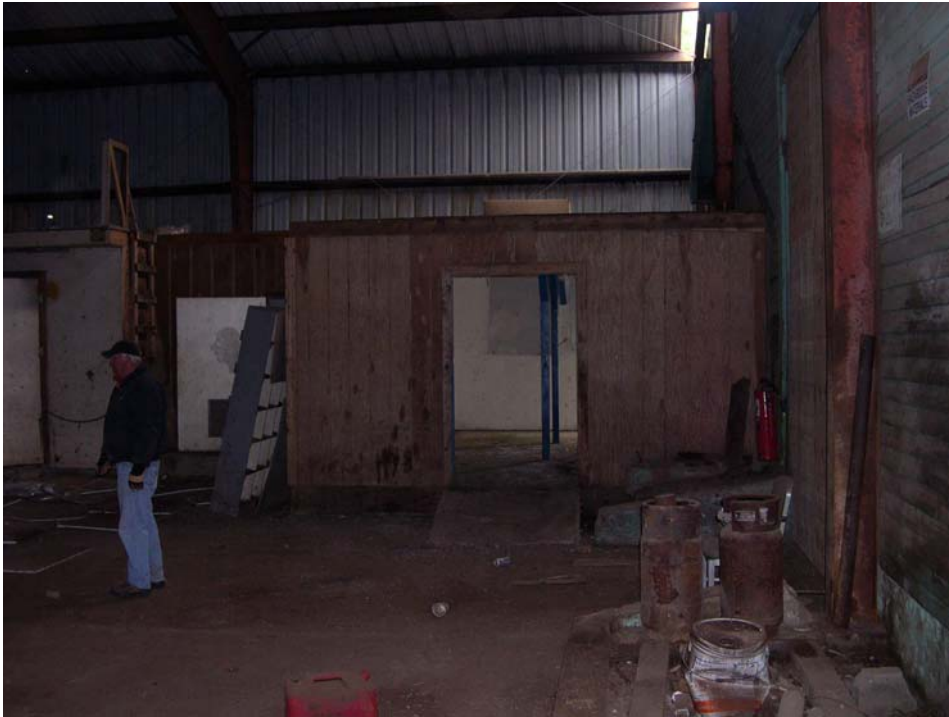
The Connector Building was free standing, with a center frame and two side frames, the columns of which were bolted to reinforced concrete footers. Steel purlins and rods connected the frames to provide structural stability. Corrugated steel metal was fastened by bolts to the purlins on the roof and the west and east walls. The south end of the Connector Building was connected to the Machine Shop's north wall, apparently only by flashing and caulking. The top, gable-shaped section of the north wall was made of wood frame covered with plywood and metal siding, and rested on the roof of the community garage. An interior wooden structure, with two separate rooms and a ceiling, was adjacent to the west wall of the Connector Building (Figure 6).

Figure 6. The wooden structure inside the Connector Building

On October 15 to 20, 2004, NOAA mobilized its contractors, Tetra Tech/Cooper Zietz and Bering Sea Eccotech (BSE), to demolish the Connector Building. A Cooper Zeitz engineer prepared a demolition plan acceptable to NOAA (Cooper Zeitz 2004), and initial demolition of the Connector Building followed. NOAA contractors removed the existing interior wooden structure, and cleaned the interior of the building from debris.

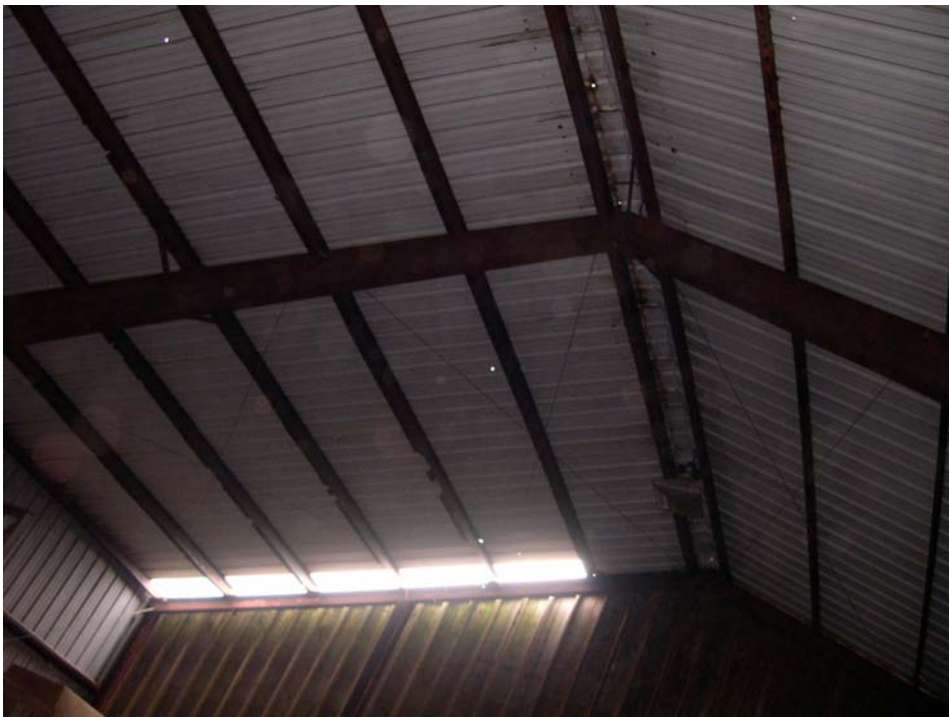
The weather on St. Paul Island is harsh. The average wind speed is 18 miles per hours, and gale-force winds exceeding 70 mph are not uncommon, especially in the winter time. Moisture in the air contains salt, and wind carries the salty spray from the breaking waves, coating exposed surfaces. Metal corrodes quickly on the Pribilof Islands, and the Connector Building was no exception. Despite its relatively young age, purlins holding the sheet metal of the roof and siding corroded to the point where their structural integrity was completely compromised (Figure 7). Likewise, bolts holding roof sheet metal corroded and could no longer hold the sheet metal in place.

Figure 7. Corroded purlins (near the crack in the roof) and missing roof sheets, July 2004

Considering the deteriorated state of the building and the fact that repairs could not be done economically and safely, NOAA decided to demolish the building and proceeded to do so in October 2004. NOAA was unable to complete the demolition at that time due to severe weather. During storms in 2004 and early 2005, sheet metal from the roof and siding broke lose and landed on the road nearby. The building became an imminent hazard to the community. Demolition of the Connector Building became a high priority.

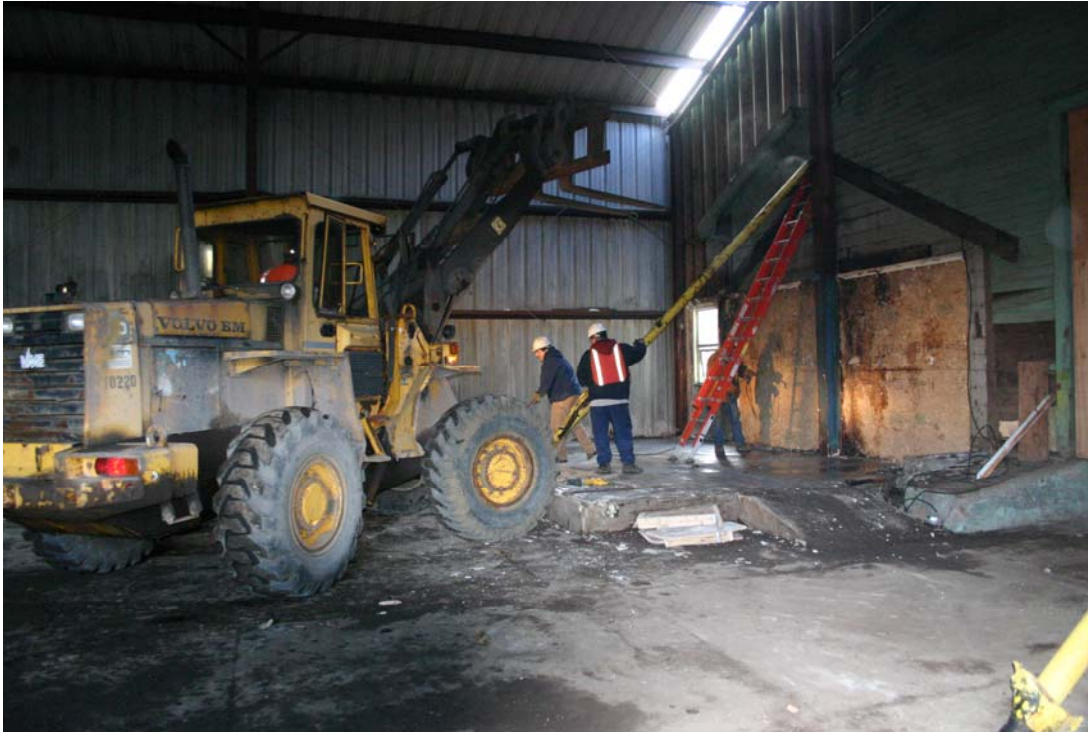
Figure 8. Bracing a frame of the Connector Building, October 2004

To support the building, 4" schedule 80 pipe braces were installed from the floor to the center columns of the side frames (Figure 8), and four cables were installed from the outside columns of the side frame to the center frame. The original bracing cables were found to be in good condition and were left in place.

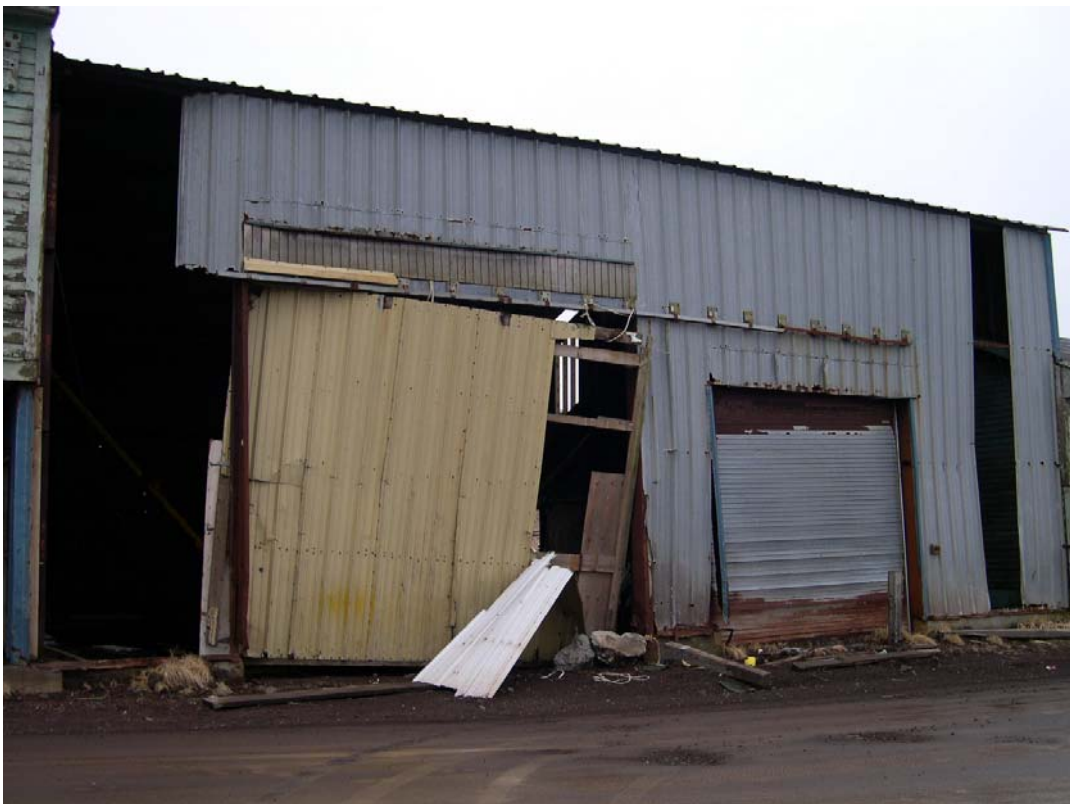
In December 2004 and January 2005, severe storms caused substantial damage to the Connector Building. Winds battered the front sliding door, throwing it off its hinges and bending its frame. The door had to be tied by ropes and cables to keep it from falling off completely. A number of sheet metal panels on the east (front) side of the Connector Building were torn by the wind and blown onto the adjacent road (Figure 9). Likewise, wind tore several sheet metal panels from the west (back) side of the building, and separated sheet metal siding on the north wall from its wooden frame, leaving it hanging precariously on the roof of the Equipment Shed (Figure 10). The building clearly presented an imminent hazard to the community, making its complete demolition an urgent matter.

Figure 9. Damaged sliding door and east wall, January 2005

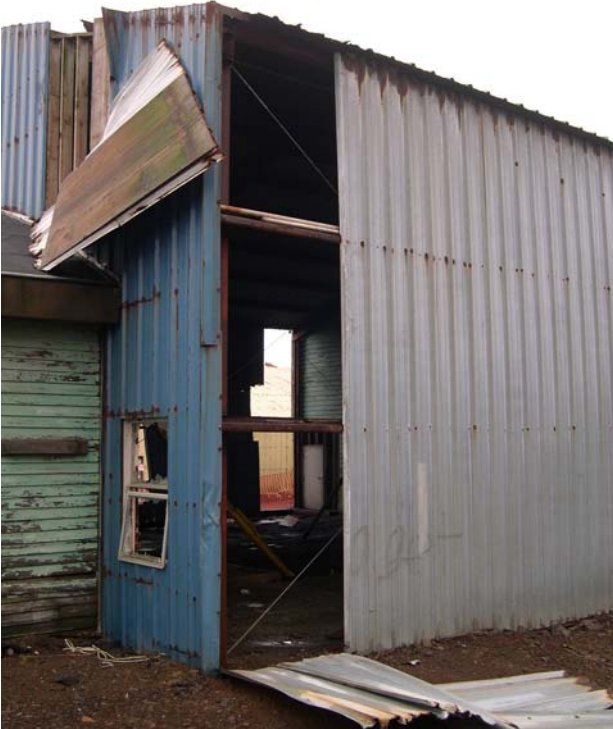
Figure 10. Damaged north and west walls, January 2005

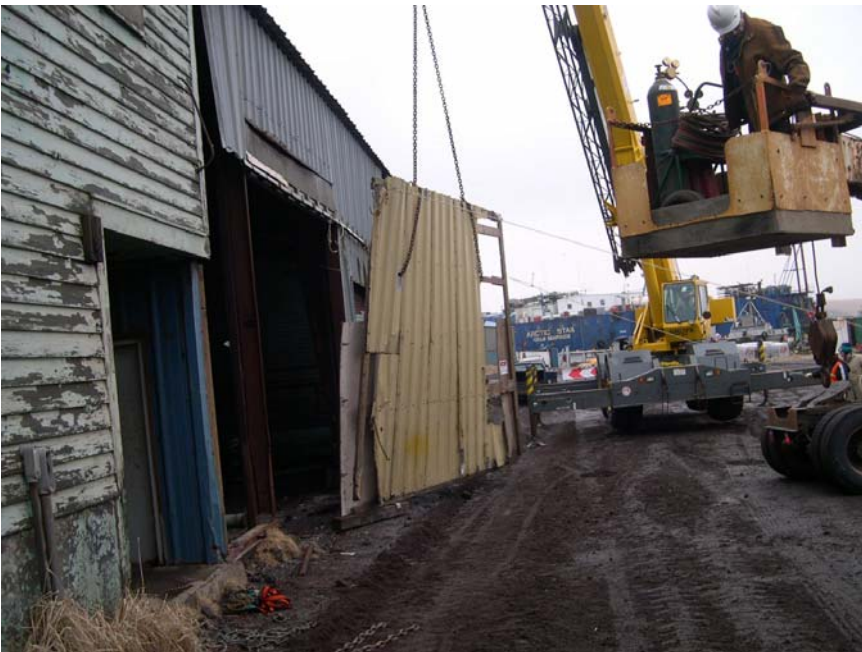
Figure 11. Removal of the sliding door, February 2005

After delaying work for two days due to high winds, demolition began on February 7, 2005. NOAA and its contractors blocked the road, erected a fence, and arranged for the local radio station to advise the community to stay away from the demolition area and use alternate routes. Using a boom truck and a 50-ton capacity Grove Crane, BSE removed the large sliding door by attaching the crane to it through holes made in the door, applying tension, cutting the door loose with a cutting torch, and finally lifting the door while stabilizing it with guide ropes and placing it on the ground. The metal and wood pieces were separated (Figure 11). Sheet metal went into the metal debris container, and wood components went to a separate pile for disposal at the landfill.

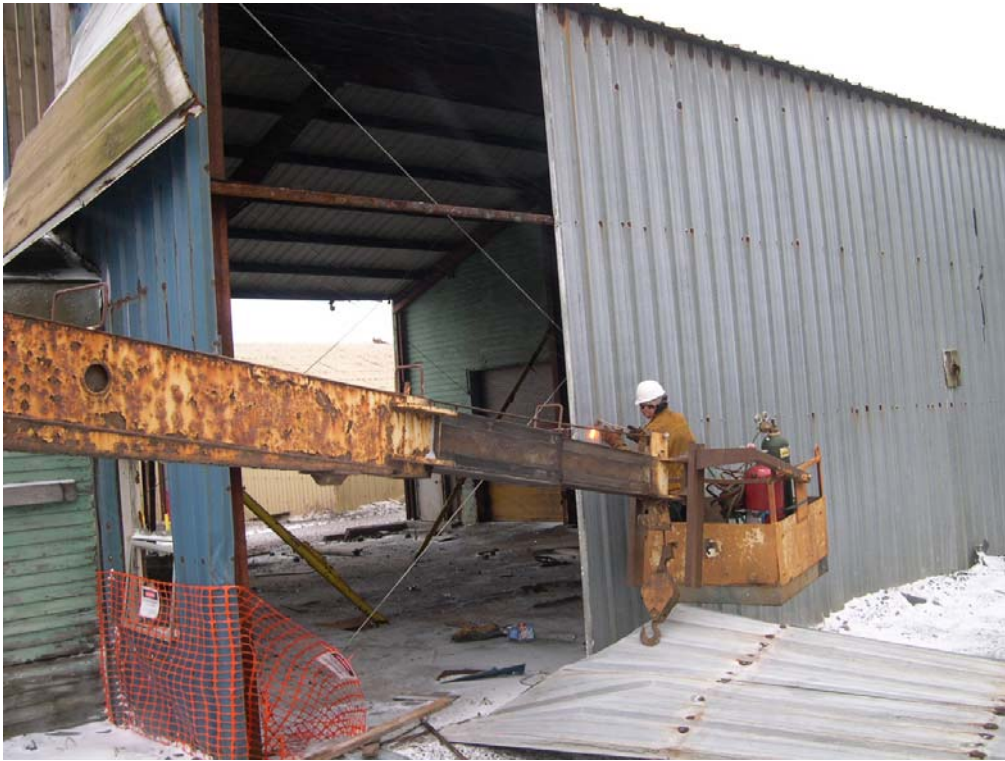
Figure 12. Removal of the west wall

The west (back) wall of the building was removed without the crane. A BSE welder in the boom truck basket torched off the bolts holding the sheet metal to the purlins, and peeled the metal off (Figure 12). The purlins themselves, some of which were extremely corroded, were cut next, followed by a piece of siding on the north wall that hanged on the Equipment Shed roof for some time.

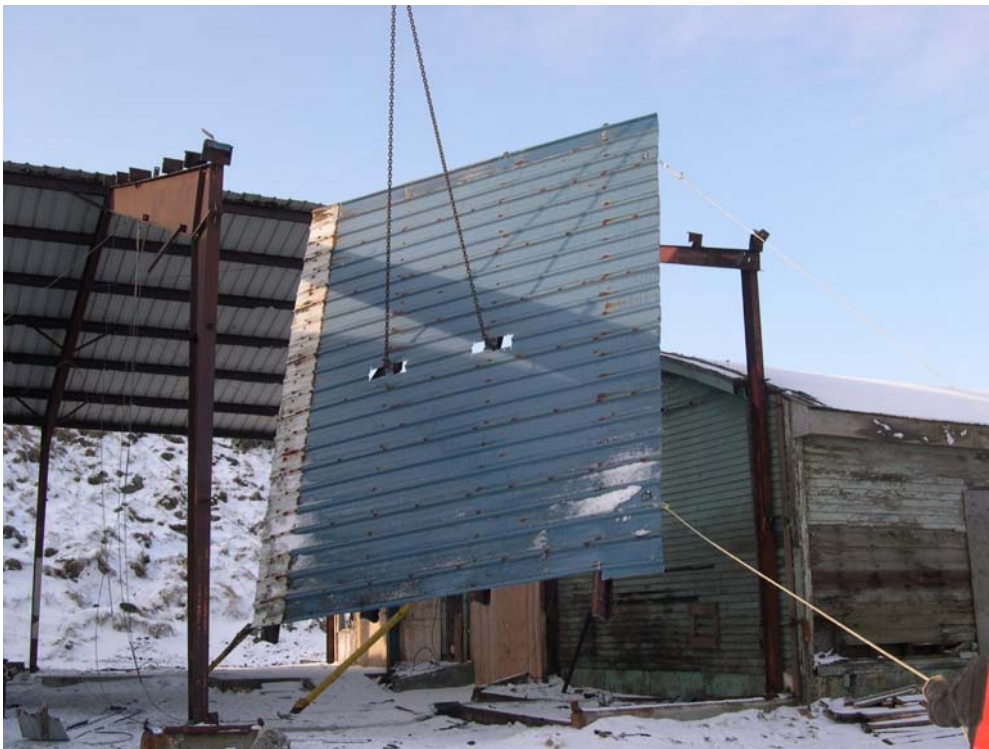
Figure 13. Removal of a roof section with the Grove crane

With all the walls gone, removal of the roof came next. Approximately three quarters of the roof was removed with the Grove Crane as follows: four holes were cut in the section of the roof to be removed, the crane riggings were inserted and tightened around roof purlins, and the crane applied tension on that section to prevent it from falling uncontrollably. A BSE welder then cut the purlins and sheet metal of that section, separating it from the adjacent roof. When the section was loose, the crane lifted it and with the help of guide ropes placed it flat near the metal debris container, where purlins and sheet metal were separated to maximize the use of container space (Figure 13). In some cases, the roof sections were dropped to the floor and were removed by the loader.

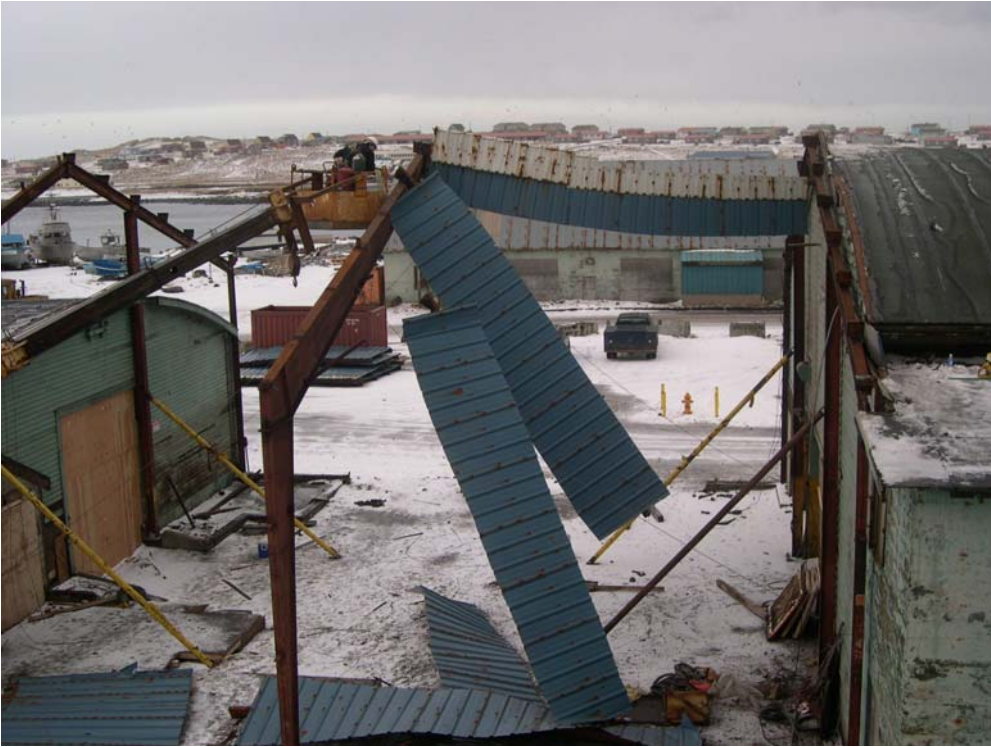
Figure 14. Removal of roof sections without the crane

The last one quarter section of the roof was removed without the crane. A BSE welder cut the sheet metal of the roof into narrow sections, each resting on one purlin in its center. The welder then cut the purlin on one end and let the end of that roof section drop. The purlin on the other end was cut next, and the whole section dropped to the floor (Figure 14). The sections on the floor were later removed with a loader and disassembled for recycling.

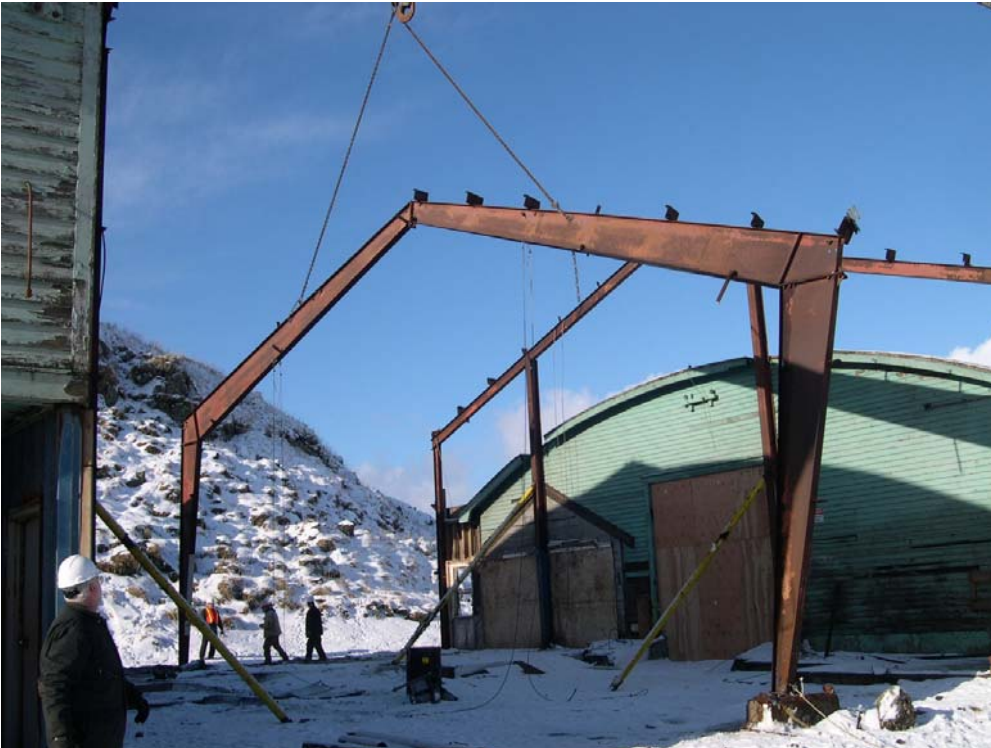
Figure 15. Removal of the center frame

The building frames were removed next, beginning with the center frame. The crane was attached to the frame and tension was applied. The frame footings were cut from their concrete foundation with a cutting torch. The cables supporting the frame were then cut, and the whole frame was lifted as one unit. The crane slowly pulled it northward and laid it on the ground north of the Connector Building with the help of guiding ropes manned by the entire crew (Figure 15). The side frames were removed half at a time in a similar fashion, each section lifted by the crane and laid flat at the area north of the building for processing (Figure 16).

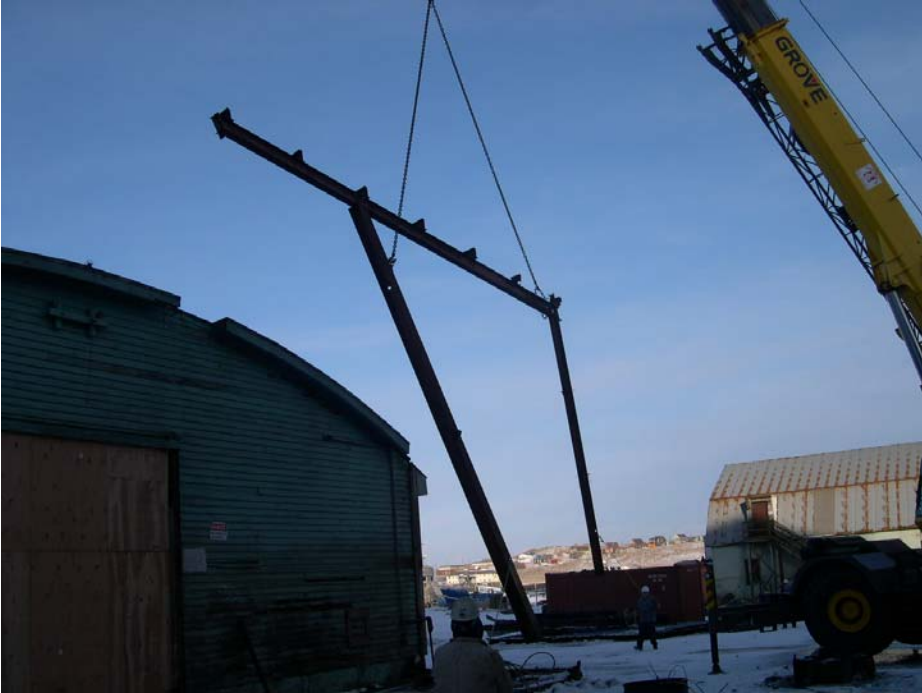
Figure 16. Removal of a section of a side frame

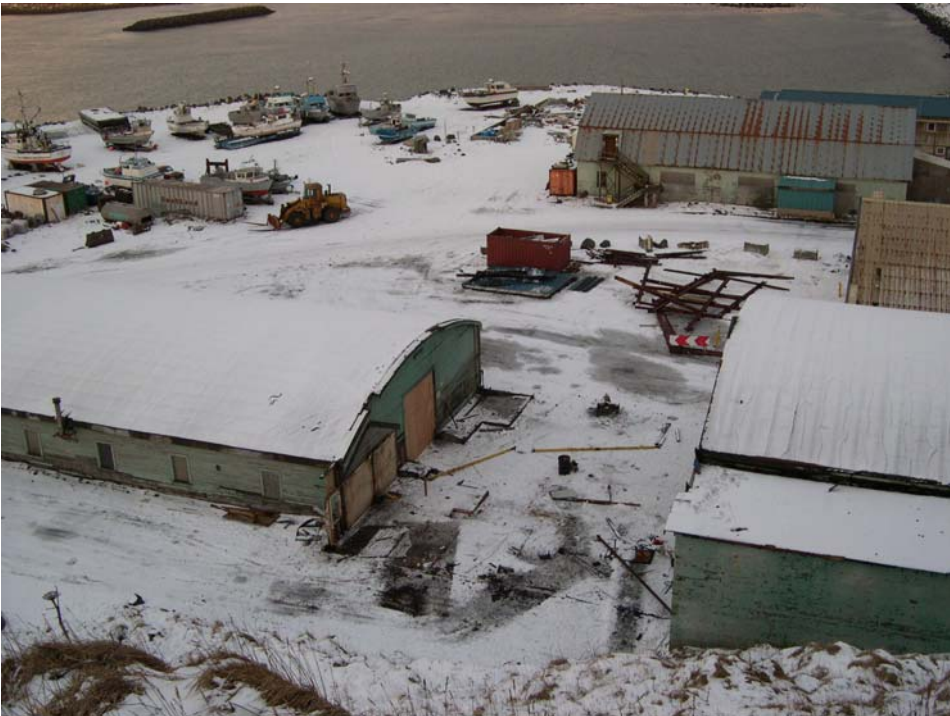
Figure 17. Aerial view of the area after the Connector Building demolition

The site where the Connector Building once stood became an open lot between the Machine Shop and the Equipment Garage (Figure 17). NOAA contractors cleaned the site of all visible debris, trash, and metal objects. At the time of demolition in February, the ground was covered with ice and snow, precluding a thorough and meticulous cleanup. NOAA tasked BSE to conduct such cleaning when conditions allowed. A fence was erected to prevent public entrance into the area.
