Request for No Further Remedial Action Planned

Site: Former Power Plant (FPP), also known as Two Party Agreement (TPA) Site 9b and National Oceanic and Atmospheric Administration (NOAA) Site 17.

Request for NFRAP
Former Power Plant, TPA 9b/Site 17
St. Paul Island, Alaska

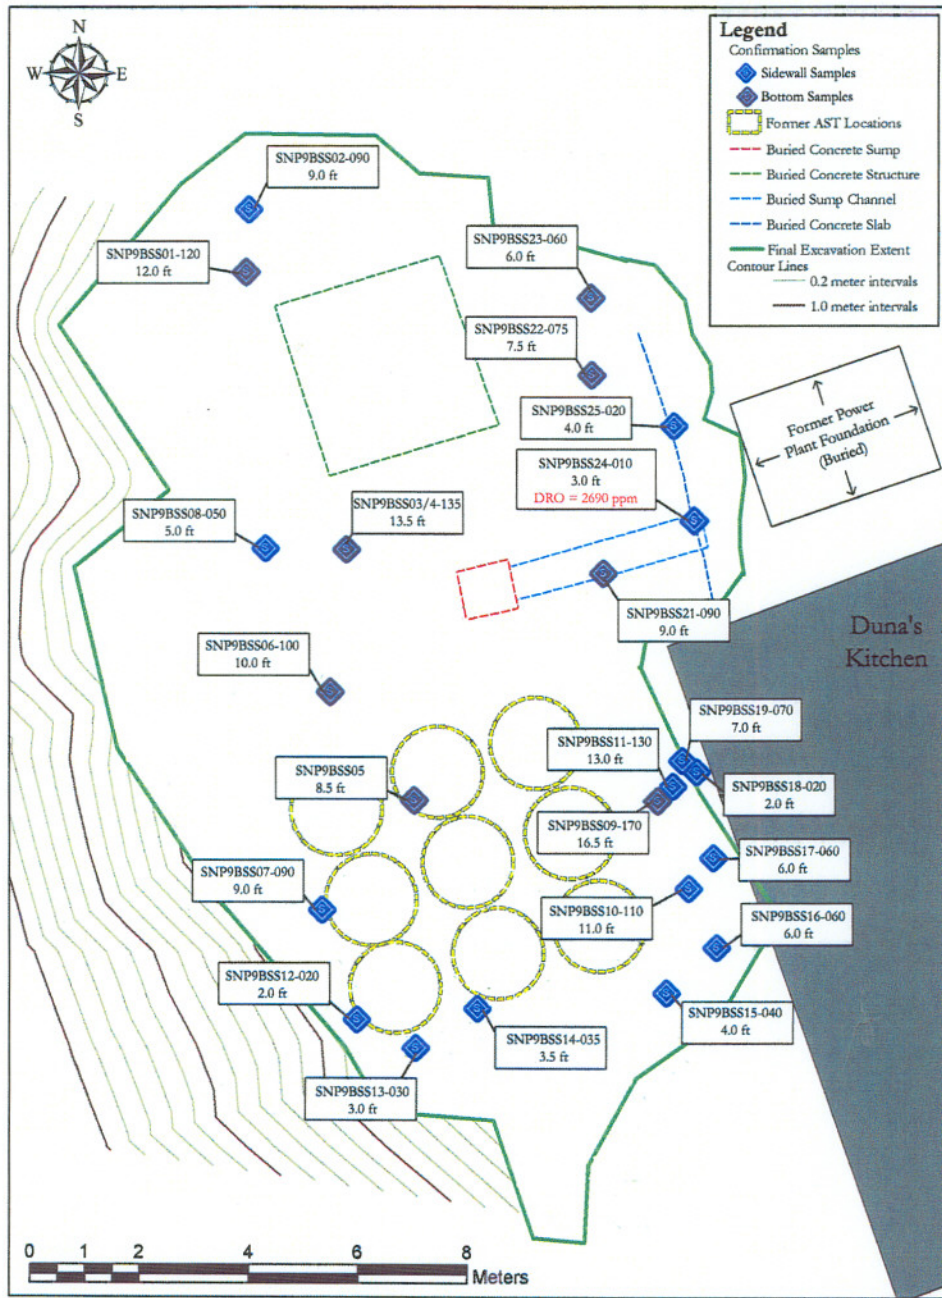
<p>Figure 3</p>	<p>Site Map Former Power Plant NOAA Site 17/TPA Site 9b St. Paul Island, Alaska</p>	<p>Source: NOAA Pribilof Project Office GIS, 2002.</p>	
---------------------	---	--	--

A 1948 Department of the Interior aerial village photograph depicts nine 1,000-gallon and one approximately 2,500-gallon aboveground storage tanks (ASTs) at the site (Department of the Interior 1951). These tanks were located within 10 feet west of the FPP building (Figure 3). It is not known when these tanks were decommissioned; however, previous investigations verified that residual contamination from the tanks existed at the site.

Confirmation sample results verified the removal of all soil contamination to alternative cleanup levels or better with the exception of one area (Table 1, Figure 3). Sample SNP9BSS24-010, collected below a concrete slab north of Duna's Kitchen, contained 2,690 mg/kg DRO, exceeding the alternative cleanup level of 2,500 mg/kg. DRO contamination above the more stringent Method Two criterion of 250 mg/kg remains in several locations including at refusal, below the steep slope supporting Short Street, and under portions of the former Post Office building. Therefore, soils were removed from this location to the maximum extent practical. All other target analytes were detected below cleanup levels established for this site.

A total of 420 yd³ of soil was removed from the FPP site. After excavation activities were completed, confirmation soil samples were collected and analyzed for the petroleum-related compounds identified in the project corrective action plan (NOAA 2002; Figure 3). The site was backfilled with clean soil and restored to grade, and large boulders were placed against the slope to prevent erosion (Figure 9).

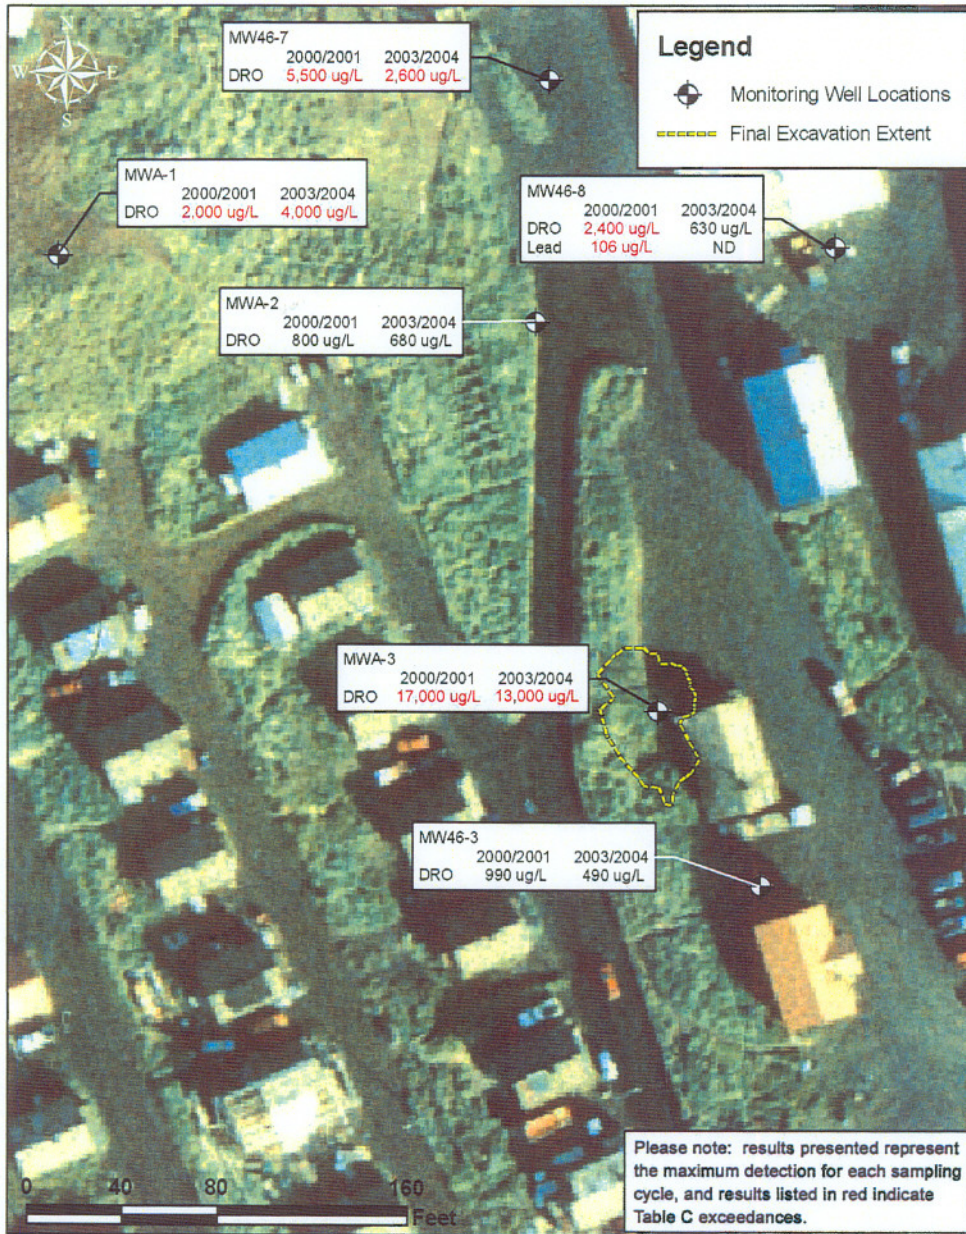
Figure 4 Groundwater Sampling Results Former Power Plant NOAA Site 17/TPA Site 9b St. Paul Island, Alaska

NOAA contractors conducted quarterly groundwater monitoring from September 2000 to September 2001 and from October 2003 to July 2004 in the vicinity of the FPP (Figure 4). During 2000-2001 sampling events, DRO was detected in MWA-3, an on-site well, at a concentration of 17,000 ug/L, exceeding the Alaska Department of Environmental Conservation (ADEC) Table C cleanup criterion of 1,500 ug/L (IT Alaska Corp. 2002). DRO was also detected below its cleanup criterion in two nearby wells, MW46-3 and MWA-2. During the first three quarters of 2003-2004 sampling, DRO was again detected above its Table C cleanup level in MWA-3, with a maximum concentration of 13,000 ug/L. MW46-3 and MWA-2 contained DRO below its cleanup criterion. A full report on 2003-2004 sampling events will be available late in 2004.

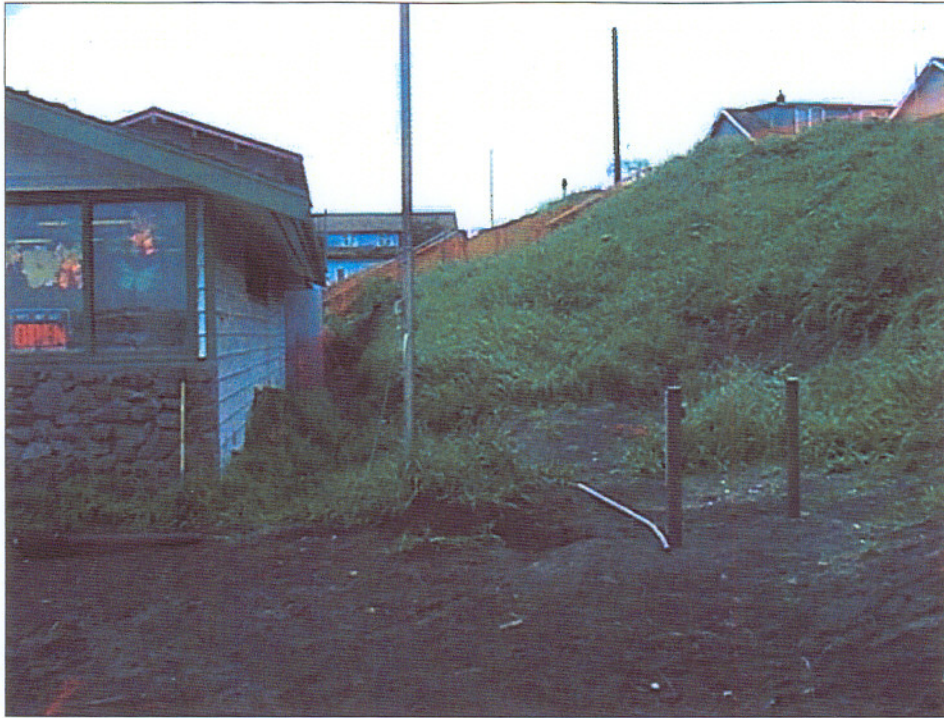
Figure 5. Former Power Plant site prior to excavation

Bering Sea Eccotech (BSE) initiated cleanup actions at the FPP on July 18, 2002 (NOAA 2003, Figure 5). Contaminated soils were excavated and removed from the site following the direction of a field engineer (Figures 6 and 7). The soils were loaded directly into trucks and transported to the petroleum-contaminated soil (PCS) stockpile at the St. Paul Blubber Dump Site pending treatment by NOAA's on-site enhanced thermal conduction (ETC) system (BSE 2003).

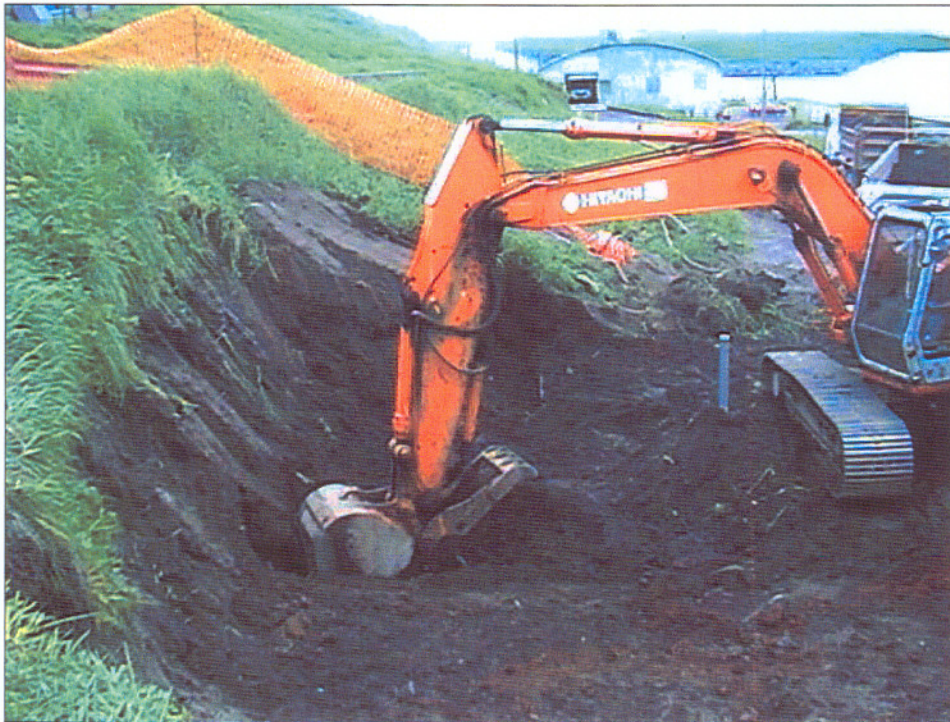
Figure 6. Excavating petroleum contaminated soils northwest of Duna's Kitchen

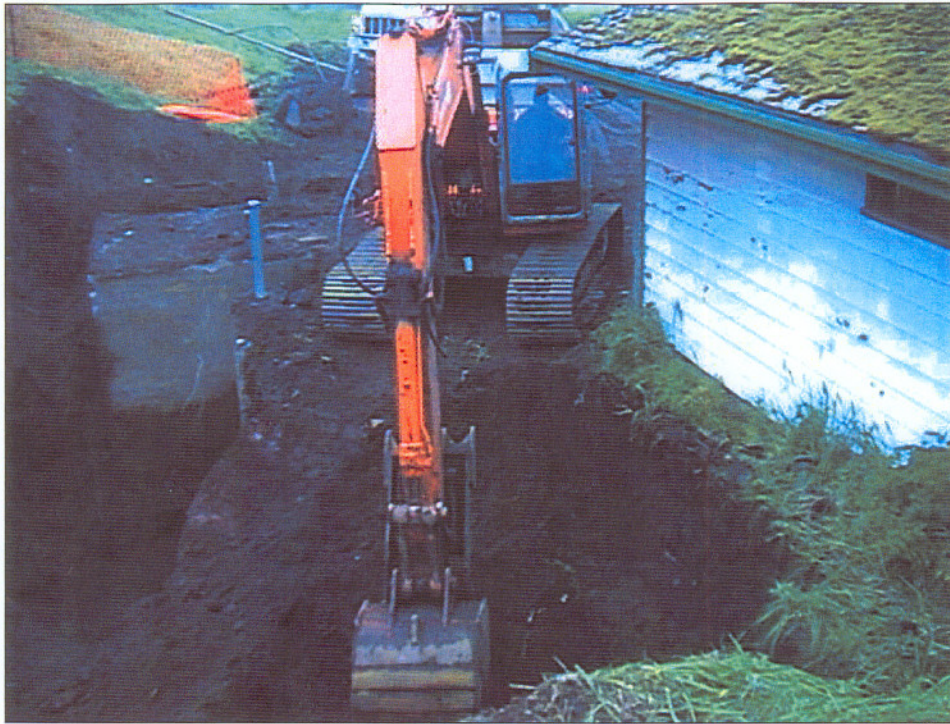
Figure 7. Excavation of petroleum contaminated soils west and south of Duna's Kitchen

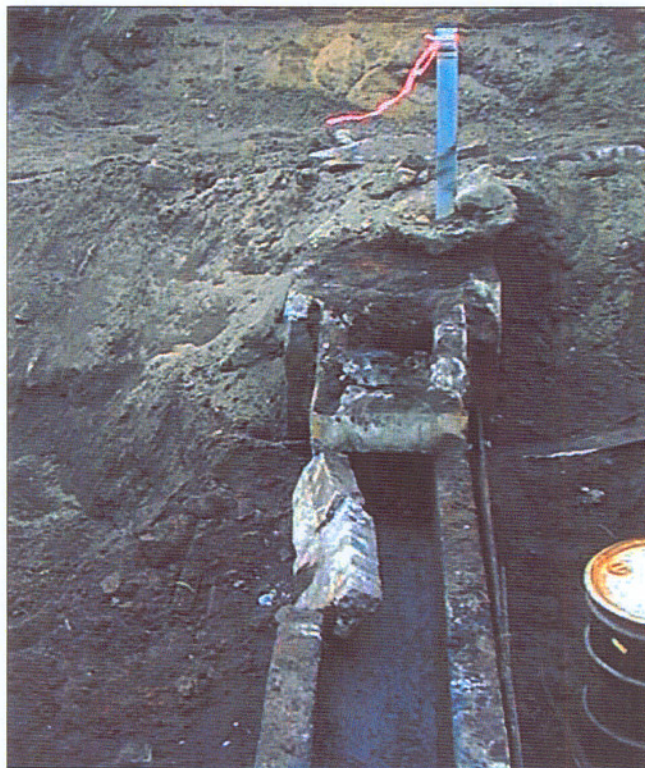
During the excavation, a concrete structure containing a chase and sump was uncovered (Figure 8). It contained a significant amount of sludge and oily debris. At the direction of the field engineer, sludge from the concrete chase and sump were removed and placed in 55-gallon drums for characterization and disposal.

Figure 8. Waste oil trough west of FPP slab – north of Duna's Kitchen

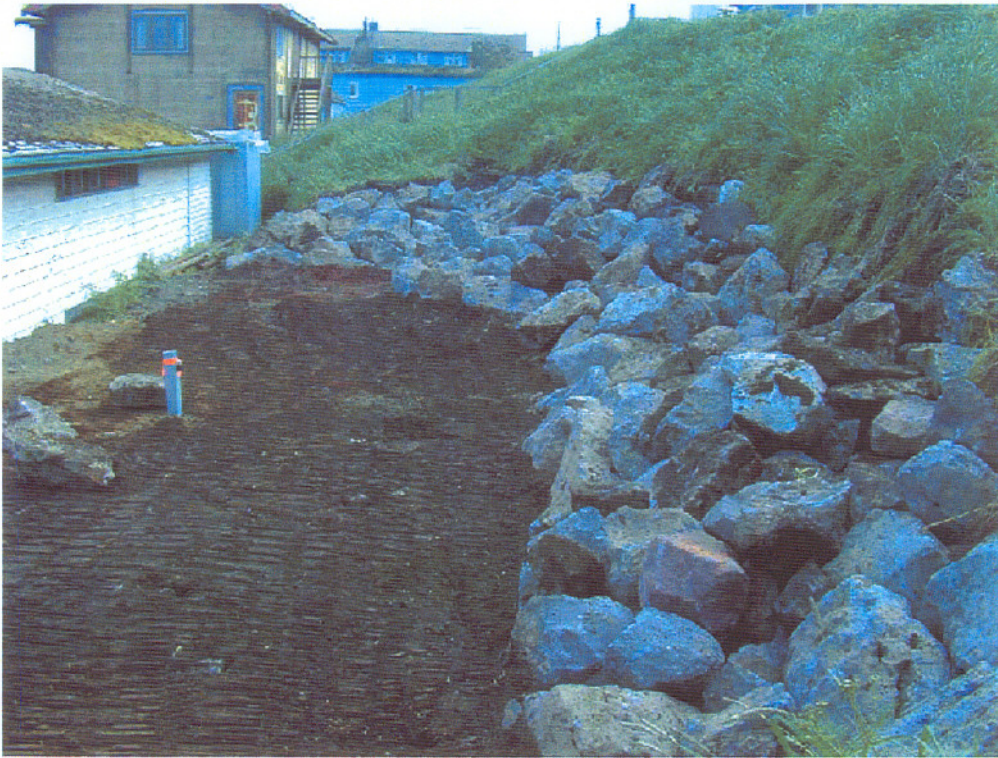
Figure 9. Final grade and rock wall to prevent erosion.
