## Request for No Further Remedial Action Planned

The Five Car Garage and Anderson Building, also known as Two Party Agreement (TPA) Site 9j and National Oceanic and Atmospheric Administration (NOAA) Site 25

Request for NFRAP  
TPA Site 9j - Five Car Garage and Anderson Building

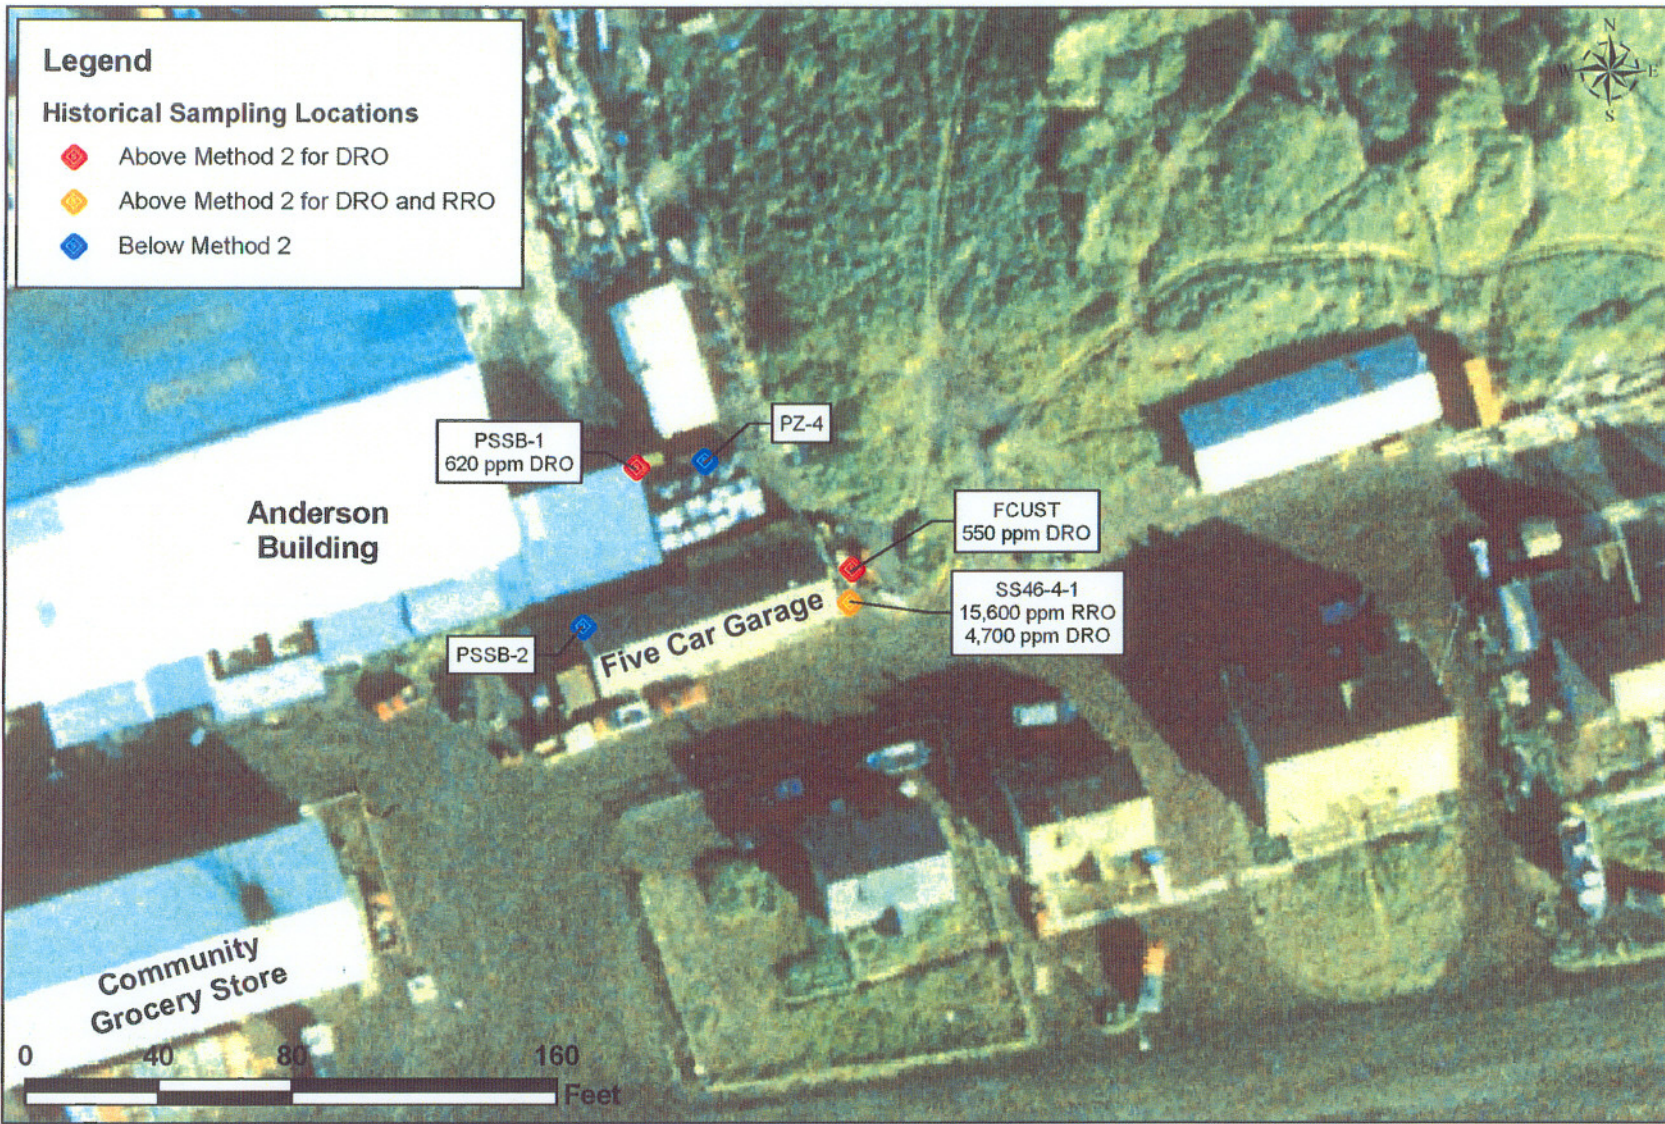
<p>Figure 3</p>	<p>Historical Sampling Results Five Car Garage and Anderson Building Site 25/TPA Site 9j St. Paul Island, Alaska</p>	<p>Sources: Historical Sampling Locations (NOAA GIS 2004), Aerial Photo (Aeromap US 1996).</p>
---------------------	--	--

Soil analytical data collected during these events revealed the presence of petroleum contamination including diesel-range organic compounds (DRO) and residual-range organic compounds (RRO) at maximum concentrations of 4,700 milligrams per kilogram (mg/kg) and 15,600 mg/kg, respectively. These concentrations exceed the ADEC levels under Method 2 and alternate method cleanup levels (ADEC 2000). The results and locations of these historical soil samples are shown on Figure 3.

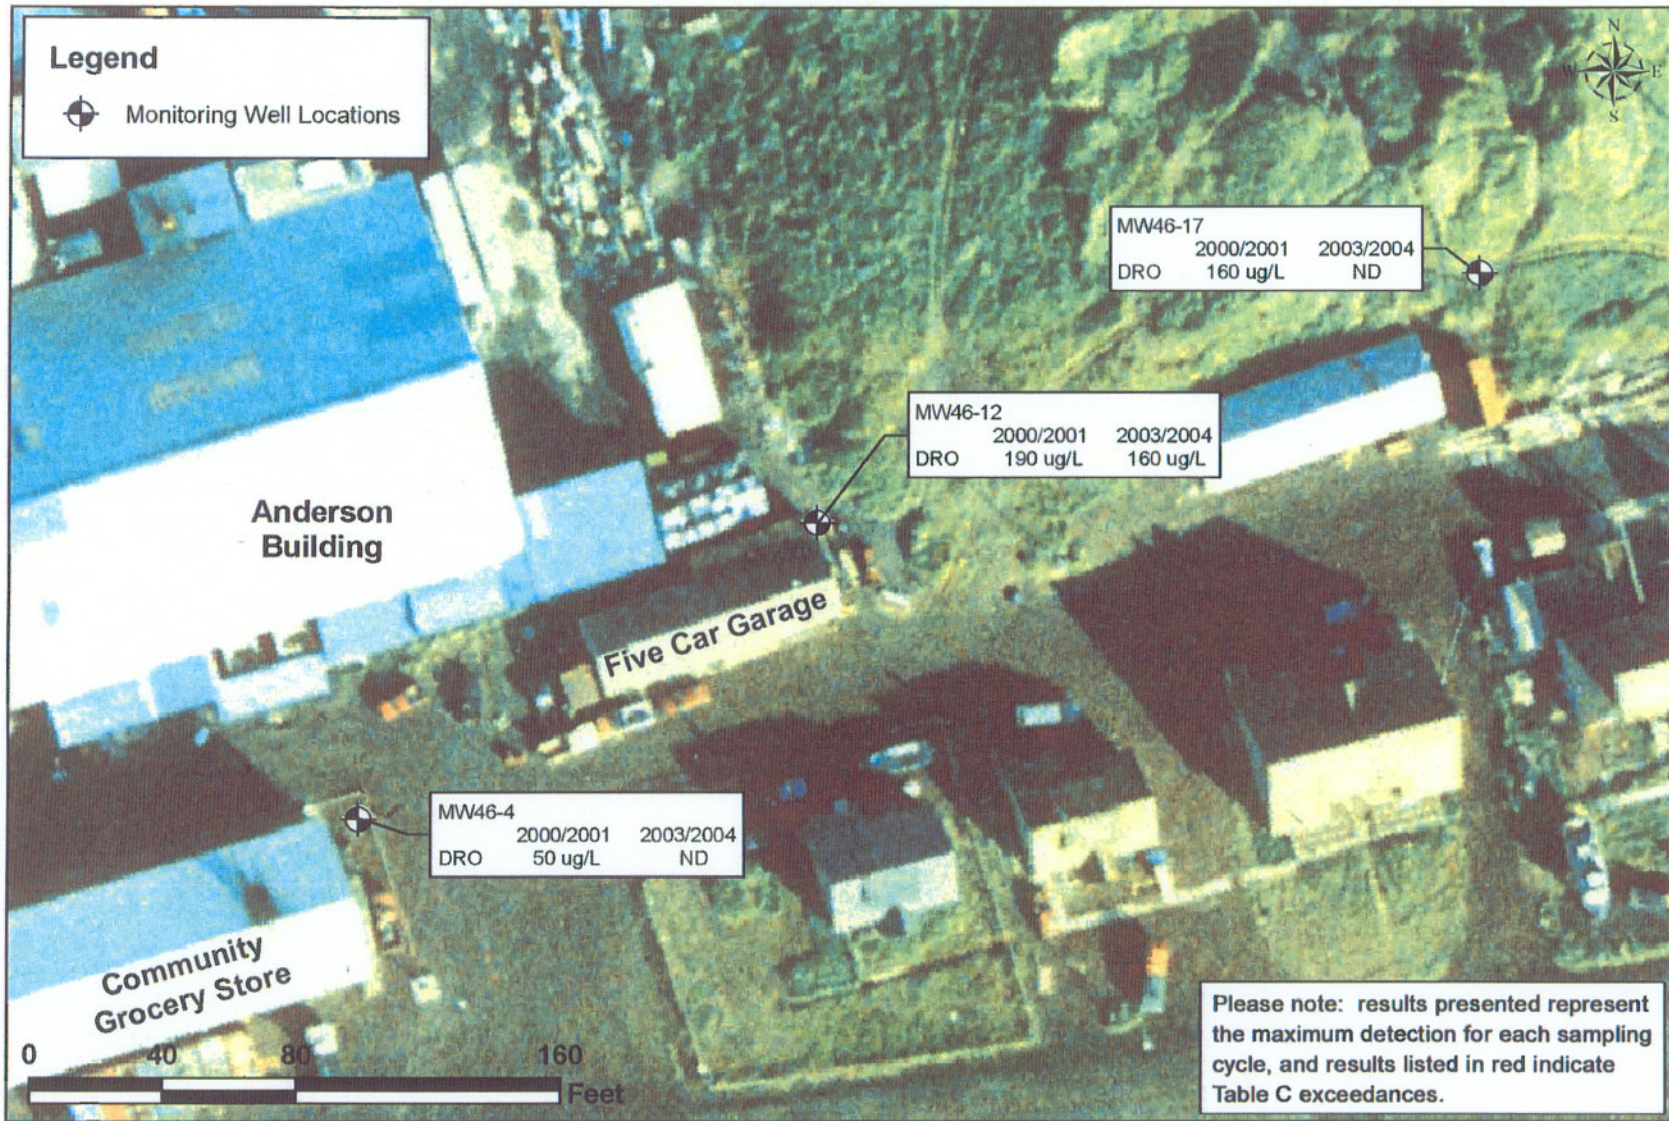
Figure 4  
 Groundwater Sampling Results  
 Five Car Garage and Anderson Building  
 Site 25/TPA Site 9j  
 St. Paul Island, Alaska

NOAA contractors conducted quarterly groundwater monitoring at 3 monitoring wells in the vicinity of the Five Car Garage and Anderson Building (Figure 4). Results detected diesel range organics (DRO) at low levels during all sampling events, but never above the Table C cleanup levels. No other contaminants exceeded the Table C cleanup levels (NOAA 2003).

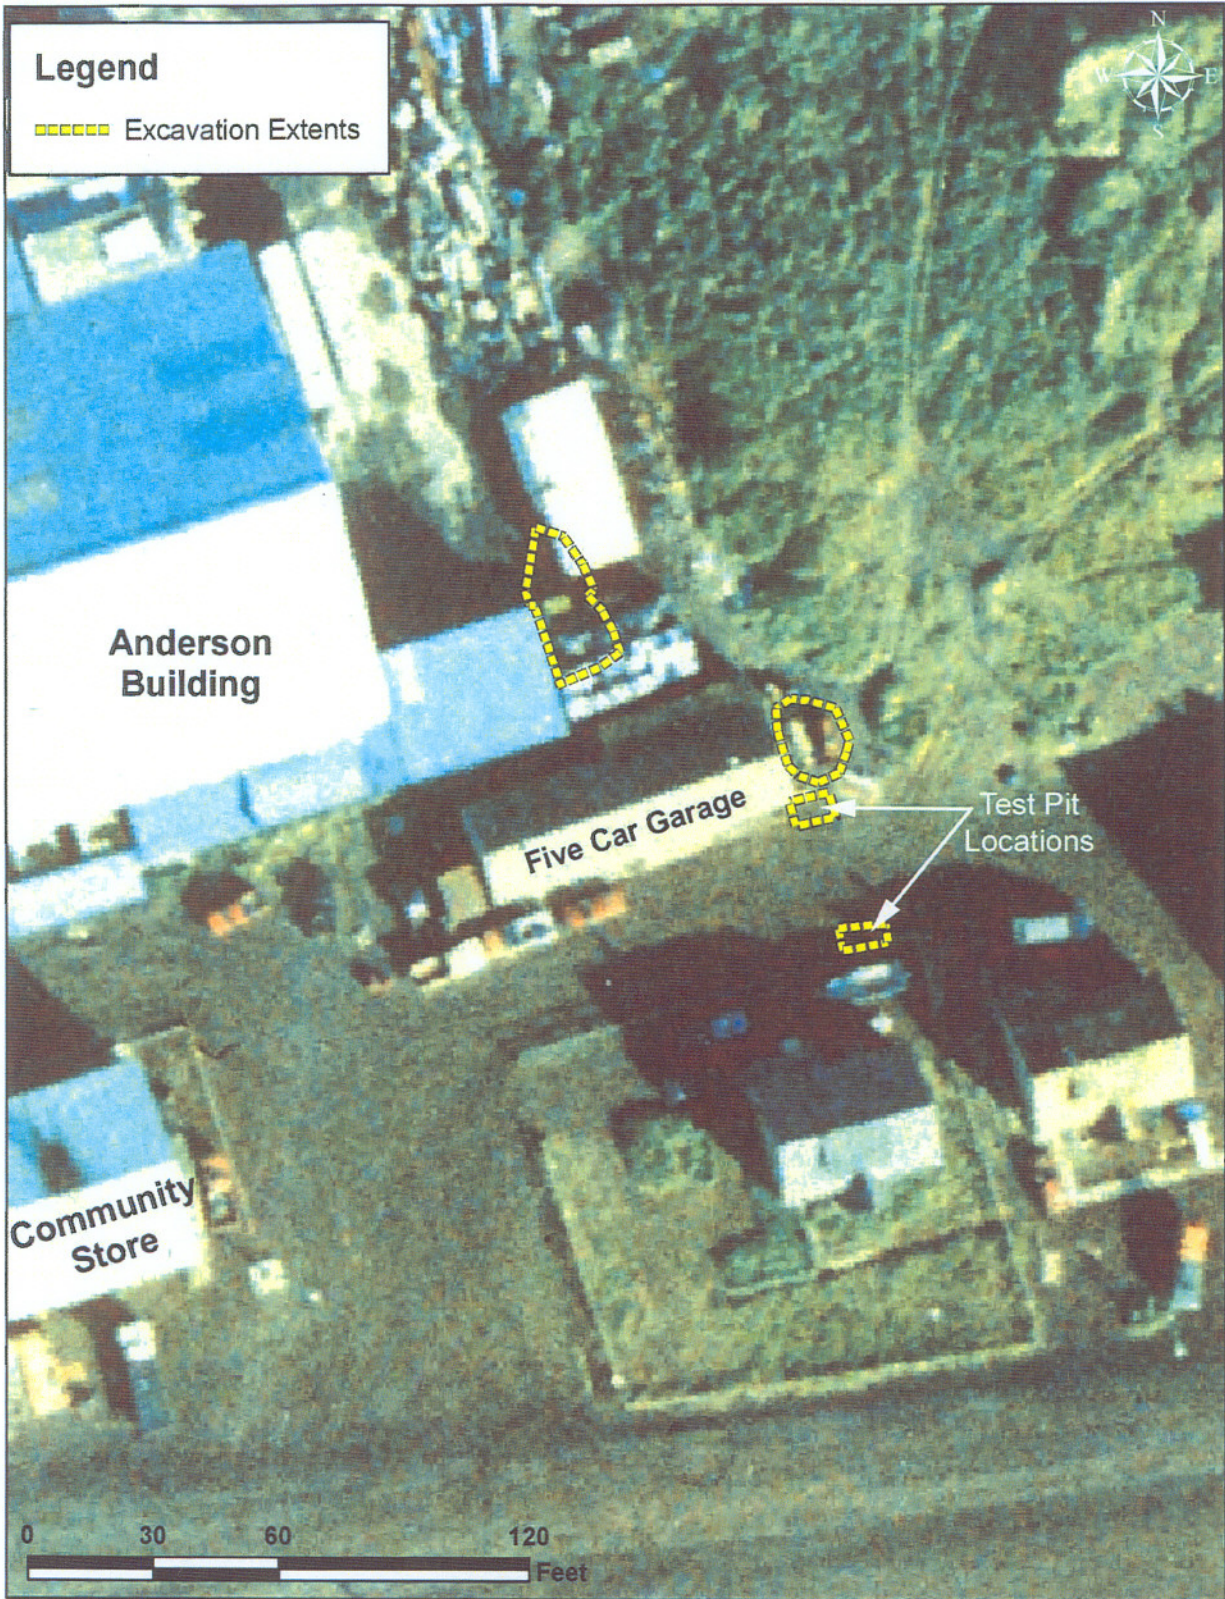
Figure  
5

Areas of Excavation  
 Anderson Building and Five Car Garage  
 Site 25/TPA Site 9j  
 St. Paul Island, Alaska

NOAA contractor Tetra Tech EM Inc. (Tetra Tech) and its subcontractor Bering Sea Eccotech (BSE) initiated corrective actions at the Former Fouke Bunkhouse on July 28, 2003 (NOAA 2004). Excavation activities began along the east side of the Five Car Garage, where the former UST was located (Figure 5). Clean overburden was removed from the area and the excavation was advanced to a maximum depth of 12 feet bgs, where groundwater was encountered at the north end of the excavation. During excavation activities, personnel uncovered a satellite cable and internet service trunk line to the island along the east side of the excavation. Additional excavation was prevented in this area due to the presence of groundwater and various utility lines, including a live electrical line and the cable line (Figure 6). Five confirmation samples were collected from the excavation including two from the bottom and three from the sidewalls. Confirmation samples were shipped for laboratory analyses, including benzene, toluene, ethylbenzene, and total xylenes (BTEX), DRO, gasoline-range organic compounds (GRO), RRO, select polynuclear aromatic hydrocarbons (PAH), and lead (Figure 6).

In addition, two test pits were excavated south of the Five Car Garage on either side of Sandy Lane to investigate reports from local officials regarding contaminated soil identified during previous construction activities in the area (Figure 5). First, a shallow test pit was excavated along the north side of Sandy Lane near the southeast corner of the Five Car Garage, but it could not be advanced beyond 2 feet bgs because of extensive, unknown utility lines; no evidence of contamination was observed and a TLC screening sample was collected from this location. Second, a test pit was excavated to a maximum depth of 6 feet bgs along the south side of Sandy Lane across from the Five Car Garage; no evidence of contamination was observed and one confirmation sample was collected from the bottom of the excavation for laboratory analyses including BTEX, DRO, GRO, RRO, select PAHs, and lead (Figure 6, Tables 1 and 2). Results from analysis of the confirmation samples indicated DRO concentrations varied from not detected to 250 mg/kg; only one of the samples collected from this site equaled or exceeded the ADEC Method Two cleanup level of 250 mg/kg, and no samples exceeded the alternative cleanup level of 2,500 mg/kg (Table 1). The elevated concentration of DRO was detected in sample SP25-CS-002-120, collected from the bottom of the north side of the excavation at 12 feet bgs. Concentrations for all other contaminants were below the ADEC Method Two cleanup levels except for one sample that exceeded the method 2 cleanup level for benzene of .02 mg/kg, sample SP25-CS-003-060, which had benzene at .41 mg/kg. Laboratory reporting limits were below ADEC Method Two cleanup levels for all analyses except benzene. For benzene, reporting limits of at most 0.03 mg/kg were achieved, which is above the ADEC Method Two cleanup level of 0.02 mg/kg, but below the alternative cleanup level of 0.5 mg/kg. No samples exceeded the alternative cleanup level for benzene of .5 mg/kg. None of the samples exceeded the ADEC method 2 levels for PAHs (Table 2).

On July 30, 2003, personnel initiated excavation activities at the Anderson Building in the vicinity of an AST located on the east side of the building (Figure 5); the AST was moved temporarily to allow excavation in this area, and was replaced upon completion of excavation activities. The area of excavation was selected based on the presence of the AST as well as historical sampling information. The excavation was advanced to a maximum depth of 7 feet bgs based on the results of TLC screening sample analyses. Six confirmation samples were collected from the excavation, including three from the bottom and three from the sidewalls. Confirmation samples were shipped for laboratory analyses including BTEX, DRO, GRO, RRO, select PAHs, and lead (Figure 6, Tables 1 and 2).

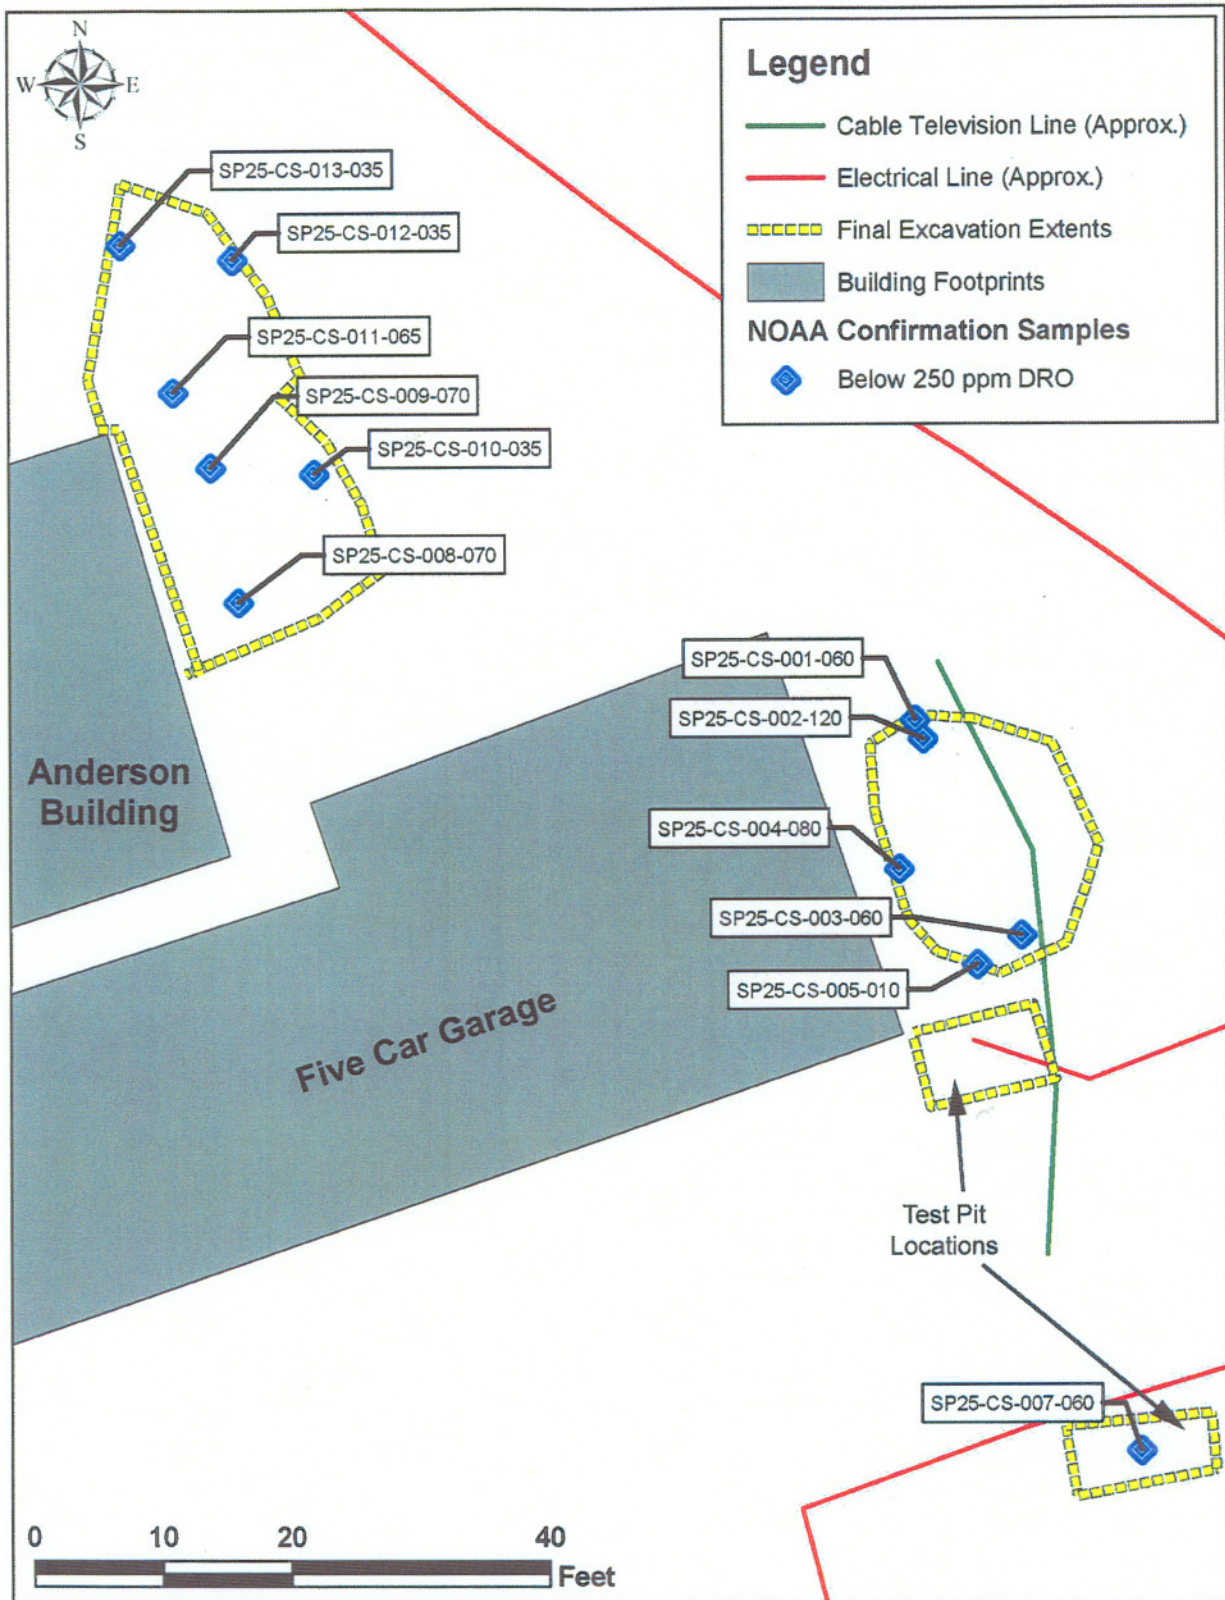
Figure  
6

Results from analysis of the confirmation samples indicated DRO was not detected, with detection limits of 10 mg/kg, which is below the ADEC Method Two cleanup level of 250 mg/kg, (Table 1). Concentrations for all other contaminants were below the ADEC Method Two cleanup levels. Laboratory reporting limits were below ADEC Method Two cleanup levels for all analyses except benzene. For benzene, reporting limits of at most 0.04 mg/kg were achieved, which is above the ADEC Method Two cleanup level of 0.02 mg/kg, but below the alternative cleanup level of 0.5 mg/kg. No benzene was detected.
