Conditional Closure Request

Site: Old Carpenter Shop, also known as St. George Island Two Party Agreement (TPA) Site 19 and as National Oceanic and Atmospheric Administration (NOAA) Site 19.

Conditional Closure Request
Old Carpenter Shop
TPA Site19/NOAA Site 19
St. George Island, Alaska

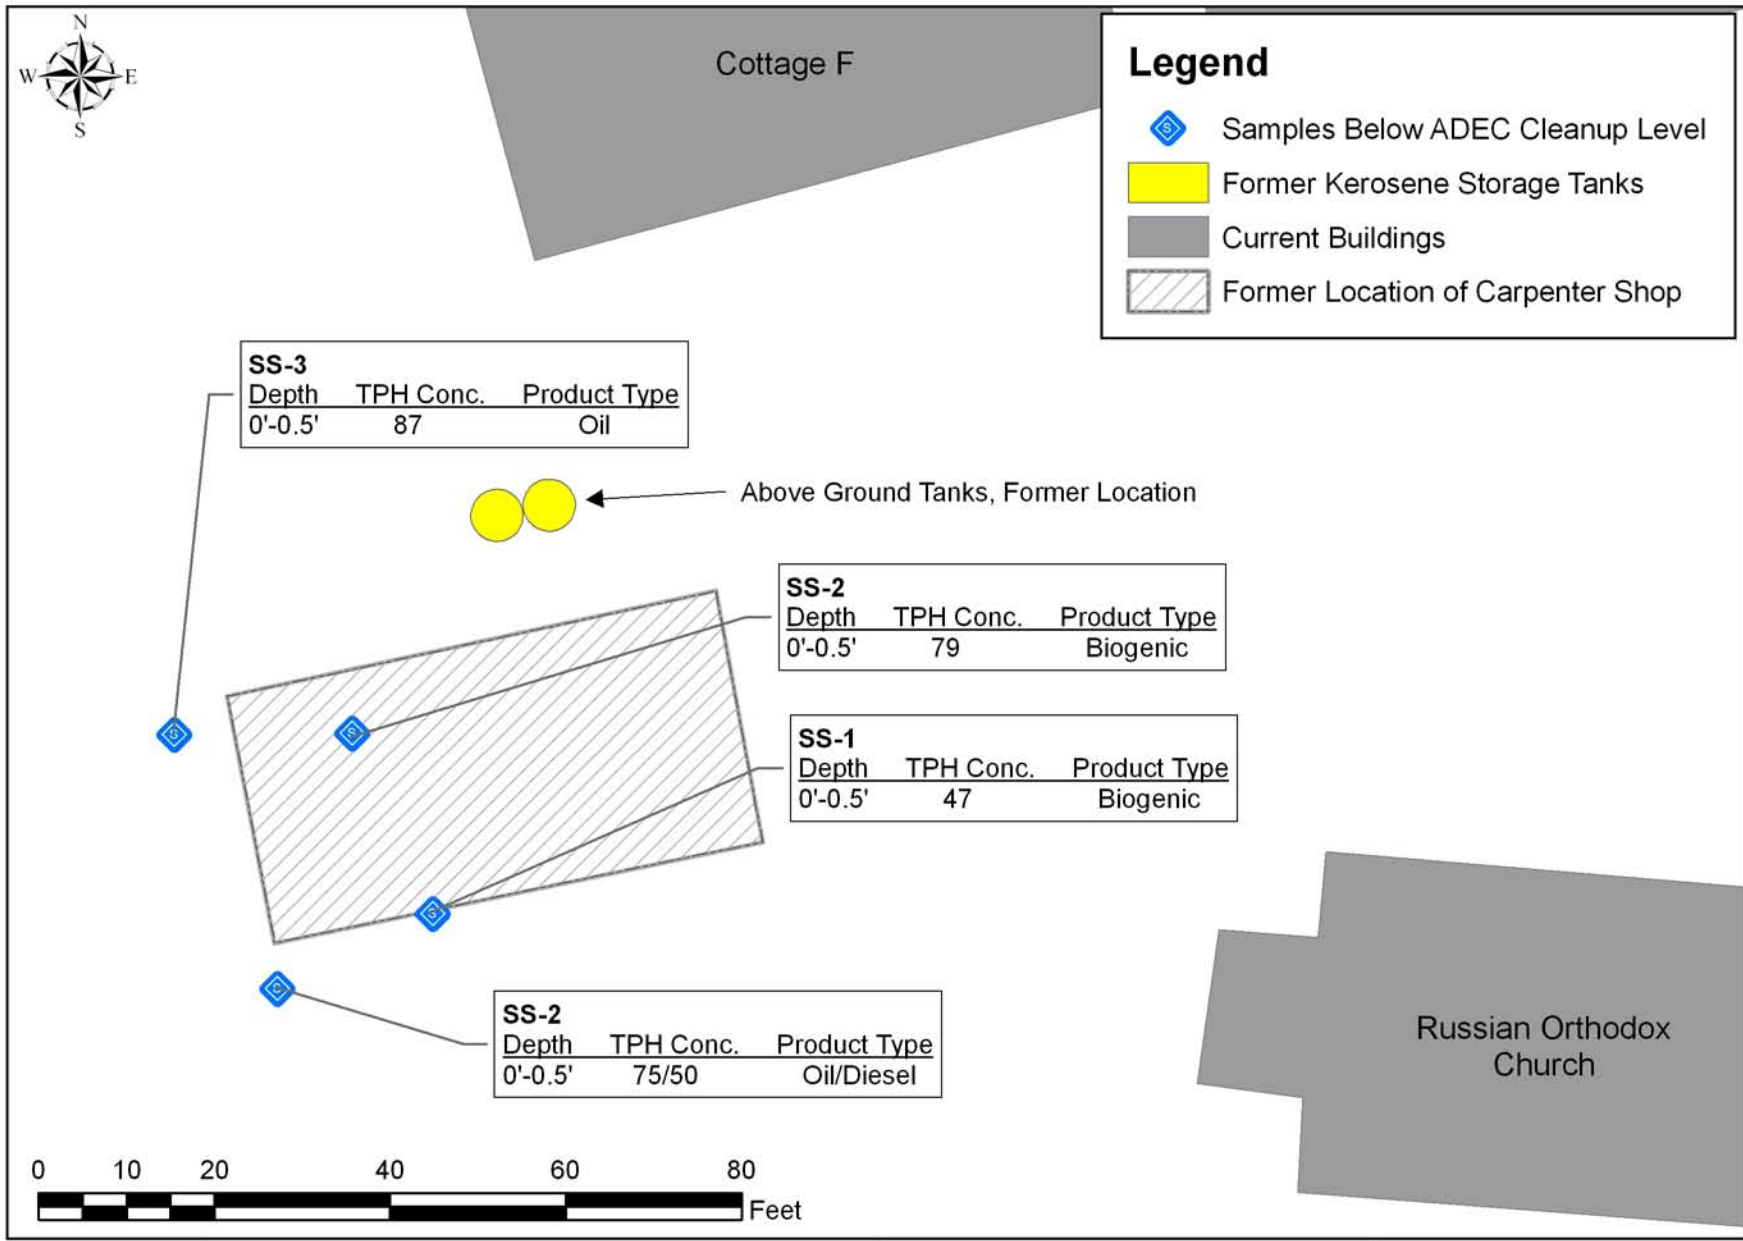
3

In 1996, Hart Crowser conducted an environmental investigation on St. George Island that included TPA Site 19. The site was divided into four quadrants and a surface soil sample (0 to 0.5 feet bgs) was collected from each quadrant (Figure 3). Each sample was analyzed for benzene, toluene, ethylbenzene and xylenes (BTEX); gasoline range organics (GRO); diesel range organics (DRO), and residual range organics (RRO). Analytical results indicated detection of DRO and RRO below Alaska Department of Environmental Conservation (ADEC) cleanup standards, with no detection of GRO and BTEX (Hart Crowser 1997). Hart Crowser's investigation report recommended no further action at TPA Site 19.

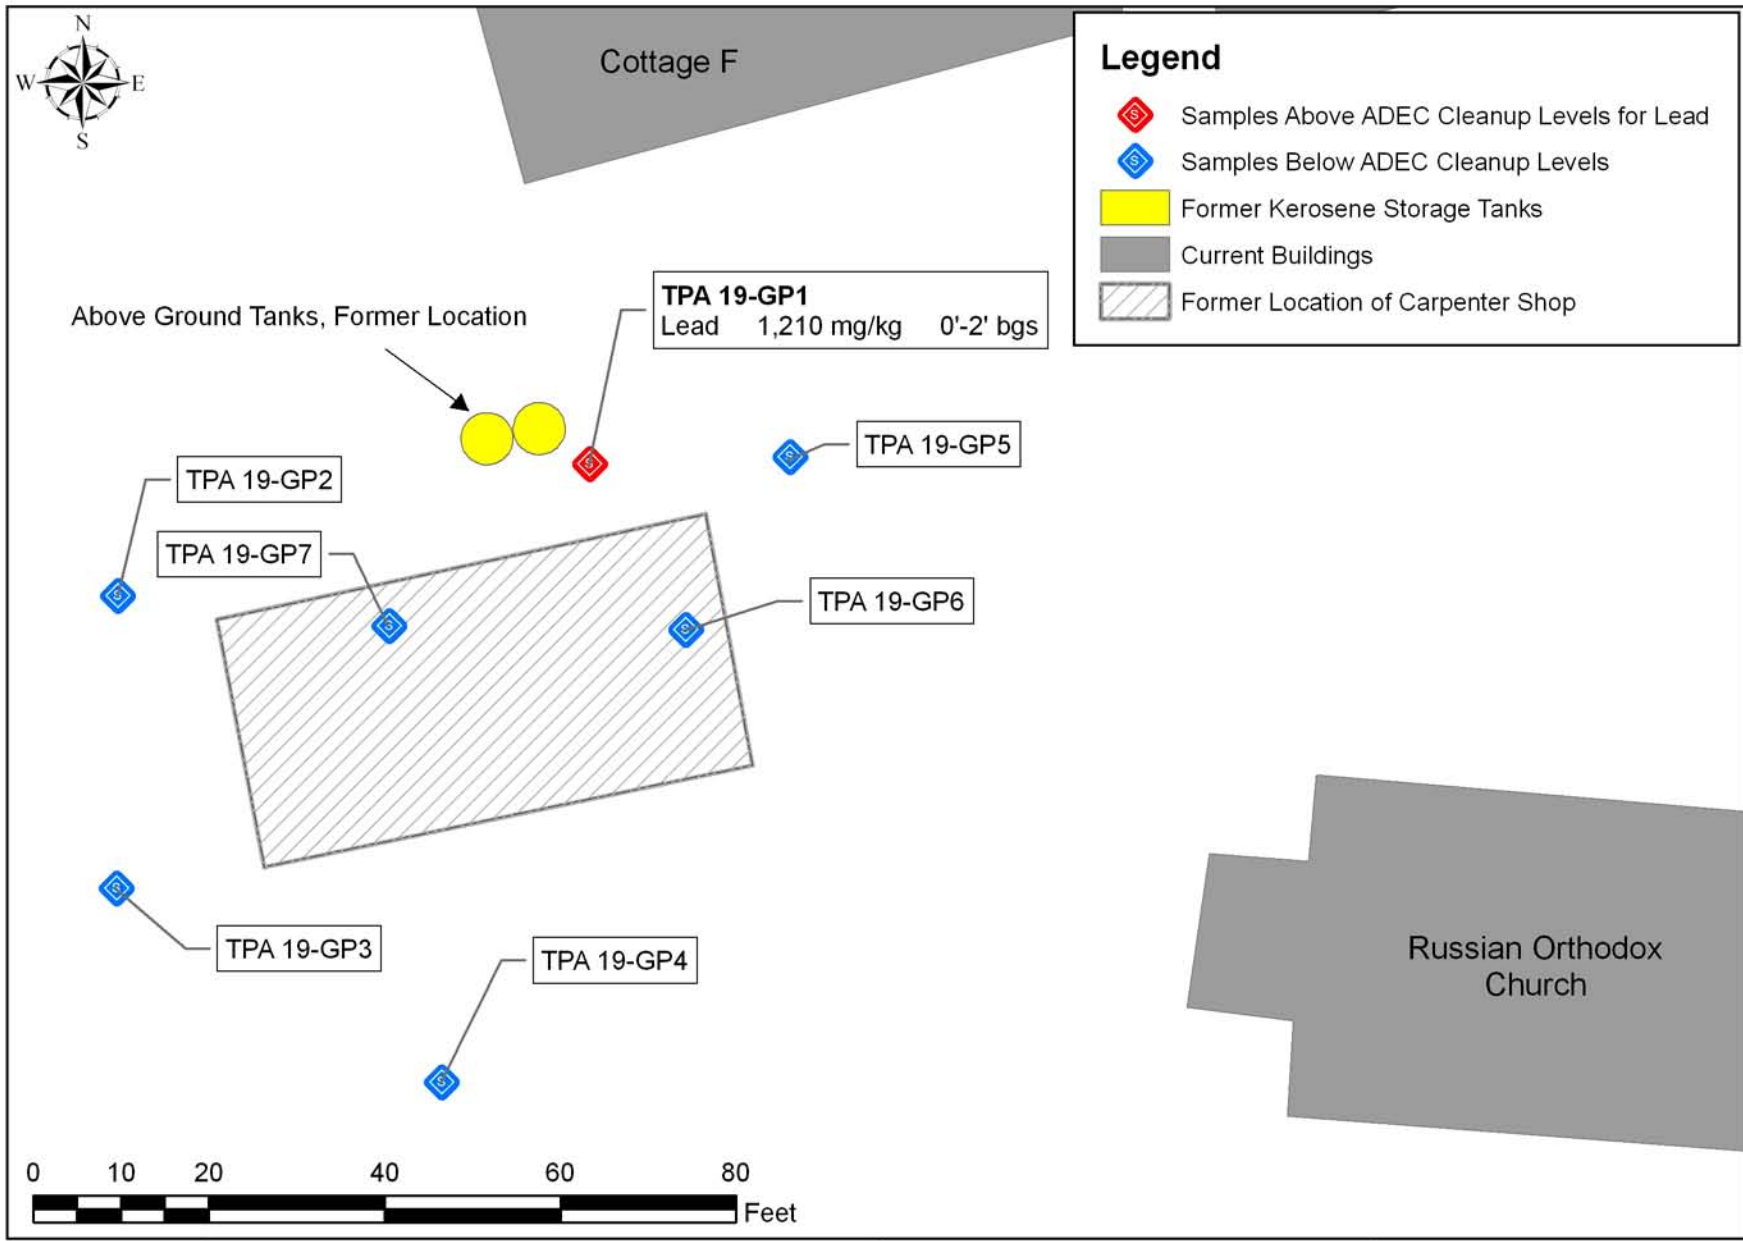
In 2001, Tetra Tech EM Inc. (Tetra Tech) conducted an environmental site characterization at TPA Site 19 which consisted of searching for underground storage tanks (USTs) and advancing seven soil borings up to 4 feet bgs (Figure 4). No USTs were located at the site. Thirteen samples were collected from the borings and analyzed at a fixed laboratory for GRO, DRO, RRO, volatile organic compounds (VOC), semi-volatile organic compounds (SVOC) and metals. Analytical results indicated either no detection, or detection well below ADEC cleanup standards for GRO, DRO, RRO, VOC and SVOC. All metals were detected at or below natural

background levels with the exception of lead. Lead was detected at one boring location (TPA19-GP1, Figure 4) at 1,210 milligrams per kilogram (mg/kg), which is above the ADEC Method Two residential cleanup criterion of 400 mg/kg (Tetra Tech 2002). The elevated concentration of lead found at TPA19-GP1 came from the 0 to 2 feet bgs sampling interval. The lead concentration from the 2 to 3.5 feet bgs was 16 mg/kg, indicating a fairly narrow band of lead contaminated soil. Tetra Tech's site characterization report recommended removal of the lead contaminated soil, the volume of which was estimated to be 3.7 cubic yards (Tetra Tech 2002).

On August 30, 2002, NOAA excavated the area surrounding the location of Tetra Tech sample TPA19-GP1 (Figure 4) to approximately 5 feet bgs and collected soil samples to facilitate delineation of the extent of lead-contaminated soil. In the excavation, a dark layer of soil 1 to 4 inches thick was observed approximately 0.5 to 1.5 feet bgs (Polarconsult 2004a). This distinct soil layer contained glass, paint chips and other debris, and appeared to be the original ground surface prior to demolition of the building. Eleven (plus one duplicate) discrete samples were collected from the excavation bottom and side walls (Figure 5); sample analyses included total lead, Toxicity Characteristic Leaching Procedure (TCLP) lead, GRO, DRO, and BTEX. Analytical results indicated lead was the only contaminant present in concentrations above ADEC cleanup requirements. Five of the eleven samples were collected from the dark layer; of these, four samples had lead concentrations above the ADEC cleanup criterion. All of the samples collected outside of the dark layer had lead concentrations well below the cleanup criterion. Based on these results, the project team decided that the dark layer of soil was a good field indicator for the presence of lead contamination. This excavation produced approximately one cubic yard (CY) of contaminated soil which was placed in a flexible individual bulk container (FIBC) and stored for future off-island disposal.

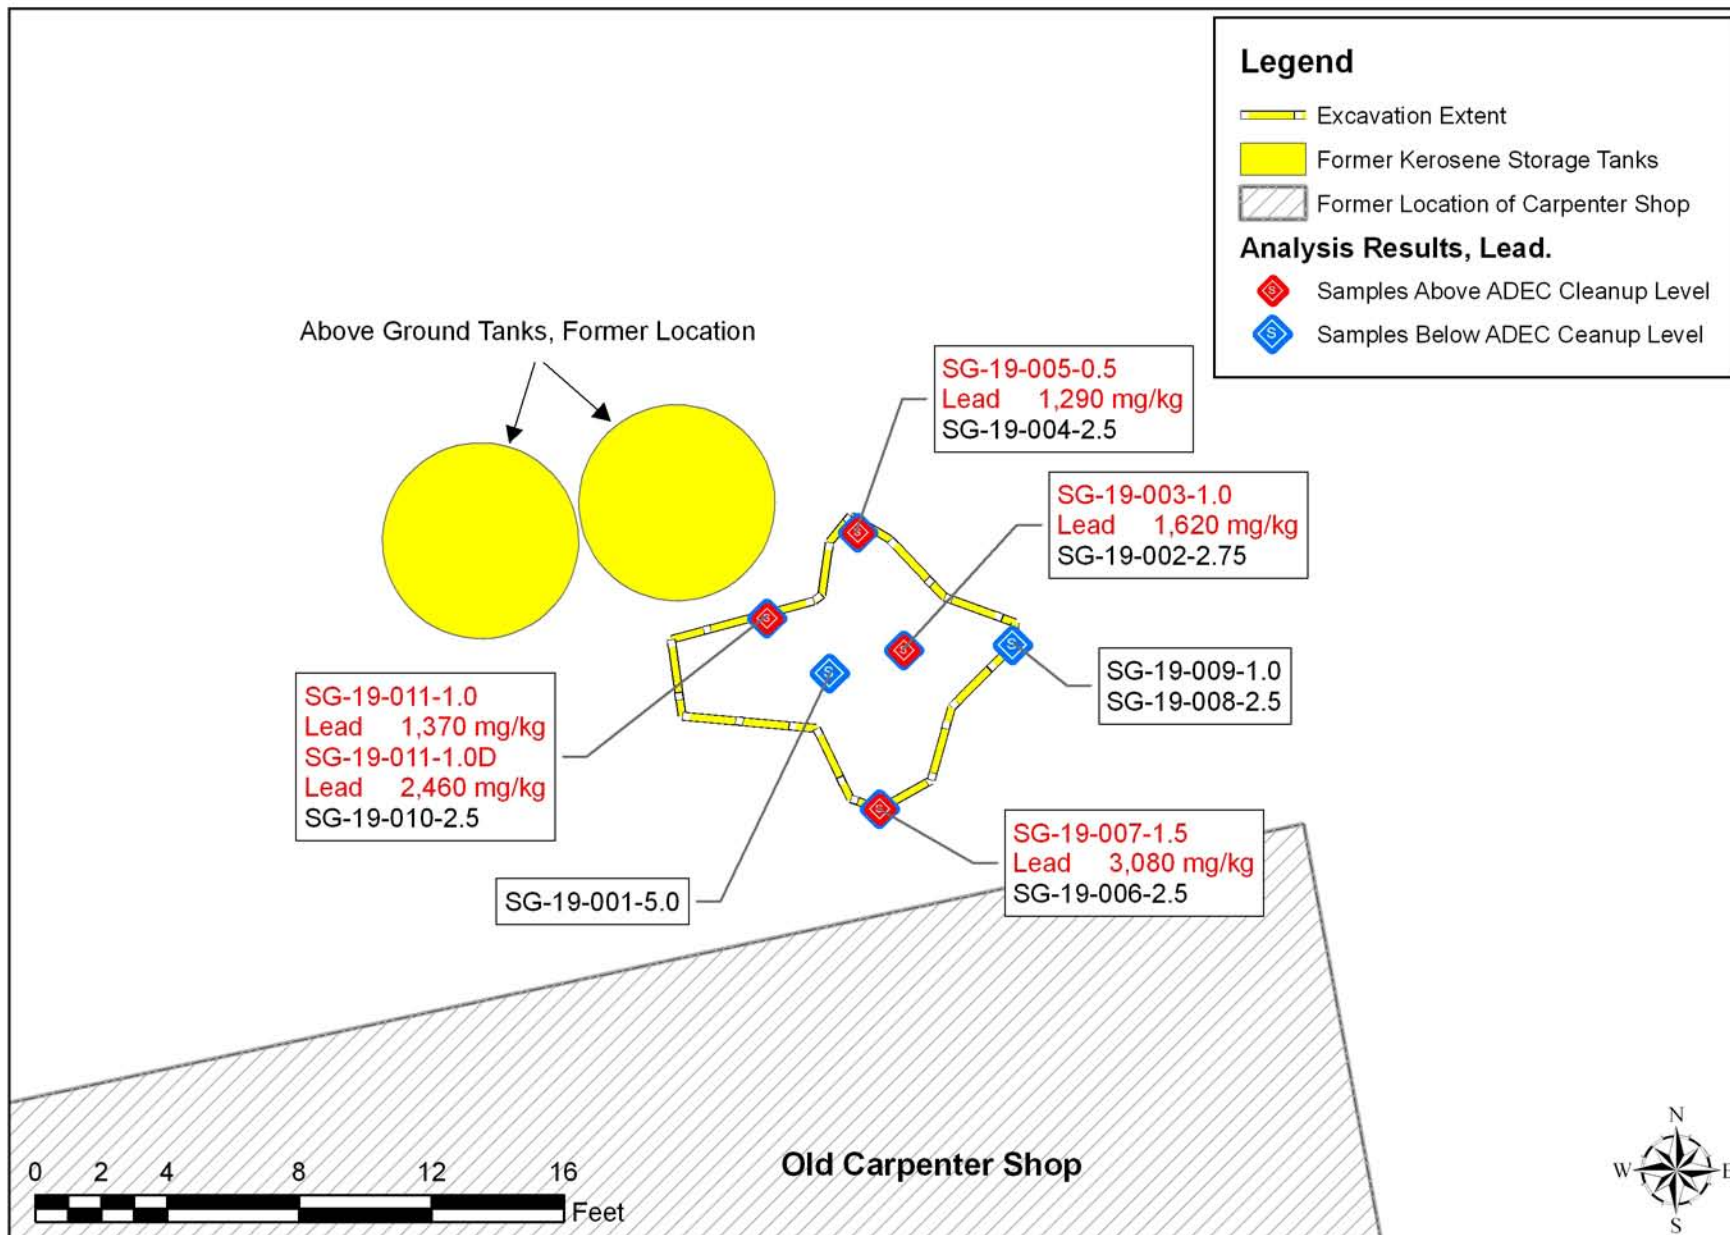
5

On October 18, 23, and 24, 2002, NOAA used a Geoprobe to advance 20 boreholes to depths of between 3.5 and 5.5 feet bgs. The boreholes were driven in the area around the August 2002 excavation site and the buried shop foundation. Continuous core samples were collected from each location with the thought that the extent and volume of the dark layer could be determined by examination of the soil within the acetate collection tubes. However, the dark layer was not easily distinguishable within the collection tubes, most likely due to cross section distortion produced during the boring (Polarconsult 2004a).

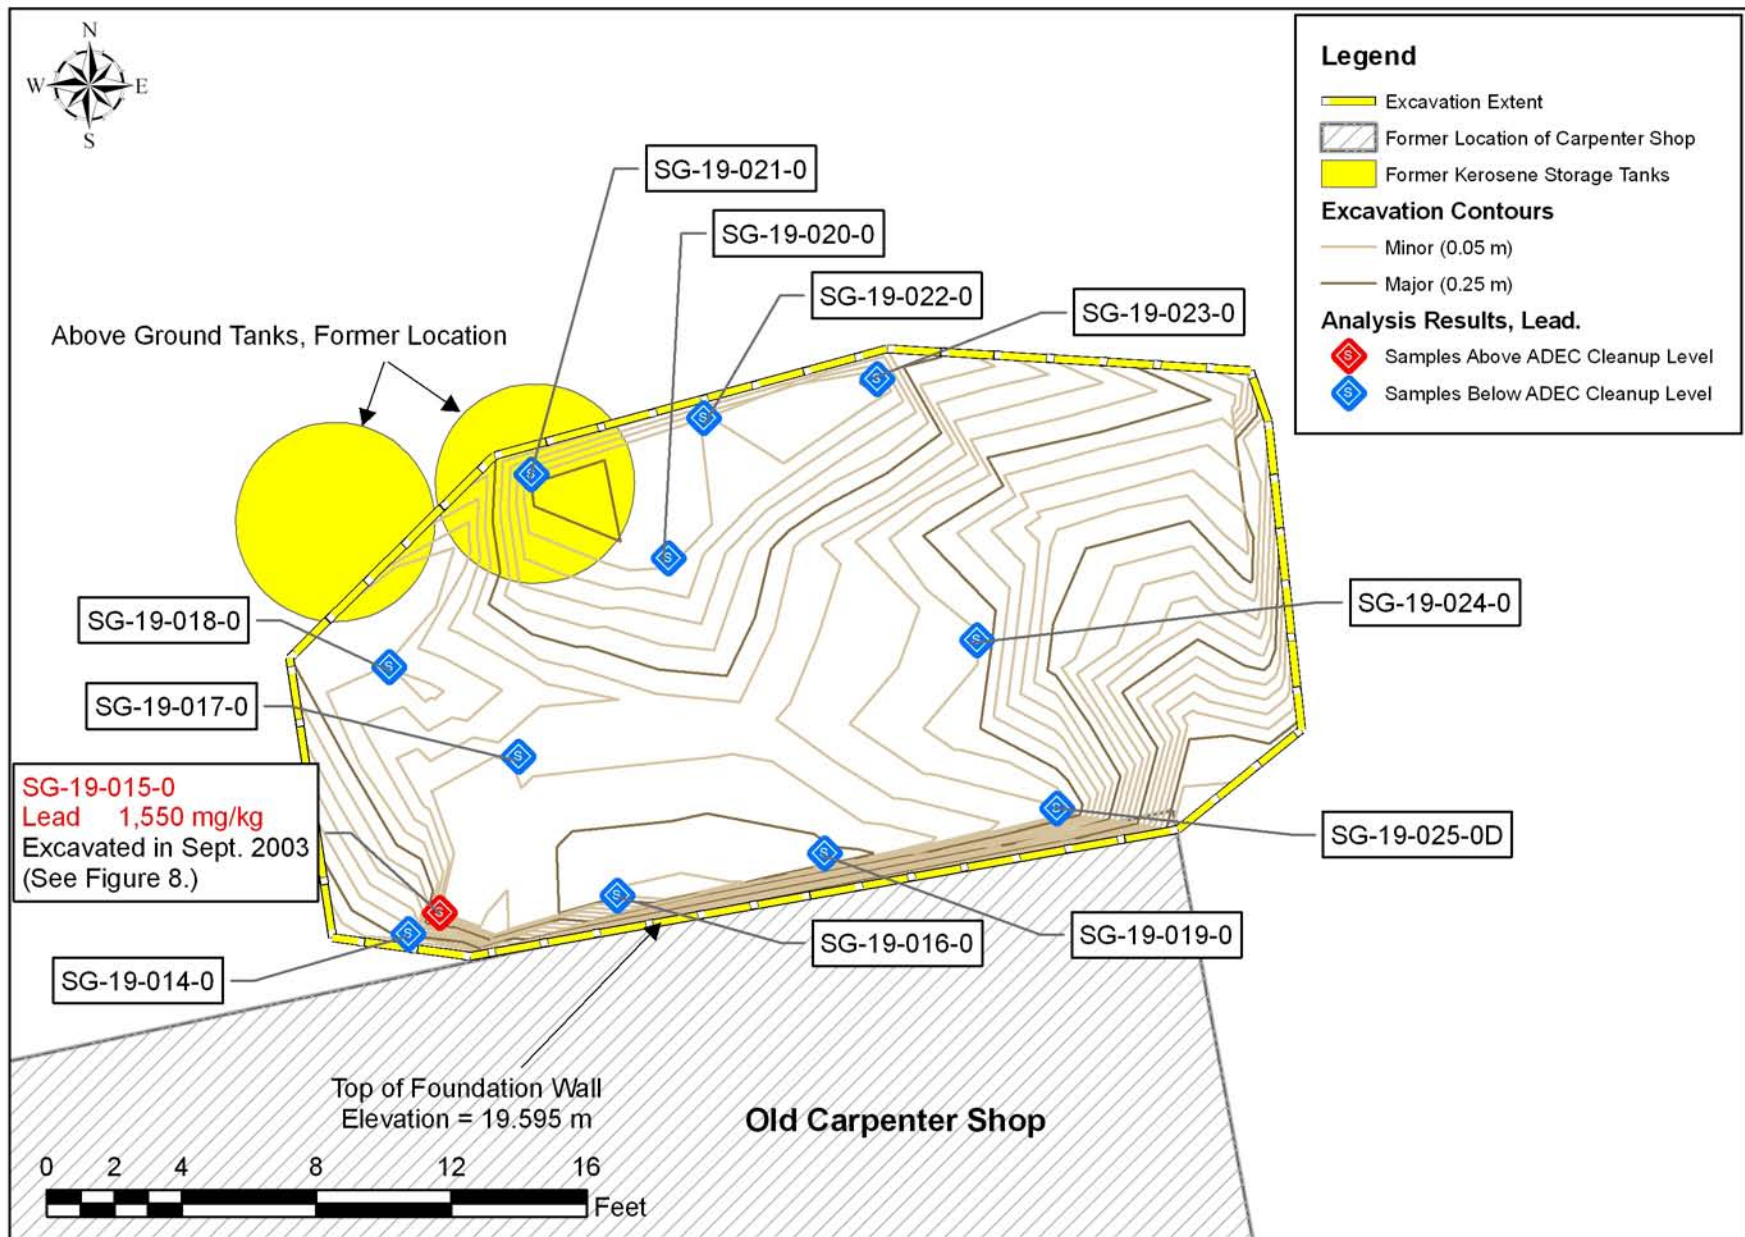
6

On October 26, 2002, soil removal recommenced at the site previously excavated in August, and continued radially until the dark soil layer was visually judged to be removed (Figure 6). The southern side of the excavation abutted and exposed the northern shop foundation.

Approximately 8 CY of soil containing the dark layer was placed directly into eight FIBCs. Approximately 11 CY of overburden soils, which appeared not to include material from the dark layer, were stockpiled on an impermeable plastic membrane and sampled to determine proper disposition (Polarconsult 2004a). Analytical results indicated that the stockpiled soil was also contaminated with lead; subsequently, this soil was placed in 14 FIBCs for storage and eventual shipment off-island. Twelve confirmation samples, plus two duplicates, were collected from the excavation and analyzed for total lead concentration. Analytical results indicated lead concentrations were below the ADEC criterion at all sample locations with the exception of SG-19-015-0 (Figure 6), where a concentration of 1,550 mg/kg was found (Polarconsult 2004a). Table 1 summarizes confirmation sampling results.

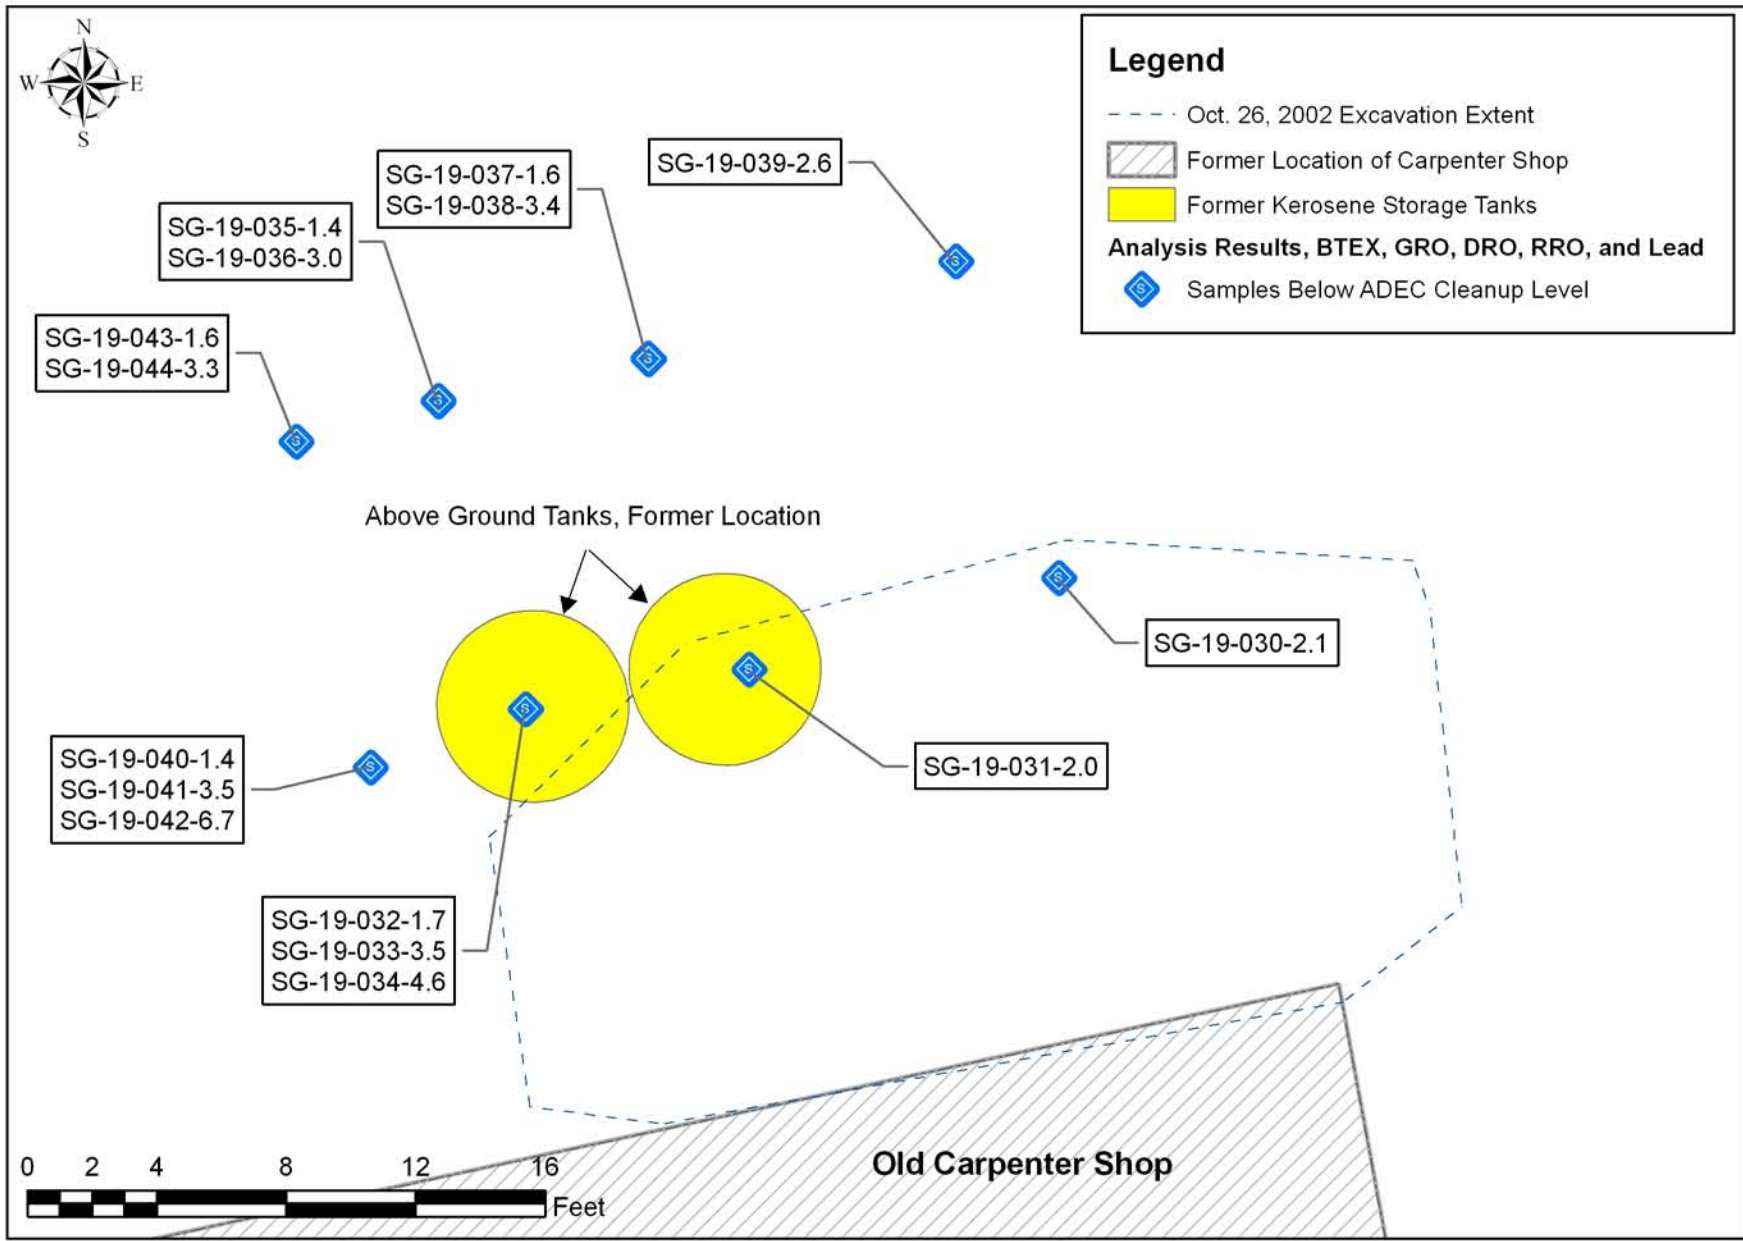
Figure
7

On October 30, 2002, NOAA collected 15 additional soil samples to determine if lead or petroleum contamination was present beyond the extent of the excavation dug on October 26, 2002. Eight boreholes were advanced, using a Geoprobe, to depths up to 7 feet bgs. The boreholes were located in a grid pattern (Figure 7), with two borings placed in the former AST locations. After boring/sampling was completed, the excavation was backfilled with thermally treated soil (Polarconsult 2004b). Boring samples were analyzed for GRO, DRO, RRO, total lead, and BTEX. Analytical results for the boring samples indicated all analyte concentrations were below applicable ADEC cleanup criteria (Polarconsult 2004a).

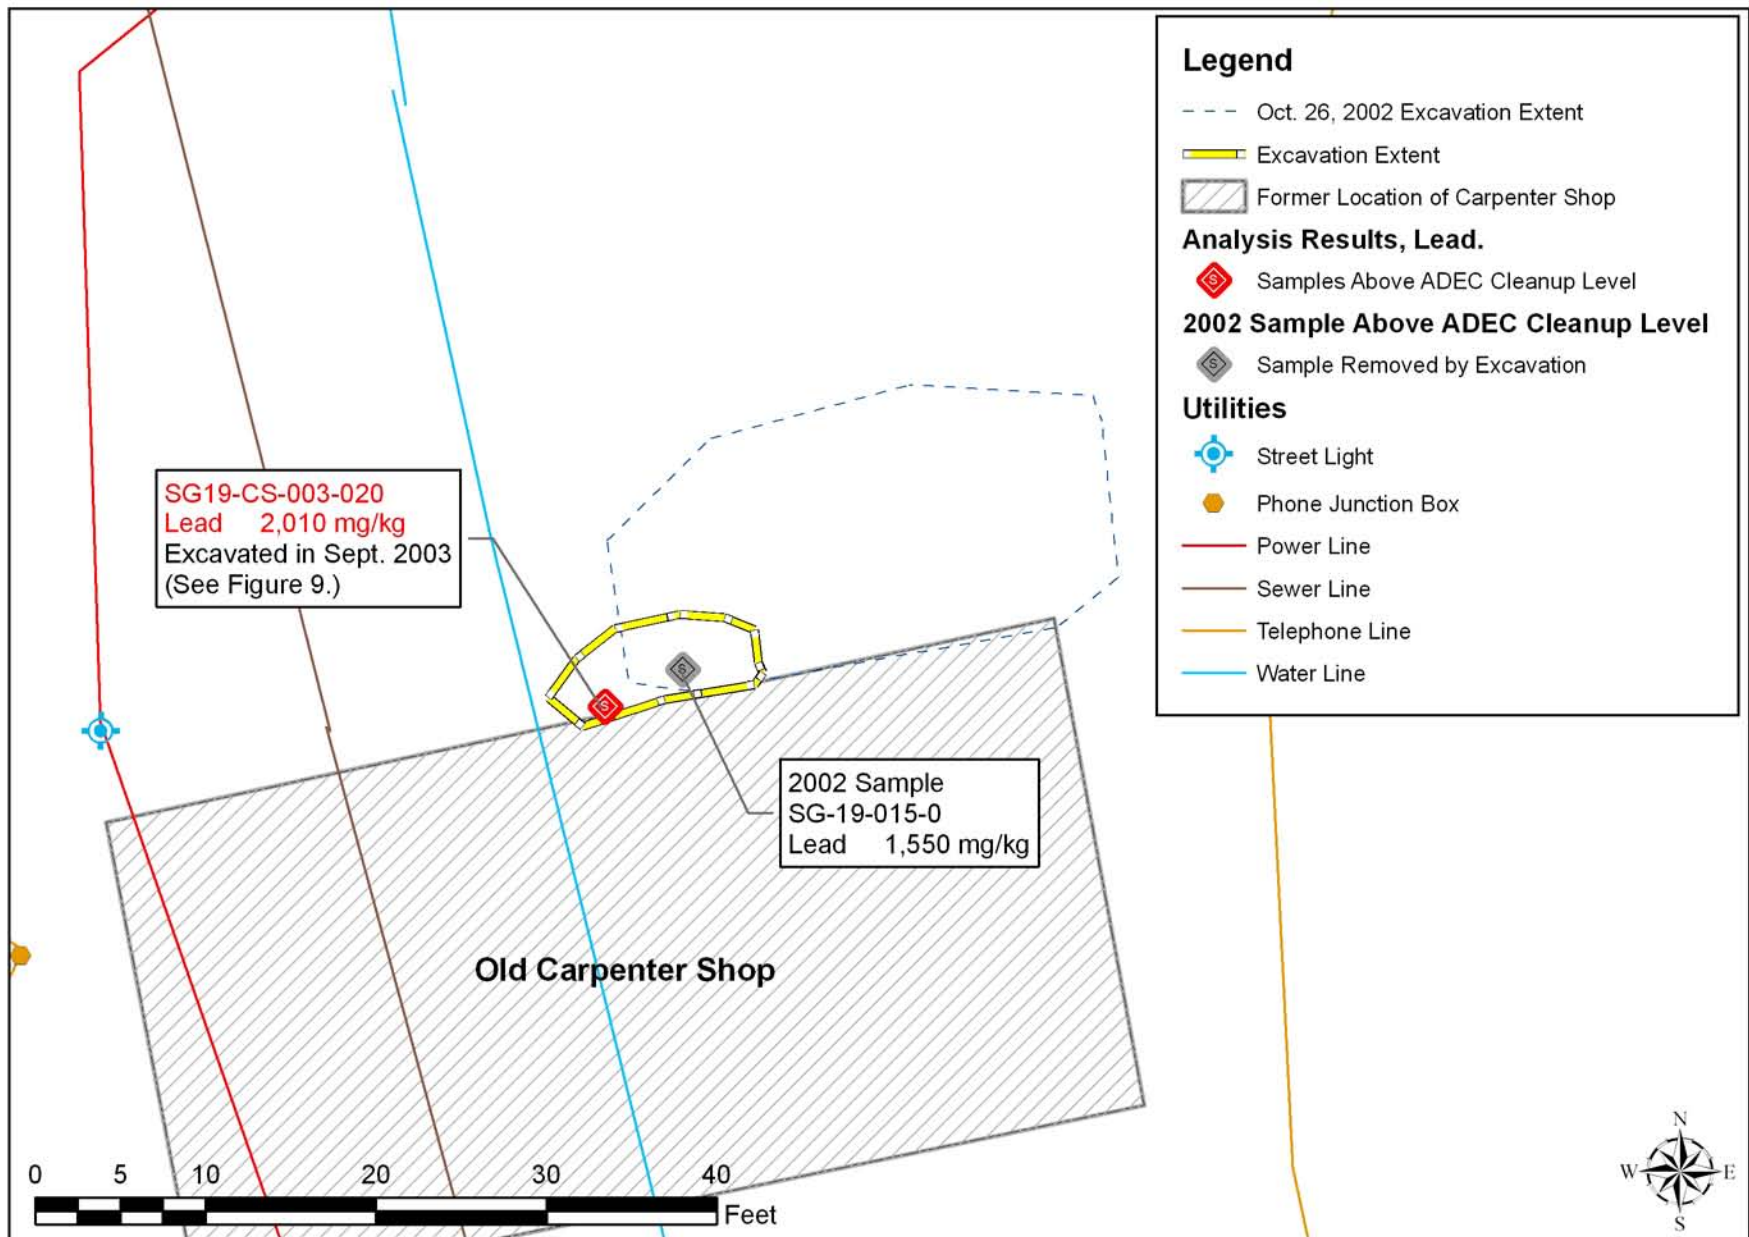
8

On September 16, 2003, NOAA resumed excavation of lead contaminated soil at the 2002 sample location SG-19-15-0 (Figure 8). Visual indicators of discolored soil and debris were used to determine what soil to remove. However, the “dark layer” of soil that was present in previous excavations was only slightly evident (Polarconsult 2004a). Approximately 3.4 CY of soil was removed and either placed directly into two FIBCs, or stockpiled on an impermeable plastic membrane for characterization sampling. A confirmation sample was collected from the excavation and sent to an off-site laboratory for lead analysis. The analytical result indicated that soil in the excavation was still contaminated with 2,010 mg/kg lead.

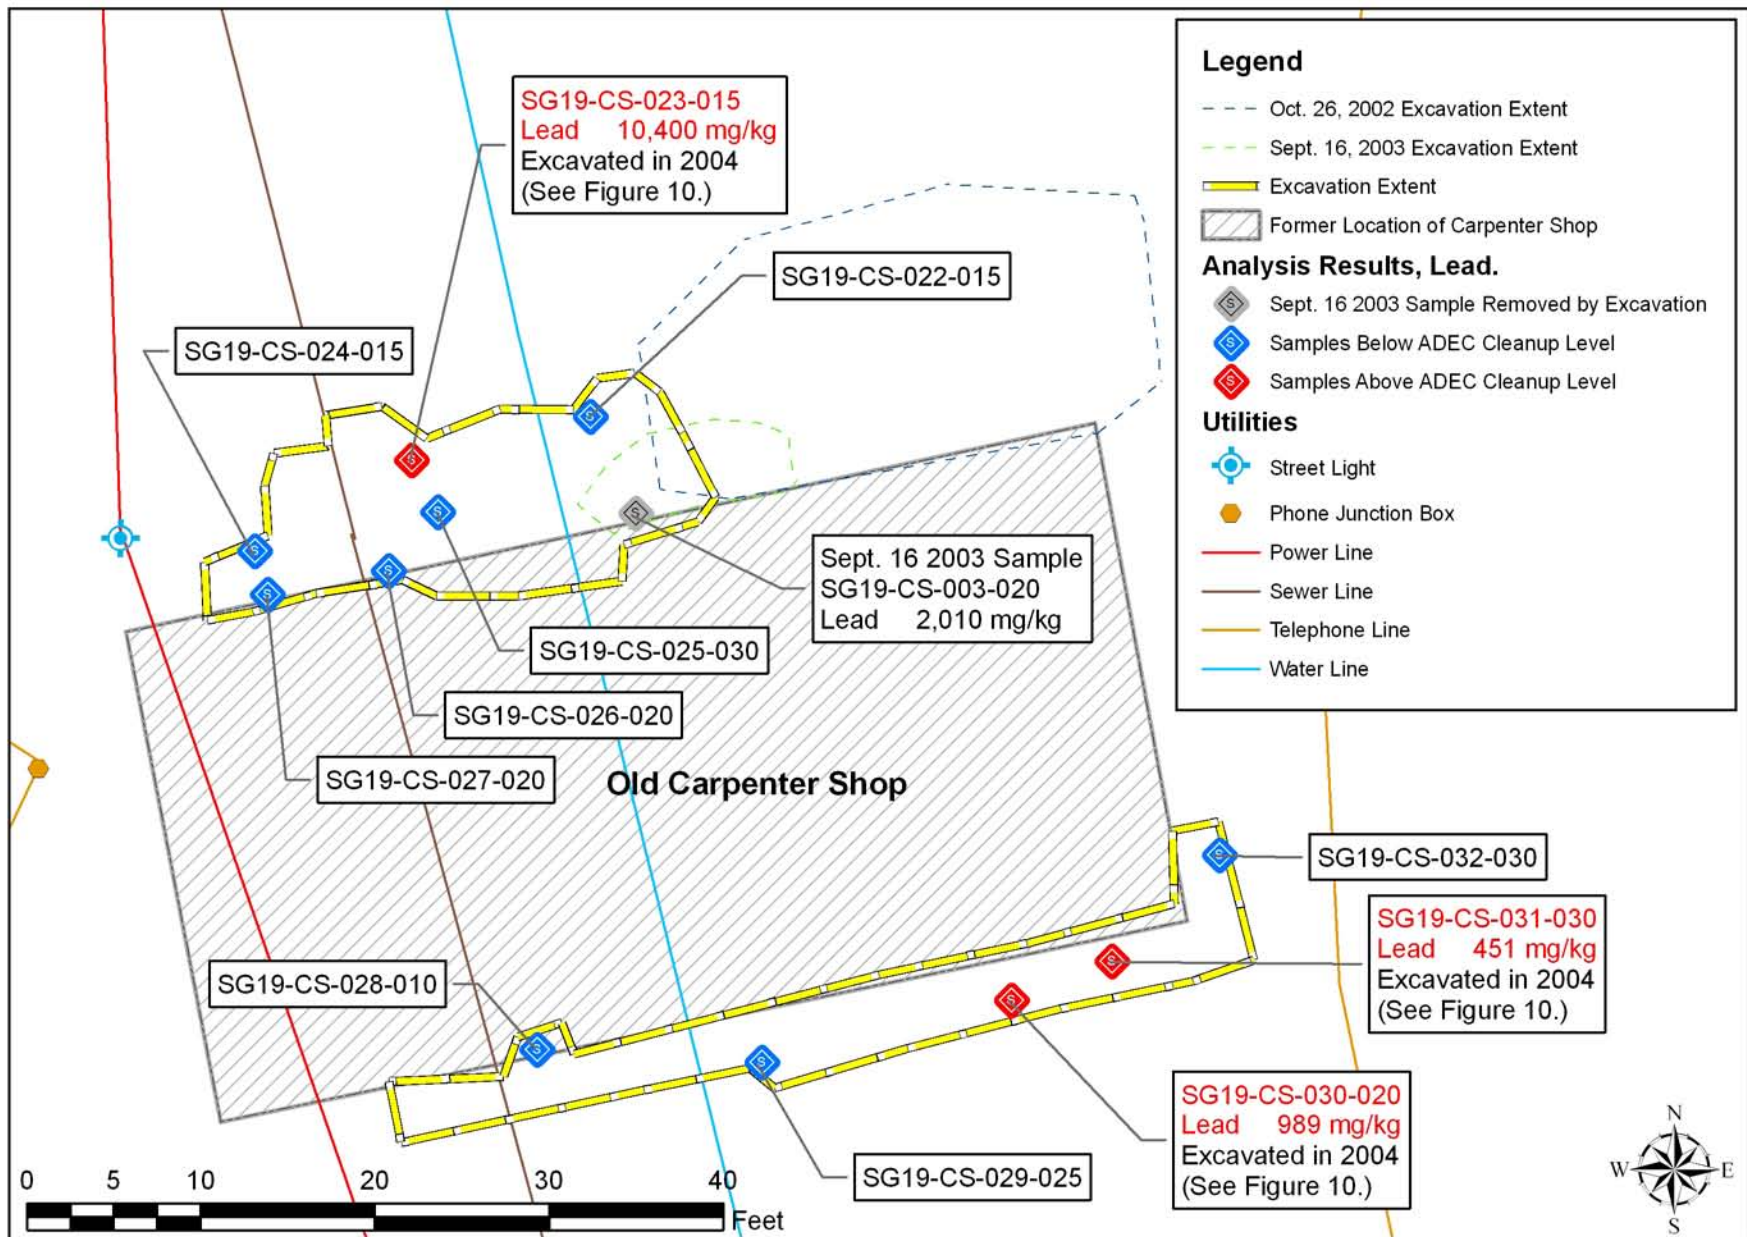
9

From October 20 through 22, 2003, soil excavation continued on the north side of the old building footprint (Figure 9). In addition to visual surveillance for discolored soil, a commercial field screening kit, Hybrivet Systems Inc. LeadCheck For Soil™ (LeadCheck), was used to direct soil removal. LeadCheck uses a dye/lead chemical reaction to produce soil sample color changes to indicate lead concentrations above 300 to 400 mg/kg. As soil excavation proceeded, field samples were collected in areas of highest discoloration or debris content, and LeadCheck was used to determine where lead contamination was still present at concentrations above the cleanup criterion, and/or where soil removal was completed. Approximately 15.4 CY of contaminated soil was removed from the north side of the abandoned foundation and placed directly into FIBCs; overburden soil was stockpiled on an impermeable plastic membrane for characterization sampling. After LeadCheck results indicated that the excavation had lead concentrations below

400 mg/kg, six confirmation samples were shipped for fixed laboratory analyses. Analytical results indicated that soil in the excavation was below 400 mg/kg at all locations with the exception of SG19-CS-023-020 (Figure 9), where a concentration of 10,400 mg/kg was found (Polarconsult 2004a).

On October 23, NOAA excavated a trench along the south and west sides of the foundation (Figure 9) to check for lead contamination. Field notes indicate that a large amount of building debris was encountered during excavation (Polarconsult 2004a). Approximately 12.6 CY was removed and stockpiled on an impermeable plastic membrane for characterization sampling. Seven field samples were collected in the trench from areas where visual observation indicated discolored and/or debris-containing soil. LeadCheck results indicated soil within the trench had lead concentrations below 400 mg/kg; subsequently, five confirmation samples (plus one duplicate) were shipped for fixed laboratory analysis.

Analytical results for the trench confirmation samples indicated that soil remained contaminated with lead in concentrations above 400 mg/kg at two locations (Figure 9). Further excavation in 2003 was not practicable due to weather conditions, therefore the north side excavation and south/west side trench were backfilled with clean scoria (Polarconsult 2004b). The stockpile characterization sample analytical results indicated that the stockpiles were also contaminated with lead; subsequently the stockpiled soil was placed in FIBCs for future off-island disposal (Polarconsult 2004a).

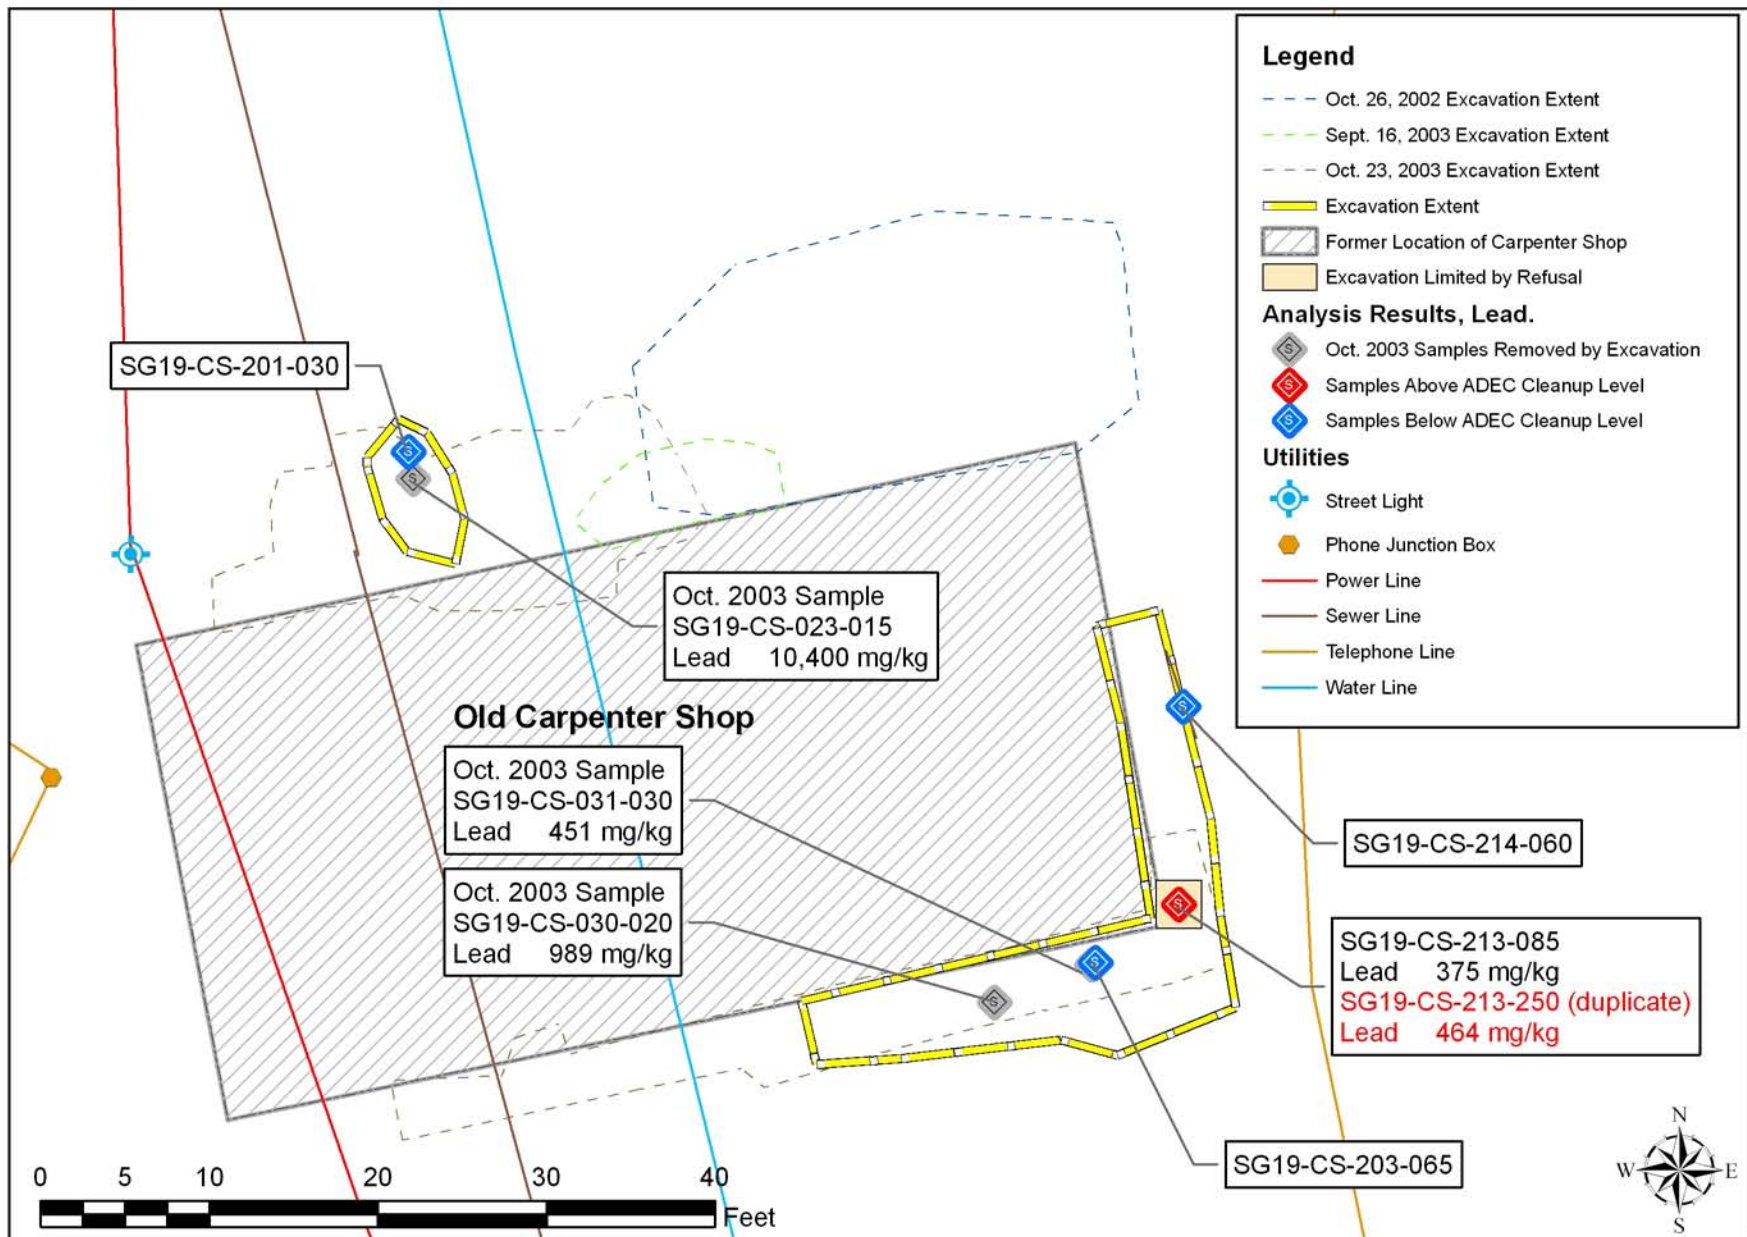
10

From June 7 through June 11, 2004, NOAA excavated the locations where 2003 confirmation sampling indicated that lead contaminated soil still remained. To improve field screening for lead, NOAA obtained a Niton 700 Series x-ray fluorescence (XRF) analyzer from the Environmental Protection Agency (EPA). EPA also detailed to NOAA an employee who was experienced in the use of XRF for field screening (NOAA 2004). The XRF, which directly measures lead concentrations in soil, was used to direct excavation. Soil removal continued until XRF readings indicated that the remaining lead concentrations were less than 400 mg/kg; confirmation samples were collected from excavation locations where the XRF indicated the highest remaining levels of lead (Tetra Tech 2005). Approximately 3 CY of soil was removed from the north side of the foundation around Polarconsult sample location SG19-CS-023-020 (Figure10), with one confirmation sample collected. Approximately 33 CY of soil was removed from the south and west sides of the foundation around Polarconsult sample locations SG19-CS-030-020 and SG19-CS-031-030 (Figure10), three confirmation samples were collected (plus one duplicate). The south/west excavation extended to depths of 6 to 8.5 bgs where equipment refusal was encountered due to large boulders (Tetra Tech 2005). All excavated soil was placed into FIBCs.

Analytical results for three of the four confirmation samples indicated lead concentrations below 400 mg/kg (see Table 1); however sample location SG19-CS-213-250 had a concentration of 464 mg/kg (Figure 10). Based on an assessment of the site conditions, it was determined that further excavation in this location was not practicable due to equipment refusal (Tetra Tech 2005). All soil excavated from the site (approximately 36 CY) was placed in FIBCs with characterization samples collected for total lead and TCLP lead. The excavations were backfilled and the site capped with clean scoria (Polarconsult 2004b). Analytical results for the FIBC characterization samples ranged from 135 to 273 mg/kg total lead. TCLP results were well below 5 mg/L, indicating that the excavated soil was not a RCRA hazardous waste.
