St. George Island, Alaska  
No Further Remedial Action Planned  
Carpentry Shop UST  
TPA Site No. 22-2

**Site:** Carpentry Shop Underground Storage Tank (UST), Two-Party Agreement (TPA) Site Number 22-2

**Location:** Lot 9 of Tract 43, Qawax Subdivision, Seward Meridian on St. George Island, Alaska. TPA 22-2 is on the east side of the current St. George Tanaq Corporation Carpentry Shop in the City of St. George. (Figures 1 and 2)

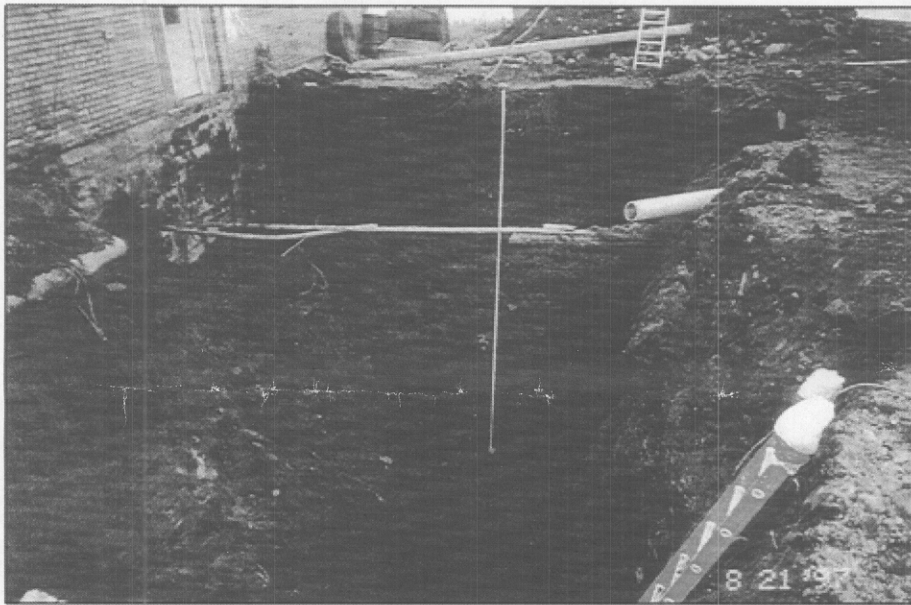
Figure 3. TPA 22-2, Carpentry Shop UST Excavation (Polarconsult 1997a).

UST removal and site remediation was conducted in accordance with the Project Work Plan (Polarconsult 1997b), and was carried out in June and August of 1997. Upon removal, the tank was found to be in poor condition with corrosion holes. Areas of contaminated soil surrounding and immediately under the tank confirmed that the majority of the site contamination was attributable to subsurface fuel leakage. Due to the non-homogenous nature of the fill and surrounding soils, leaking fuel traveled in discrete vertical and lateral paths. Visual, olfactory, and field instruments were used to direct digging of contaminated soil. Additionally, soil samples from the excavation sidewalls and bottom were collected for fixed lab analyses to determine areas requiring further soil removal. Excavation continued until soil diesel range organic (DRO) concentrations were confirmed below 200 mg/kg, further vertical excavation was deemed impracticable due to equipment limitations, or the stability of the carpentry shop foundation was threatened (Figure 3). A total of approximately 341 yd<sup>3</sup> of DRO contaminated soil was removed and transported to NOAA's Petroleum Contaminated Soil (PCS) stockpile, about one mile west of the City of St. George. The PCS stockpile was treated using NOAA's enhanced thermal conduction system in 2000 and 2001 (Polarconsult 2001). The excavation was backfilled with soil from the local scoria mine. An impermeable plastic sheet was placed over the excavation and covered with scoria to reduce surface water infiltration.

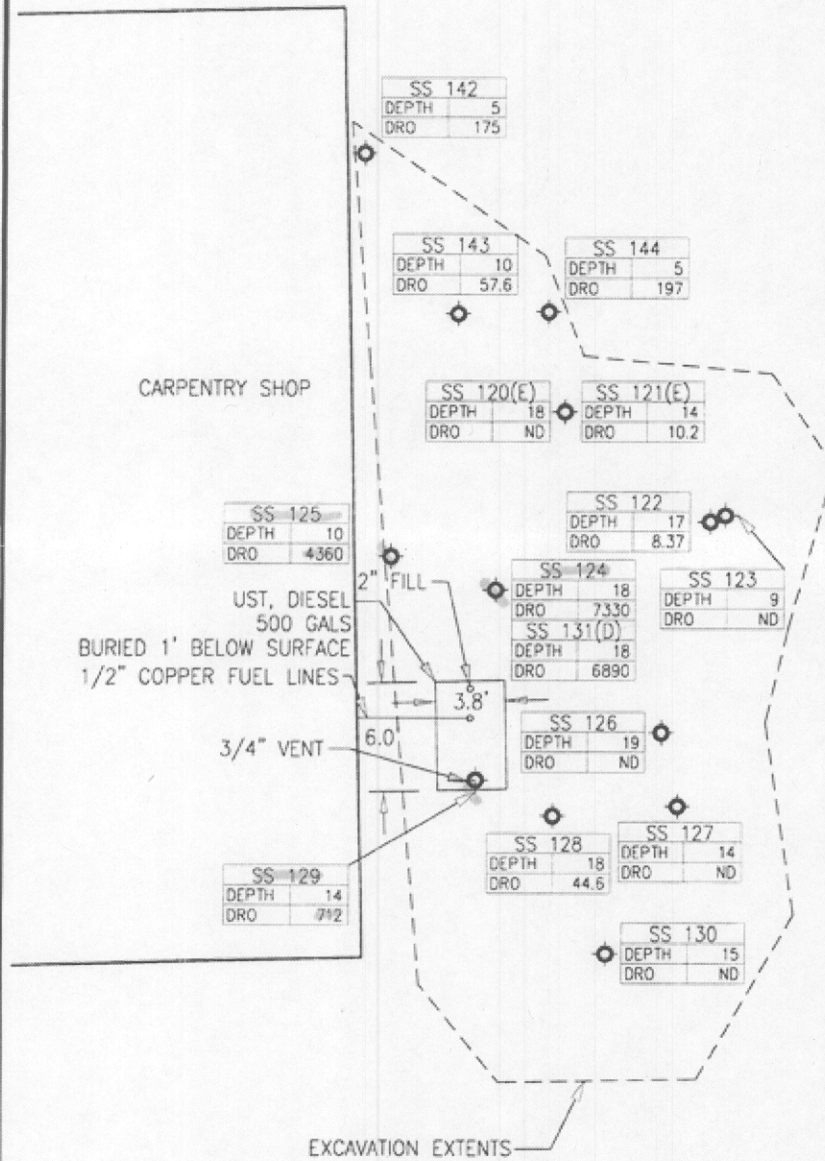
Figure 4. Site 22-2, Carpentry Shop UST (Polarconsult 1997a).

Figure 4 shows the former UST location, horizontal extents of the excavation, sample locations, sample depths, and fixed lab sample results. Samples SS 124/131 (SS 131 is a duplicate), SS 125, and SS 129 indicate that soil contaminated with DRO above the Under 40 Inch Zone, Method 2 cleanup concentration of 250 mg/kg was left in portions of the site. Soil at sample locations SS 125 and SS 129 was not removed due to concerns about undermining the carpentry shop foundation. Soil at sample location 124 was judged to be at the maximum excavation depth achievable at this site. Analyses for other potential contaminants were not conducted due to the tank history of storing only diesel fuel, and the knowledge that DRO contamination levels would drive cleanup decisions. Sample results are shown in Table 1.

In summary, the contamination source and all contaminated soil that is practicably accessible has been removed from TPA Site 22-2. Contamination due to diesel fuel migrating to the water table is being addressed in a separate action that is inclusive of groundwater throughout the City of St. George (TTEMI 2003).
