Request for No Further Remedial Action Planned

Site: Tanaq Shop/Store Tank, also known as St. George Island Two Party Agreement (TPA) Site 22-3/National Oceanic and Atmospheric Administration (NOAA) Site 24. This site is also referred to as Tanaq Shop/Store Underground Storage Tank (UST).

(10/05/04) Request for NFRAP
 Tanaq Shop Store Tank
 TPA Site 22-3/Site 24
 St. George Island, Alaska

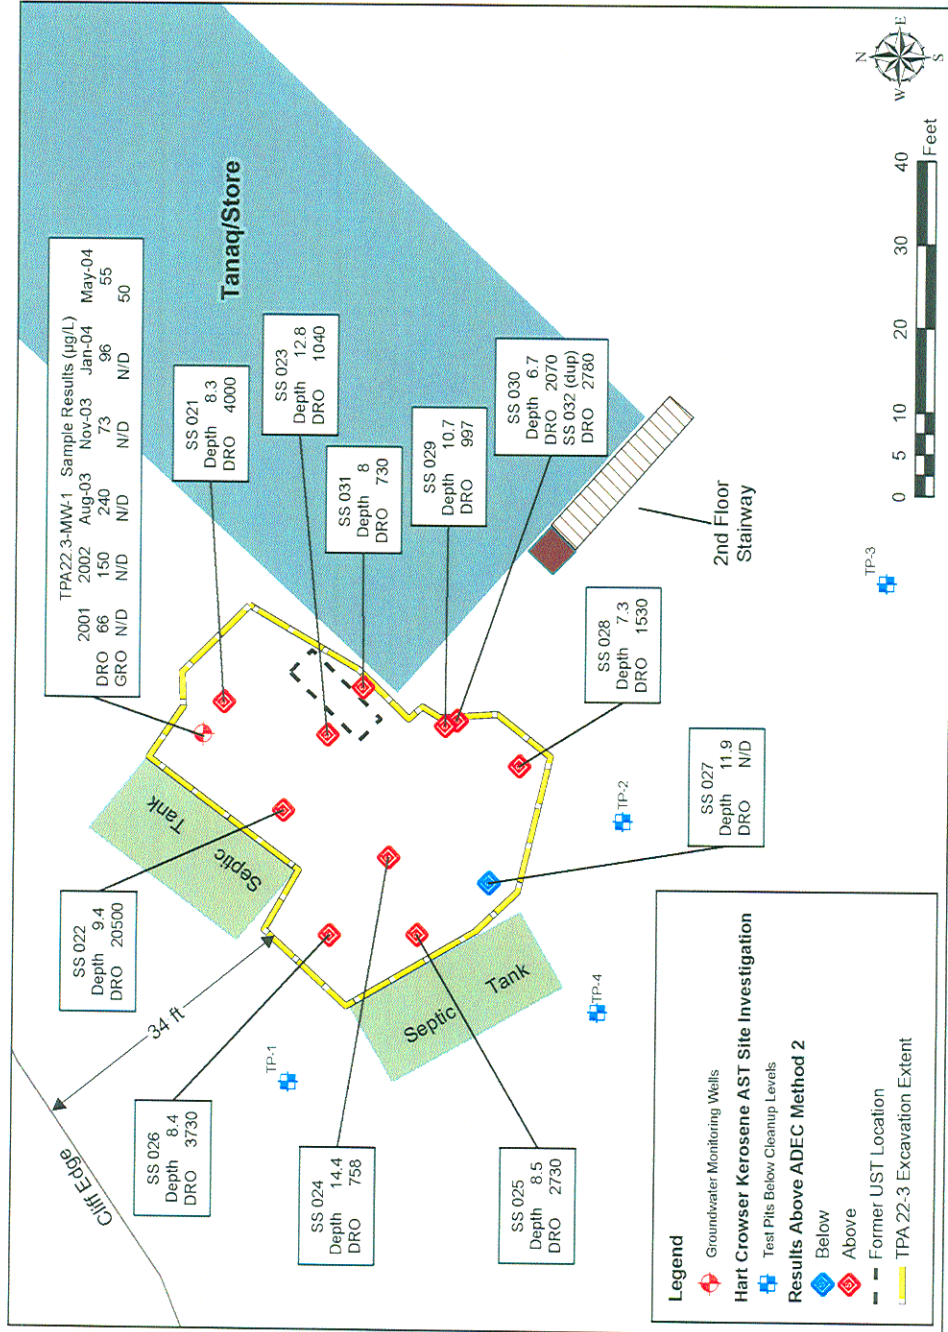
Summary of Site Investigations and Cleanup Actions: In 1997, as part of a multi-site environmental investigation, debris removal, and UST decommissioning effort, Tanaq, with Polarconsult Alaska, Inc. providing environmental consultation, removed the Tanaq Shop Store Tank. Site assessment at the time of removal determined that the soil surrounding the UST was contaminated with diesel range organics (DRO). Subsequently, approximately 402 cubic yards of contaminated soil was excavated from the site. The excavation started at the UST location and expanded horizontally until further excavation was not possible due to the risk of undermining building foundations, interference from nearby septic tanks, and concerns about excavating adjacent to the nearby cliff (Polarconsult 1997). The excavation expanded vertically until equipment refusal was reached due to an underlying basalt layer. Per the report, the soil became progressively more solid with depth, until further excavation was not practicable. Figure 3 shows the extent of the 1997 excavation.

Polarconsult collected eleven soil samples and one duplicate from locations and depths shown on Figure 3. All samples were analyzed for DRO using AK-102 protocols. Two samples, SS 025 and SS 028, were also analyzed for benzene, toluene, ethylbenzene, and total xylenes (BTEX). The BTEX results were below action levels (benzene was not detected), however analyses results for DRO ranged from non-detect at sample location SS 027, to 20,500 mg/kg at sample location SS 022. Samples were collected from the excavation bottom at refusal and along sidewalls, with depths ranging from 6.7 feet to 14.4 feet. Surface contamination due to fuel spillage was removed during excavation. As would be expected, diesel fuel flowing from the subsurface

holes in the tank traveled down through the soil, therefore remaining contamination at the site is found at depths near and past refusal. Although these results indicate DRO contamination was left at the site above the most restrictive applicable ADEC Method Two (ADEC 2003) cleanup level of 250 mg/kg (migration to groundwater), the samples were collected when further excavation was deemed impracticable.

Figure 3 shows approximate test pit locations (TP-1, TP-2, TP-3, TP-4) from a 1995 Hart Crowser investigation of a nearby historic kerosene storage area (Hart Crowser 1997). The Hart Crowser report states that these test pits were excavated to equipment refusal depth, which ranged from 7 to 9 feet. Sixteen samples were taken from the pits and analyzed for DRO, gasoline range organics (GRO), petroleum hydrocarbons, and BTEX. Analyses results indicate that GRO and BTEX were not detected, and the maximum DRO concentration was 180 mg/kg at refusal depth (9 feet) in TP-1. All sample results were below ADEC cleanup standards, and Hart Crowser's recommendation was for no further action in the area of their investigation. For TPA Site 22-3/Site 24, the Hart Crowser results indicate that the DRO contamination drops to concentrations below cleanup requirements by the time it reaches the test pit locations, just beyond the 1997 excavation extents.

Figure 3 also shows groundwater analyses results for samples taken from monitoring well TPA22.3-MW-1 in 2001 through 2004 (TTEMI 2004). The highest DRO concentration detected was in August 2003 at 240 µg/L. The 18 AAC 75, Article 3, Table C, cleanup standard for ground water is 1500 µg/L for DRO (1300 µg/L for GRO). The analyses results show that, although DRO/GRO concentrations at TPA Site 22-3/Site 24 meet ADEC groundwater cleanup requirements, the groundwater has been impacted by the UST leakage. However, DRO concentrations between 2001 and 2004 do not show an increasing trend, indicating that the remaining contamination is not substantially moving to the groundwater. Further excavation will not likely provide additional reduction in groundwater DRO levels. The GRO detected in May 2004 at 50 µg/L seems to be an anomaly as it has not been detected before in this area, and there is no known source. Future sample results will be reviewed to determine GRO trends, if any.

Recommended Action: NOAA believes that the limited benefit derived from removing the remaining contaminated soil at TPA Site 22-3/Site 24 is not worth the potential cost of accelerating cliff loss and the loss of a currently utilized commercial building that includes a U.S. Post Office and community grocery. Soil contaminated with DRO above ADEC cleanup levels based on direct ingestion and inhalation criteria will likely never pose a threat to humans and wildlife due to its location and depth below ground surface. Impact to area groundwater was mitigated with the removal of the leaking UST and the bulk of the contaminated soil. Current DRO concentration in the groundwater, always well below ADEC cleanup criteria, would not likely improve significantly as a result of additional excavation. On the other hand, there is a plausible risk that continued excavation, with its inherent ground vibration, would contribute to cliff loss near the Tanaq building. In accordance with paragraph 59 of the Two Party Agreement (NOAA 1996), NOAA requests written confirmation that NOAA completed all appropriate and practicable corrective action at the Tanaq Shop Store Tank, TPA Site 22-3/Site 24 in accordance with the Agreement, and that ADEC requires no plan for further remedial action from NOAA.

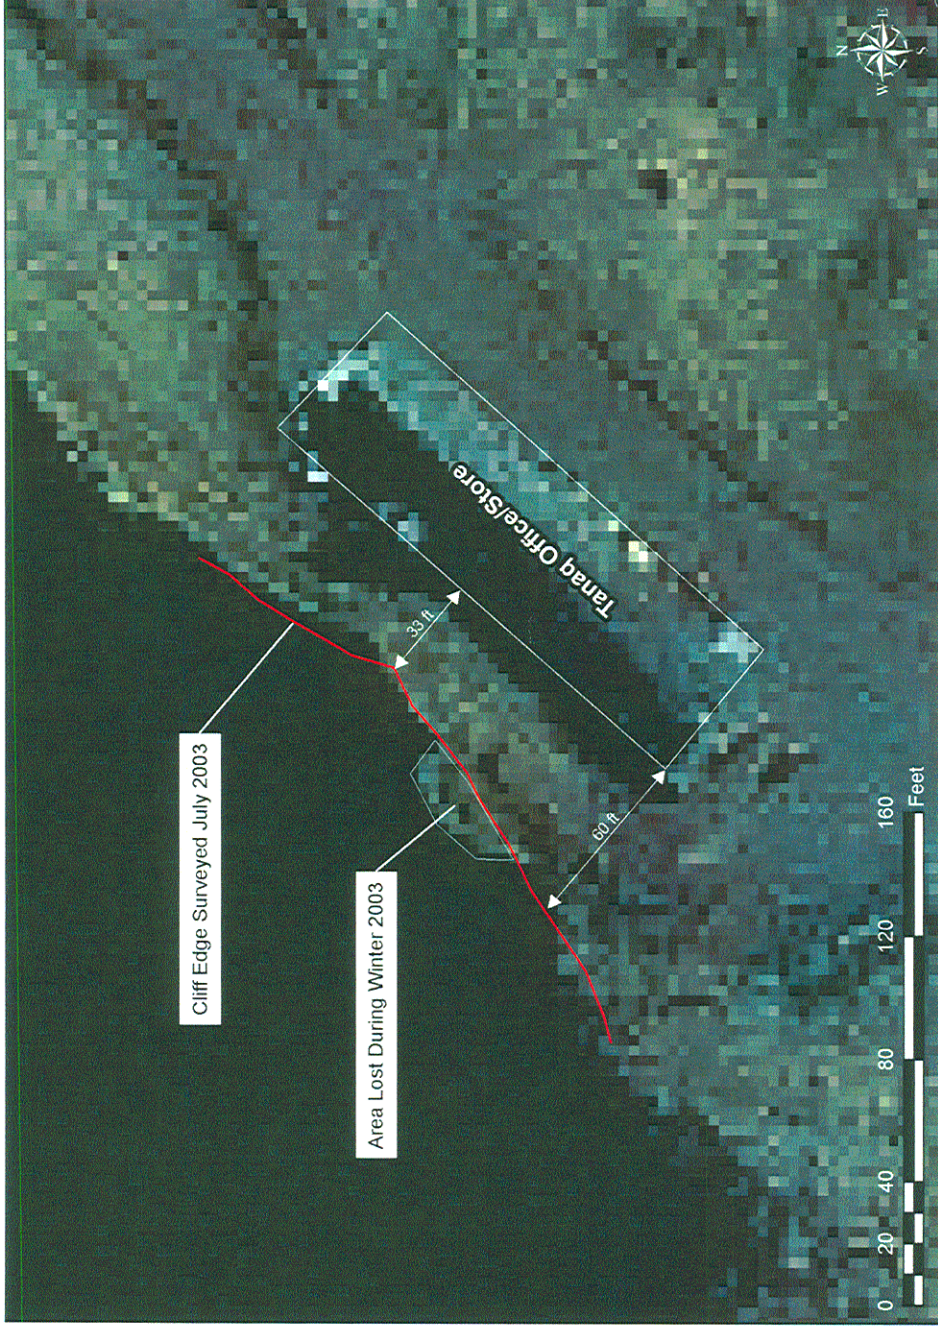
Other Considerations: Figure 4 shows the cliff edge as photographed in 2001 versus the cliff edge as surveyed by NOAA in 2003. Other evaluations of cliff loss, accomplished by comparing rectified aerial photographs of the cliff edge with a fixed inland survey point, indicate that the cliff is receding at an average rate of six inches per year. Cliff loss appears to occur in sections rather than on a steady incremental basis; this loss is evidenced by the dramatic slough that occurred during the winter of 2003, shown on Figure 4. The cliff loss is a result of the natural undercutting of the cliff base by Bering Sea wave action, coupled with probable freeze/thaw accelerated separation of the basalt cliff face. Potential areas of future cliff face separation are discernable as elongated depressions near the cliff edge. The situation is serious enough that signs have recently been posted in town along the cliff edge warning of its instability.

NOAA believes that excavation of the remaining contaminated soil at TPA Site 22-3/Site 24 has a potential for further accelerating the natural cliff loss, and the landowner, St. George Tanaq Corporation, (NOAA 2004) also acknowledges this concern. This induced cliff loss would occur due to new or increased crack formation in the area of the cliff as a result of ground vibrations associated with nearby excavation activities. These cracks would aid the natural freeze/thaw cycle of breaking down the cliff face. Vibrations would be caused somewhat by the movement of heavy excavation equipment, such as Tanaq's 30-ton Caterpillar 325 BL Track Excavator, in the area between the building and the cliff edge; but much more damaging would be the extreme ground vibration caused by the excavator bucket scraping against the consolidated basalt at its refusal point in the bottom of the excavation pit. This contact by the bucket with the dense basalt is unavoidable because the retrievable contaminated soil is located just above this basalt layer. The use of smaller excavation equipment such as Tanaq's Case 590 Loader/Backhoe is not practicable due to its limited horizontal and vertical reach, and lack of heft for digging through soil that becomes progressively more solid with depth. Use of lighter excavation equipment would also produce heavy ground vibration when the bucket meets solid basalt.

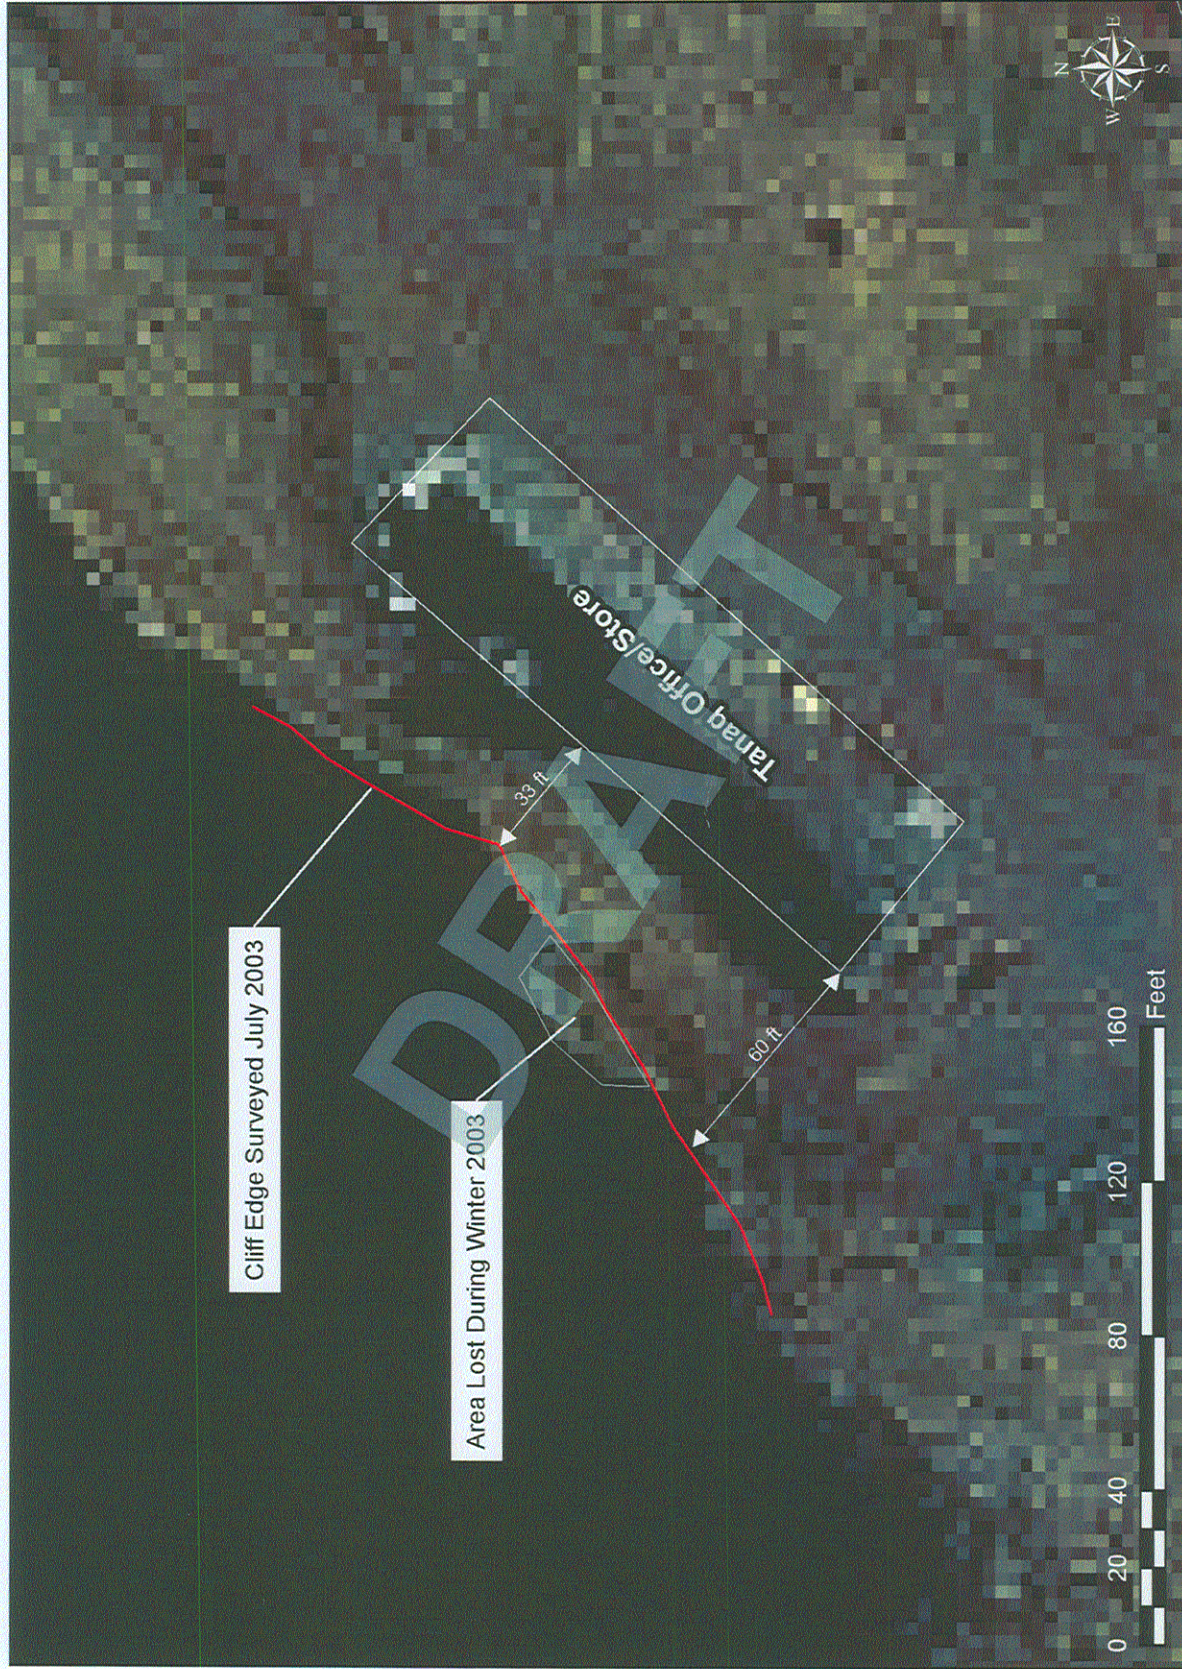
Figure
 3

Enclosure (1), Figure 3, shows the cliff edge as photographed in 2001 versus the cliff edge as surveyed by NOAA in 2003. Other evaluations of cliff loss, accomplished by comparing rectified aerial photographs of the cliff edge with a fixed inland survey point, indicate that the cliff is receding at an average rate of six inches per year. Cliff loss appears to occur in sections rather than on a steady incremental basis; this loss is evidenced by the dramatic slough that occurred during the winter of 2003, shown on Figure 3. The cliff loss is a result of the natural undercutting of the cliff base by Bering Sea wave action, coupled with probable freeze/thaw accelerated separation of the basalt cliff face. Potential areas of future cliff face separation are discernable as elongated depressions near the cliff edge. The situation is serious enough that signs have recently been posted in town along the cliff edge warning of its instability.

NOAA believes that excavation of the remaining contaminated soil at TPA Site 22-3 has a potential for further accelerating the natural cliff loss. This induced cliff loss would occur due to new or increased crack formation in the cliff face as a result of ground vibrations associated with nearby excavation activities. These cracks would aid the natural freeze/thaw cycle of breaking down the cliff face. Vibrations would be caused somewhat by the movement of heavy excavation equipment, such as Tanaq's 30-ton Caterpillar 325 BL Track

Excavator, in the area between the building and the cliff edge; but much more damaging would be the extreme ground vibration caused by the excavator bucket scraping against the consolidated basalt at its refusal point in the bottom of the excavation pit. This contact by the bucket with the dense basalt is unavoidable because the retrievable contaminated soil is located just above this basalt layer. The use of smaller excavation equipment such as Tanaq's Case 590 Loader/Backhoe is not practicable due to its limited horizontal and vertical reach, and lack of heft for digging through soil that becomes progressively more solid with depth. Use of lighter excavation equipment will still produce heavy ground vibration when the bucket meets solid basalt.

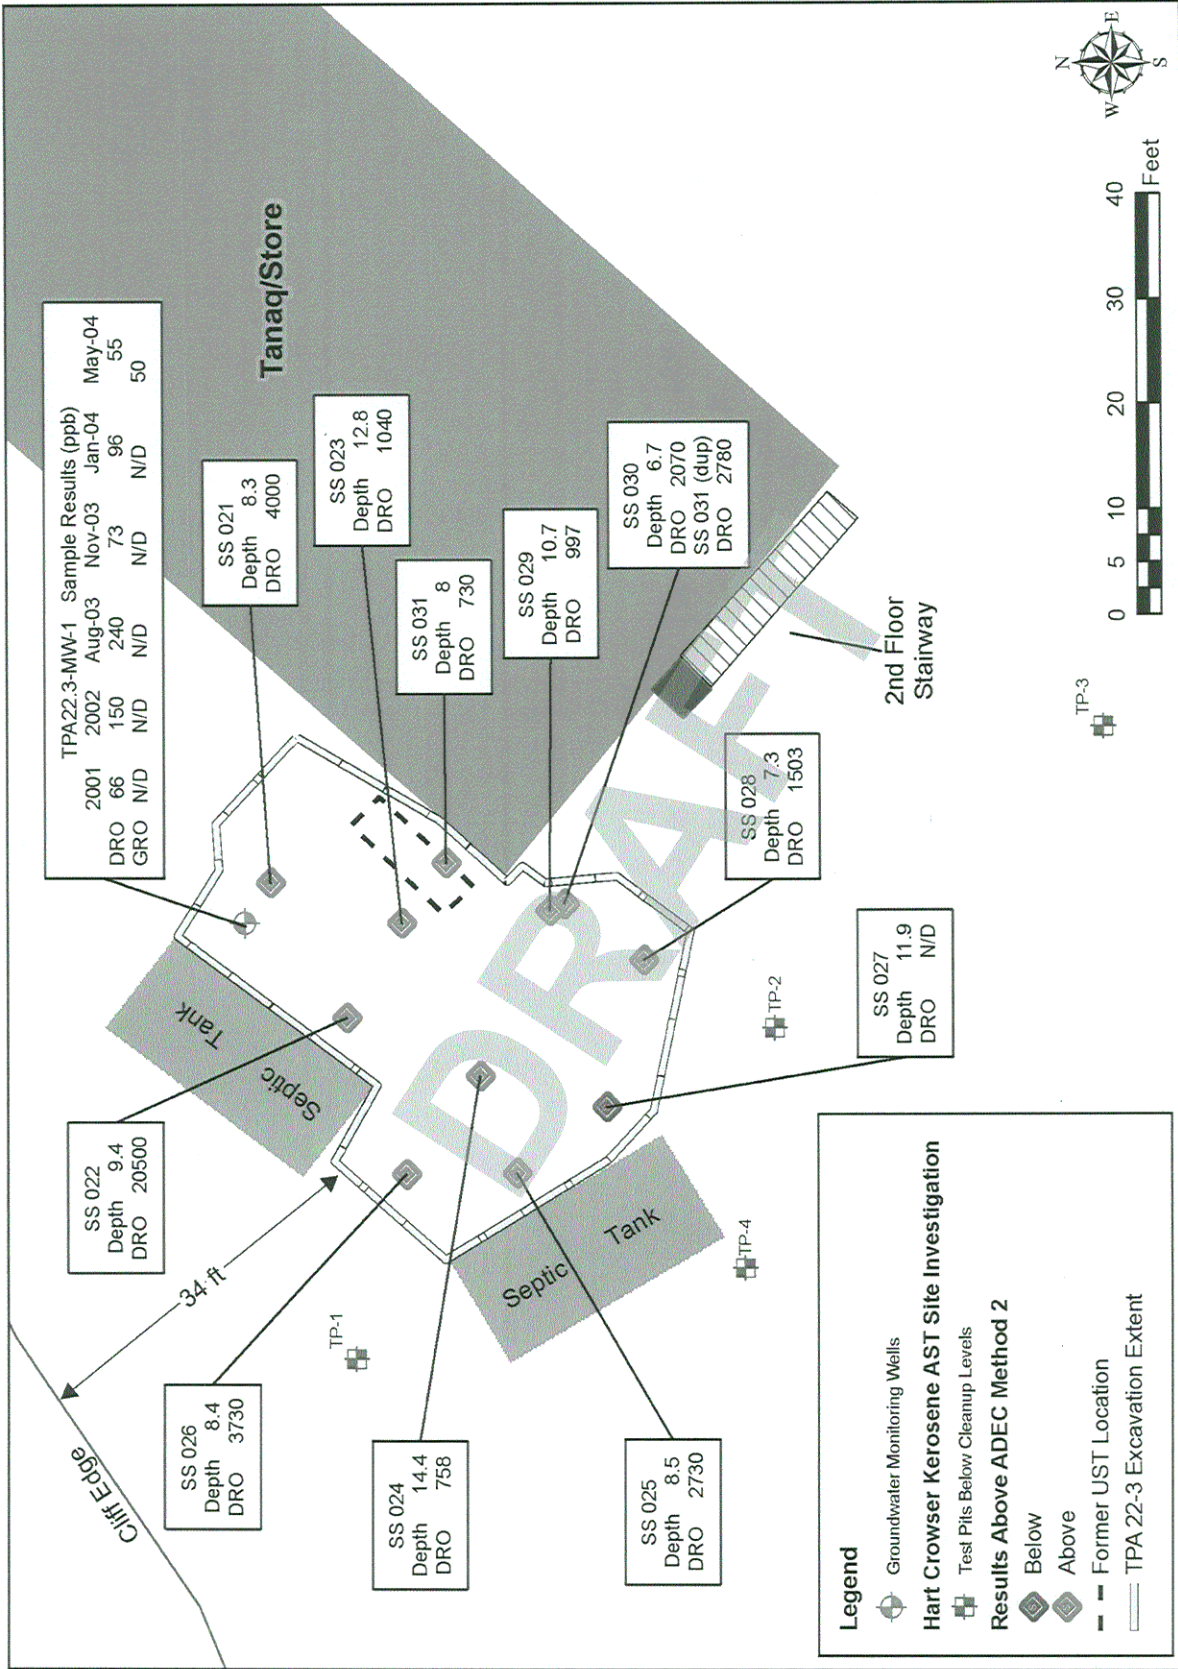
Enclosure (1), Figure 4, shows DRO analytical results ranging from non-detect at sample location SS 027 to 20,500 ppm at sample location SS 022. Samples were collected from the excavation bottom at refusal and along sidewalls, with depths ranging from 6.7 feet to 14.4 feet. As would be expected, diesel fuel flowed from the leaking tank down through the soil, therefore contaminated soil is found at depths near refusal, not at the surface. Although these results indicate DRO contamination was left at the site above the most restrictive applicable ADEC Method Two cleanup level of 250 ppm (migration to groundwater), the samples were collected when further excavation was deemed impracticable.

Figure 4 shows approximate test pit locations (TP-1, TP-2, TP-3, TP-4) from a 1995 Hart Crowser investigation of a nearby historic kerosene storage area (*Draft Hart Crowser Expanded Site Inspection, St. George Island, Pribilof Islands, Alaska*, dated June 1996). The Hart Crowser report states that these test pits were excavated to equipment refusal depth, which ranged from 7 to 9 feet. Sixteen samples were taken from the pits and analyzed for DRO, gasoline range organics (GRO), petroleum hydrocarbons, benzene, toluene, ethylbenzene, and total xylenes (BTEX). Analytical results indicate that GRO and BTEX were not detected, and the maximum DRO concentration was 180 ppm at refusal depth (9 feet) in TP-1. All sample results were below ADEC cleanup standards, and Hart Crowser's recommendation was for no further action in the area of their investigation. For TPA Site 22-3, the Hart Crowser results indicate that the DRO contamination drops to concentrations below cleanup requirements by the time it reaches the test pit locations, just beyond the 1997 excavation extents.

Figure 4 also shows groundwater analytical results for samples taken from monitoring well TPA22.3-MW-1 in 2001 through 2004. The highest DRO concentration detected was in August 2003 at 240 parts per billion (ppb). The 18 AAC 75, Table C, cleanup standard for ground water is 1500 ppb for DRO (1300 ppb for GRO). The analytical results show that, although DRO/GRO concentrations at TPA Site 22-3 meet ADEC groundwater cleanup requirements, the groundwater has been impacted by the UST leakage. However, DRO concentrations between 2001 and 2004 do not show an increasing trend, therefore further

excavation would not likely provide additional reduction in groundwater DRO levels. The GRO detected in May 2004 at 50 ppb seems to be an anomaly as it has not been detected before in this area, and there is no known source. Future sample results will be reviewed to determine GRO trends, if any.
