# ST GEORGE SEAL PLANT RESTORATION PROJECT

*January 12, 2000*

## Executive Summary

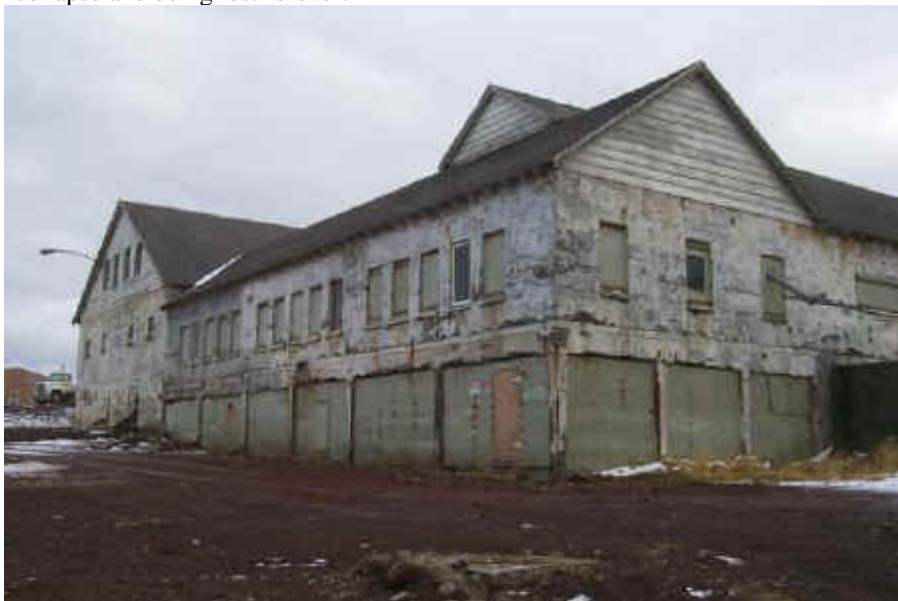
A sealing plant located on St. George was used to process sealskins and render remains. This sealing plant, the last one of its kind, was designated to the National Register of Historic Places in 1986. This building, the largest one on the island, was disintegrating from the combined attack of salt, water, and frosts and was in danger of collapse and being lost forever.

**Figure 1. Original Condition of the Seal Plant**

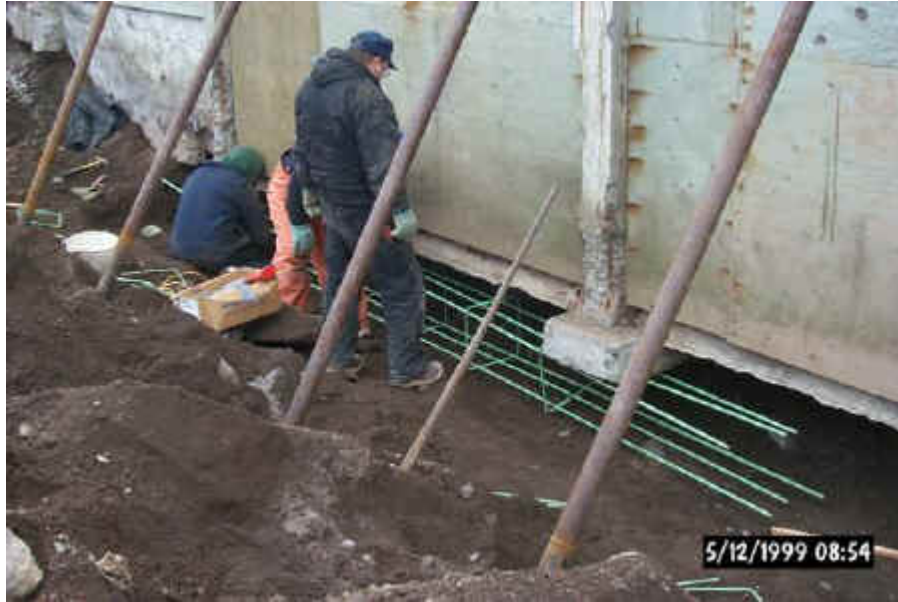
**Figure 3. Construction of the Perimeter Grade Beam**

It was then determined that the perimeter support beam could be supported by the timber infill panel which was necessary anyway to meet the archeological requirements. This meant that the extensive structural improvements required in the plans were not needed for this beam. Instead, the damaged concrete and reinforcing bars were removed and replaced with new concrete. The infill panels were designed to transfer load to the underlying concrete floor. As an alternative to excavating and constructing pad foundations under each column and constructing a new column, an 18 inch by 24 inch deep grade beam was constructed around the north and west sides of the basement. With the grade beam, the shear walls could be moved to the northwest corner of the building, and significant additional expense was avoided.

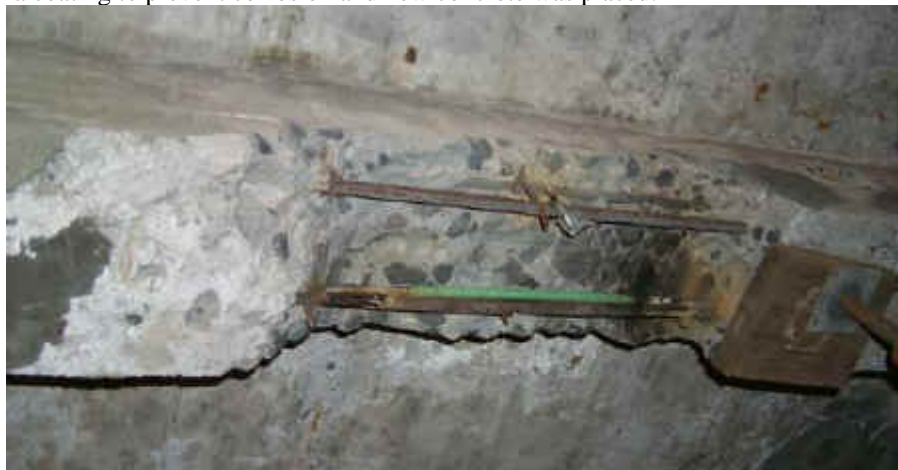
**Figure 4. New Rebar for the Blubber House Slab and Support Beams**

Alpha Engineering's plans also specified the replacement of corroded rebar in the Blubber House floor. These plans were impossible to implement because of reinforcement overlapping requirements required by code. Instead, the severely corroded bar was exposed, cleaned, and new bar was welded to it. The steel was treated with a coating to prevent corrosion and new concrete was placed.

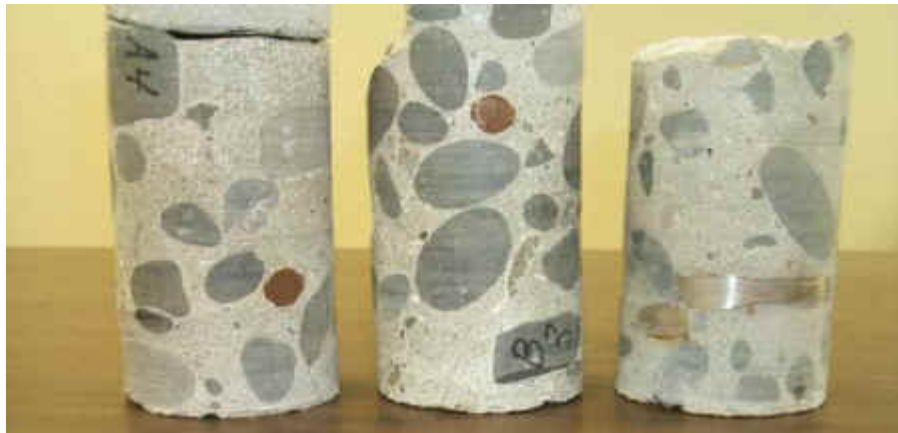
**Figure 5. Concrete Cores from the Blubber House Slab**

Concrete strength of the slab is based on a single compressive test performed by R&M on a core. The result was a compressive stress of 8844 psi. It is impossible to calculate the expected 95% confidence level strength based on this one measurement. However, R&M suggested that the strength may well have been higher if a better core sample had been obtained (implying that the sample was in some way physically damaged during the coring process). Also, using strengths 50% as strong resulted in less than a 5% change in overall slab strength. This is due to the fact that the slab is underreinforced (slab does not meet 99 ACI minimum reinforcement ratio requirements) and the net effect of reducing the concrete strength is a minor reduction in the moment arm within the slab.

Based on the above analysis, the recommended safe, long term live load for the slab is 50 psf. This is equivalent to the live loads prescribed for office space.

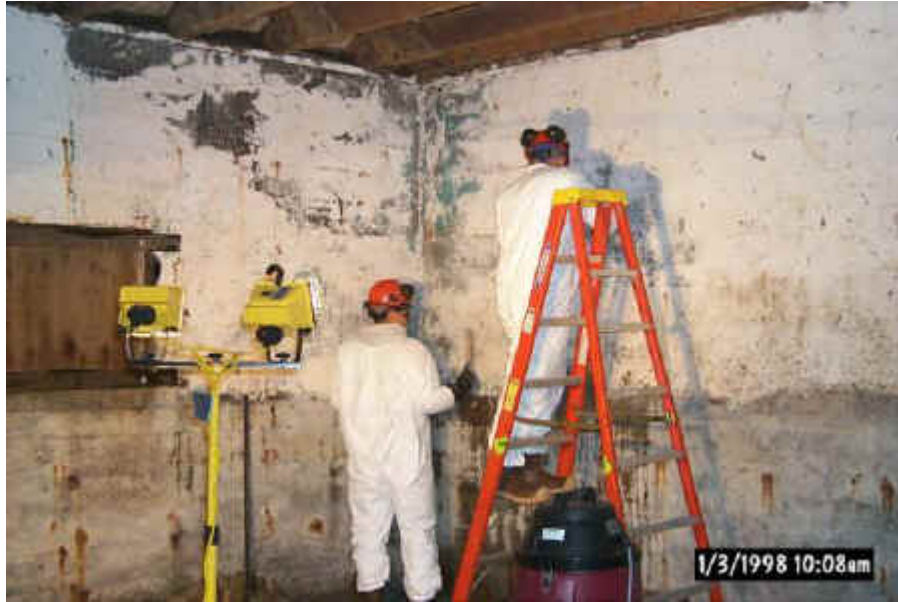
Large portions of the exterior and interior surfaces of the Seal Plant were coated with lead based paint. A specialist was retained by St. George Tanaq Corporation to determine the extent and locations of the lead base paint. With the exception of the NOAA housing area (which was not part of the survey) and around the wooden gable ends, the investigation showed the entire building was painted with lead based paint. The survey also indicated that lead paint had contaminated the soil around the perimeter of the building due to paint flaking off over time.

**Figure 7. Lead Paint Removal**

In accordance with the plan in the proposal, air monitoring was done initially to determine if using the "Back to Nature VIII" stripper resulted in deterioration of the air quality enough to require respirators. Monitoring showed respirators were not required to meet OSHA requirements, however, many of the workers opted to utilize them anyway. Tyvec suits were provided as over garments and the workers wore gloves and hats during the abatement process.

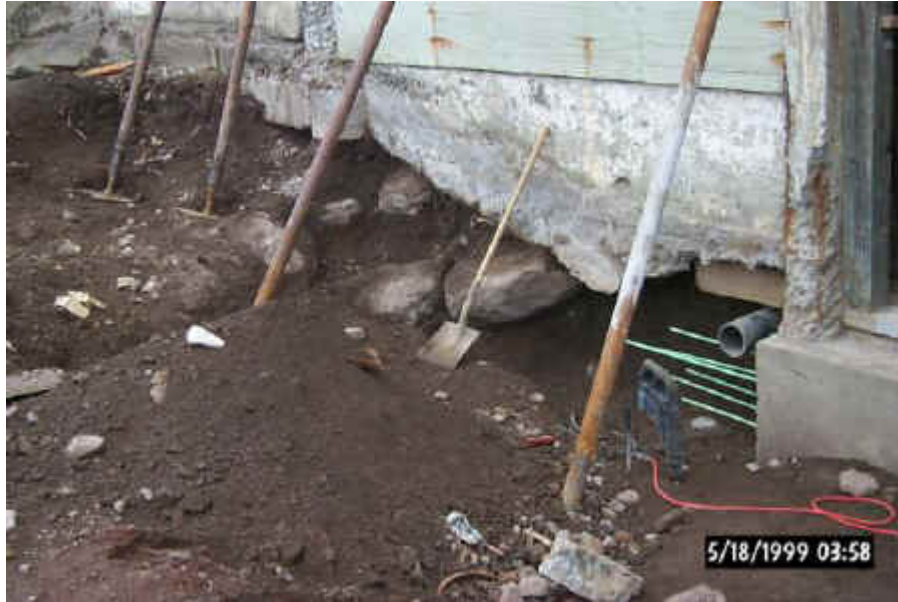
**Figure 8. Large Rock in Path of Perimeter Grade Beam Construction**

In several instances, during construction of the grade beam, excavation could not be done because solid rock was encountered. In this case reinforcing bar was epoxied 8 inches into the solid rock and the forms were cut to conform the concrete to the rock. At the ends of the grade beam where existing concrete was encountered, the reinforcing was epoxied into that as well. The dimensions of the perimeter foundation were a minimum of 18 inches wide by 24 inches deep, with the exception of rock areas.

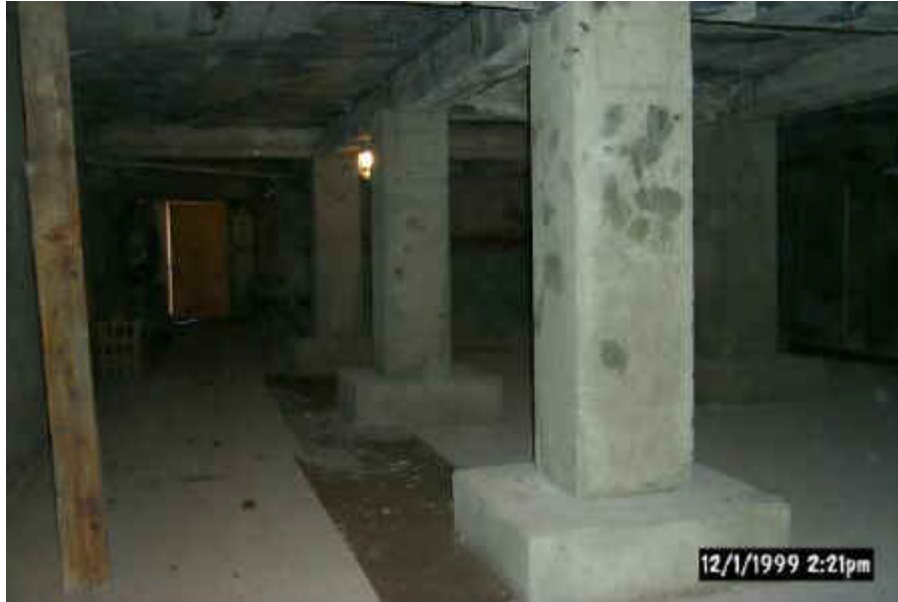
The interior columns were, in most cases, less deteriorated than those on the outside wall. Concrete was lost where reinforcing corroded and the expansion forces of the iron oxide caused the concrete to spall off. With the footings on the concrete floor and the original columns encapsulated as part of the footing, it was logical to add a minimum 4-inch outer column over the existing column.

**Figure 9. Oversized Interior Columns in the Blubber House Basement**

The beams supported by the existing column were supported by temporary screw jacks during the work. The existing column had all loose material removed and badly corroded reinforcing was exposed. If the reinforcing was not too corroded, it was cleaned off and coated with a corrosion inhibitor. A new rebar cage was applied then the forms were constructed and the column was poured with +3,500 psi concrete. Because the new column is larger than the old it decreases the span of the floor support beams by 8 inches. This has the net effect of significantly increasing their carrying capacity.

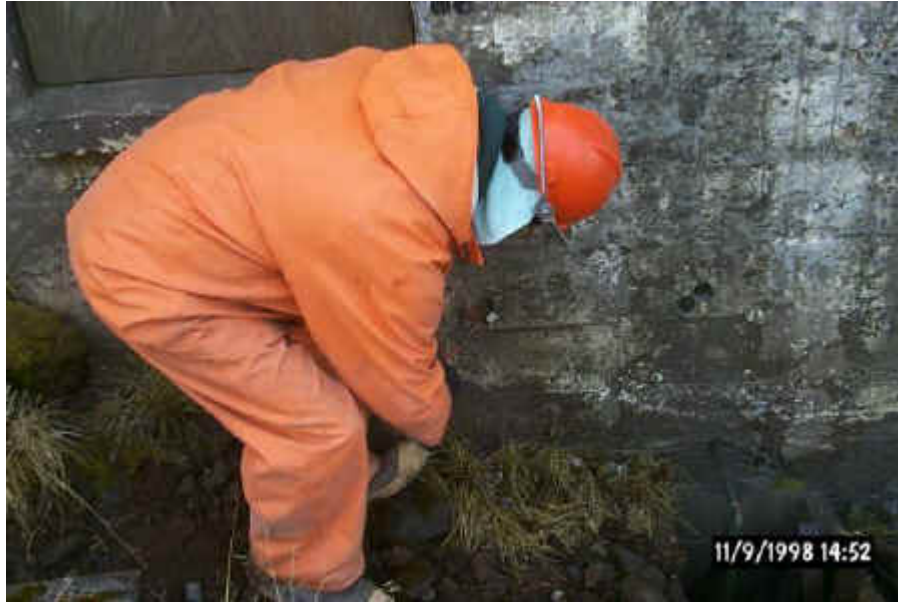
**Figure 10. Wire Tie Removal**

The specifications called for removing the form ties on the exterior walls. As shown on the original plans, there were a large number of these ties. The cores were made with dry bits and water diamond bit drilling. Water was difficult to get when it was cold and restricted the use of the diamond core drill. Once the drilling work was completed the tie wire was broken off and the holes patched with S88 mortar. It should be noted that the form ties had corroded and rust would show through the paint. However, some of the aggregate has high iron content and exhibits similar properties. The specifications did not call for removing the tie wires in the interior of the building.

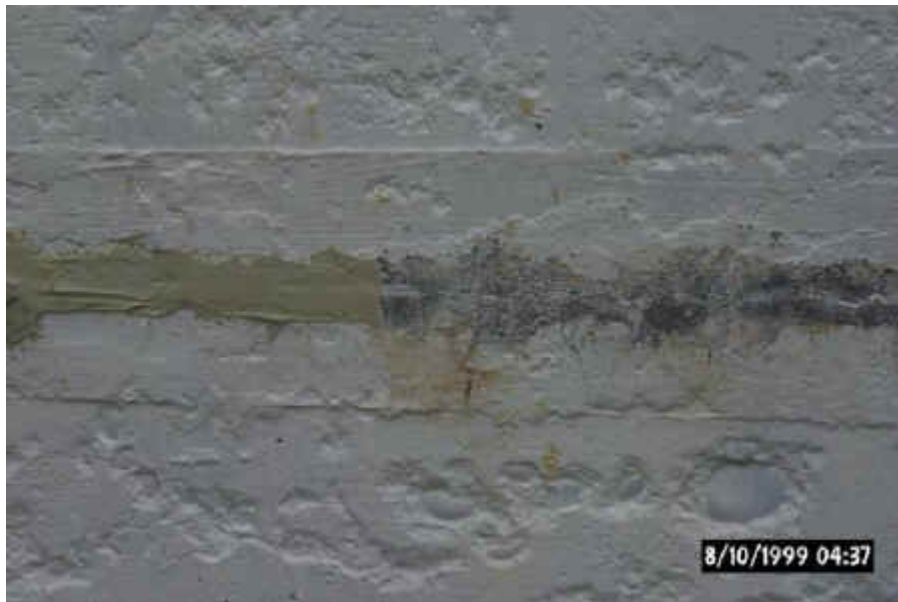
**Figure 11. Repaired Crack with Capping Paste Still Covering the Left Side**

In 1999, an expert, Leo Manes, was brought in from Vector, a firm that does extensive crack repair work on bridges and nuclear power plants. He trained and worked with a team of local workers and they repaired all of the injectable and repairable cracks. Even during the summer time it was still too cold for the epoxy to flow effectively. The crew built an enclosure for the pump that was heated. The hot epoxy flowed easily into the smallest of cracks.

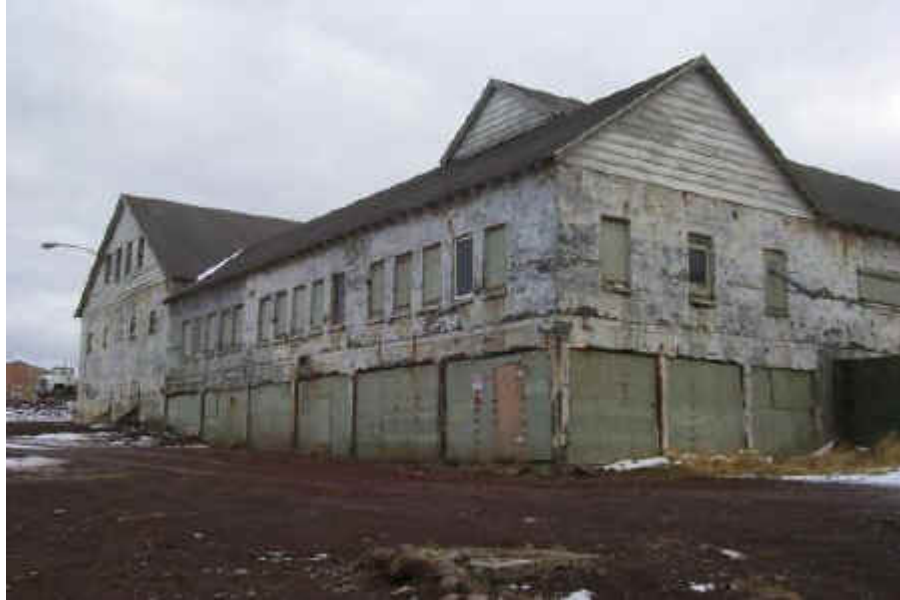
**Picture of the Seal Plant before any work began in 1998.**

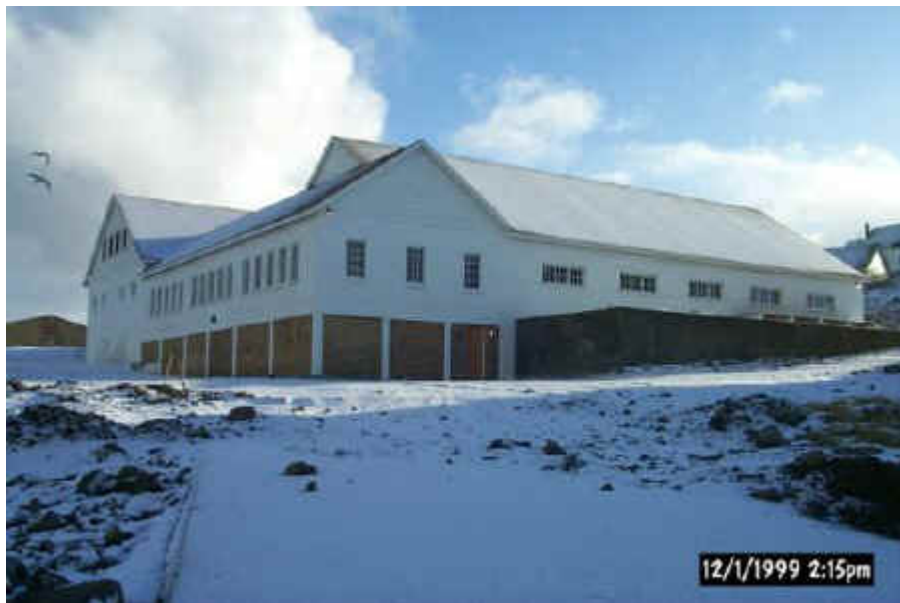
**Finished Project. Frost on the roof is covering the cedar shingles which are the same as the ones on the exterior of the blubber house basement infill panels.**

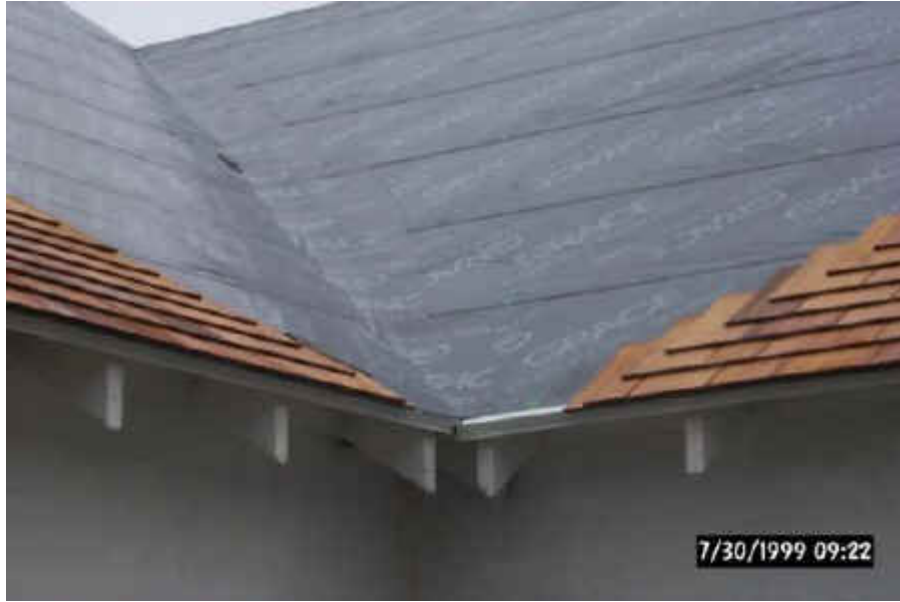
**New roof installation. Note the use of ice and water shield over the entire roof area.**

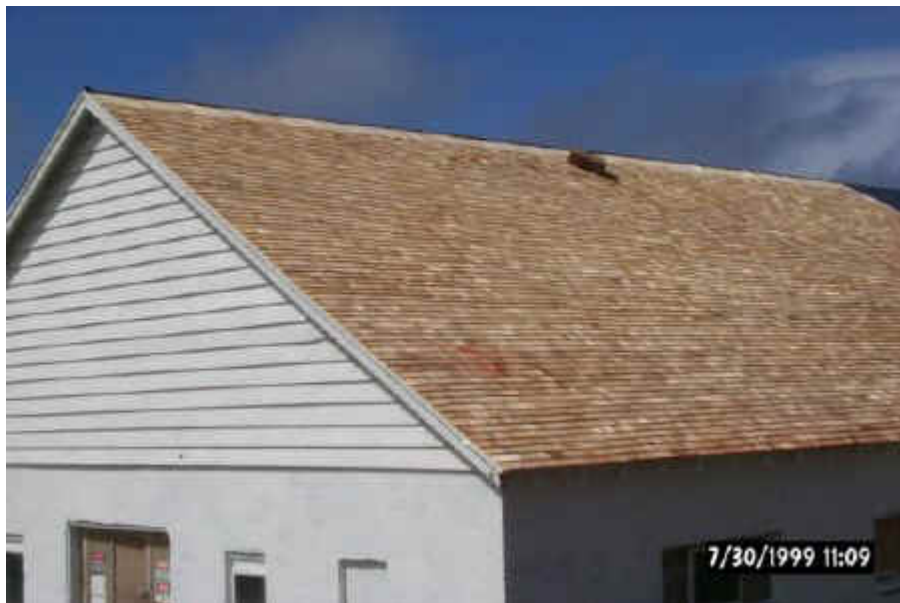
**Close up of new cedar shingles.**

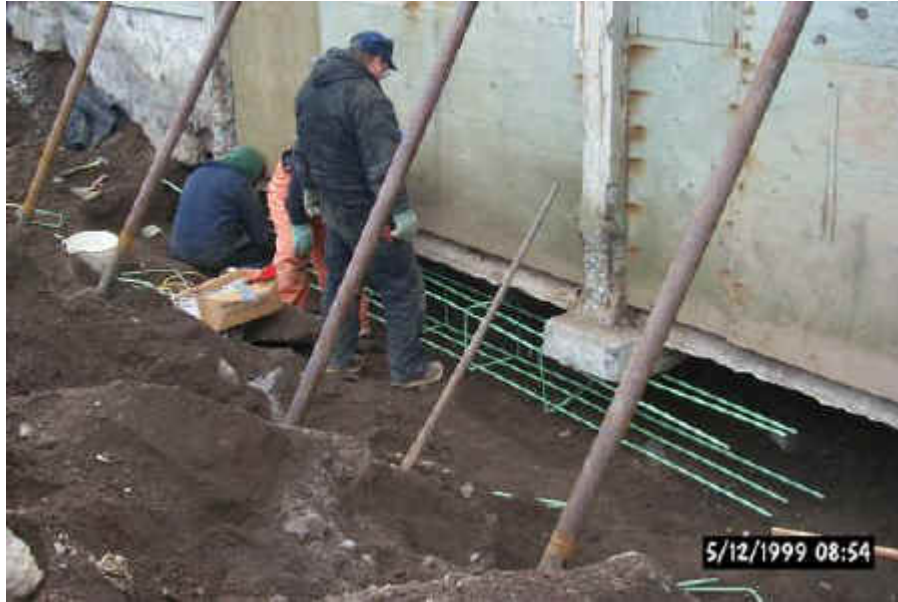
**Installing grade beam rebar under the existing slab and exterior columns of the blubber house basement.**

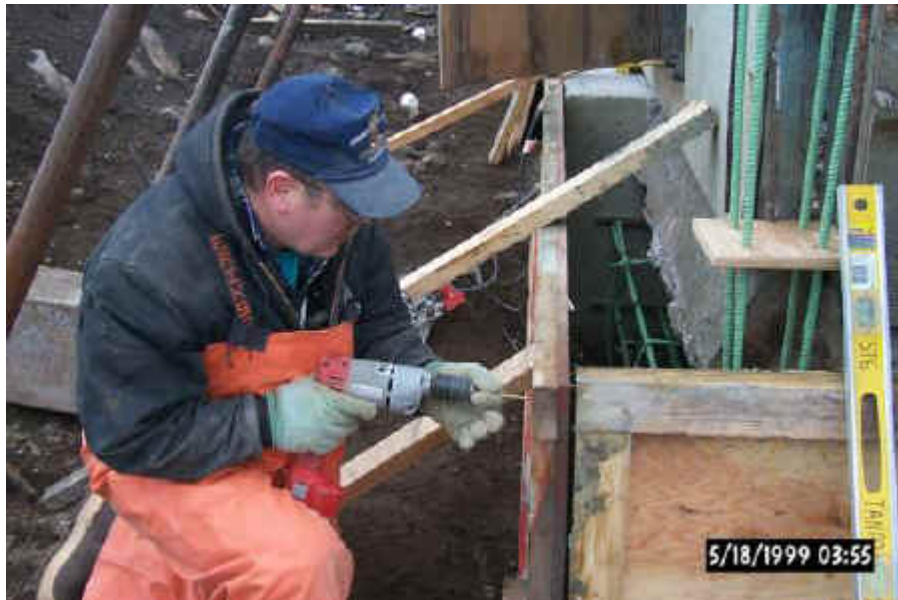
**Putting forms together for grade beam.**
