Request for No Further Remedial Action Planned

The Municipal Garage/Machine Shop (Municipal Garage) site is known by several different names including the Equipment Shed, Community Garage, and Elephant Hut. It is formerly referred to as Two-Party Agreement [TPA] Site 9e, and as National Oceanographic and Atmospheric Administration (NOAA) site 20.

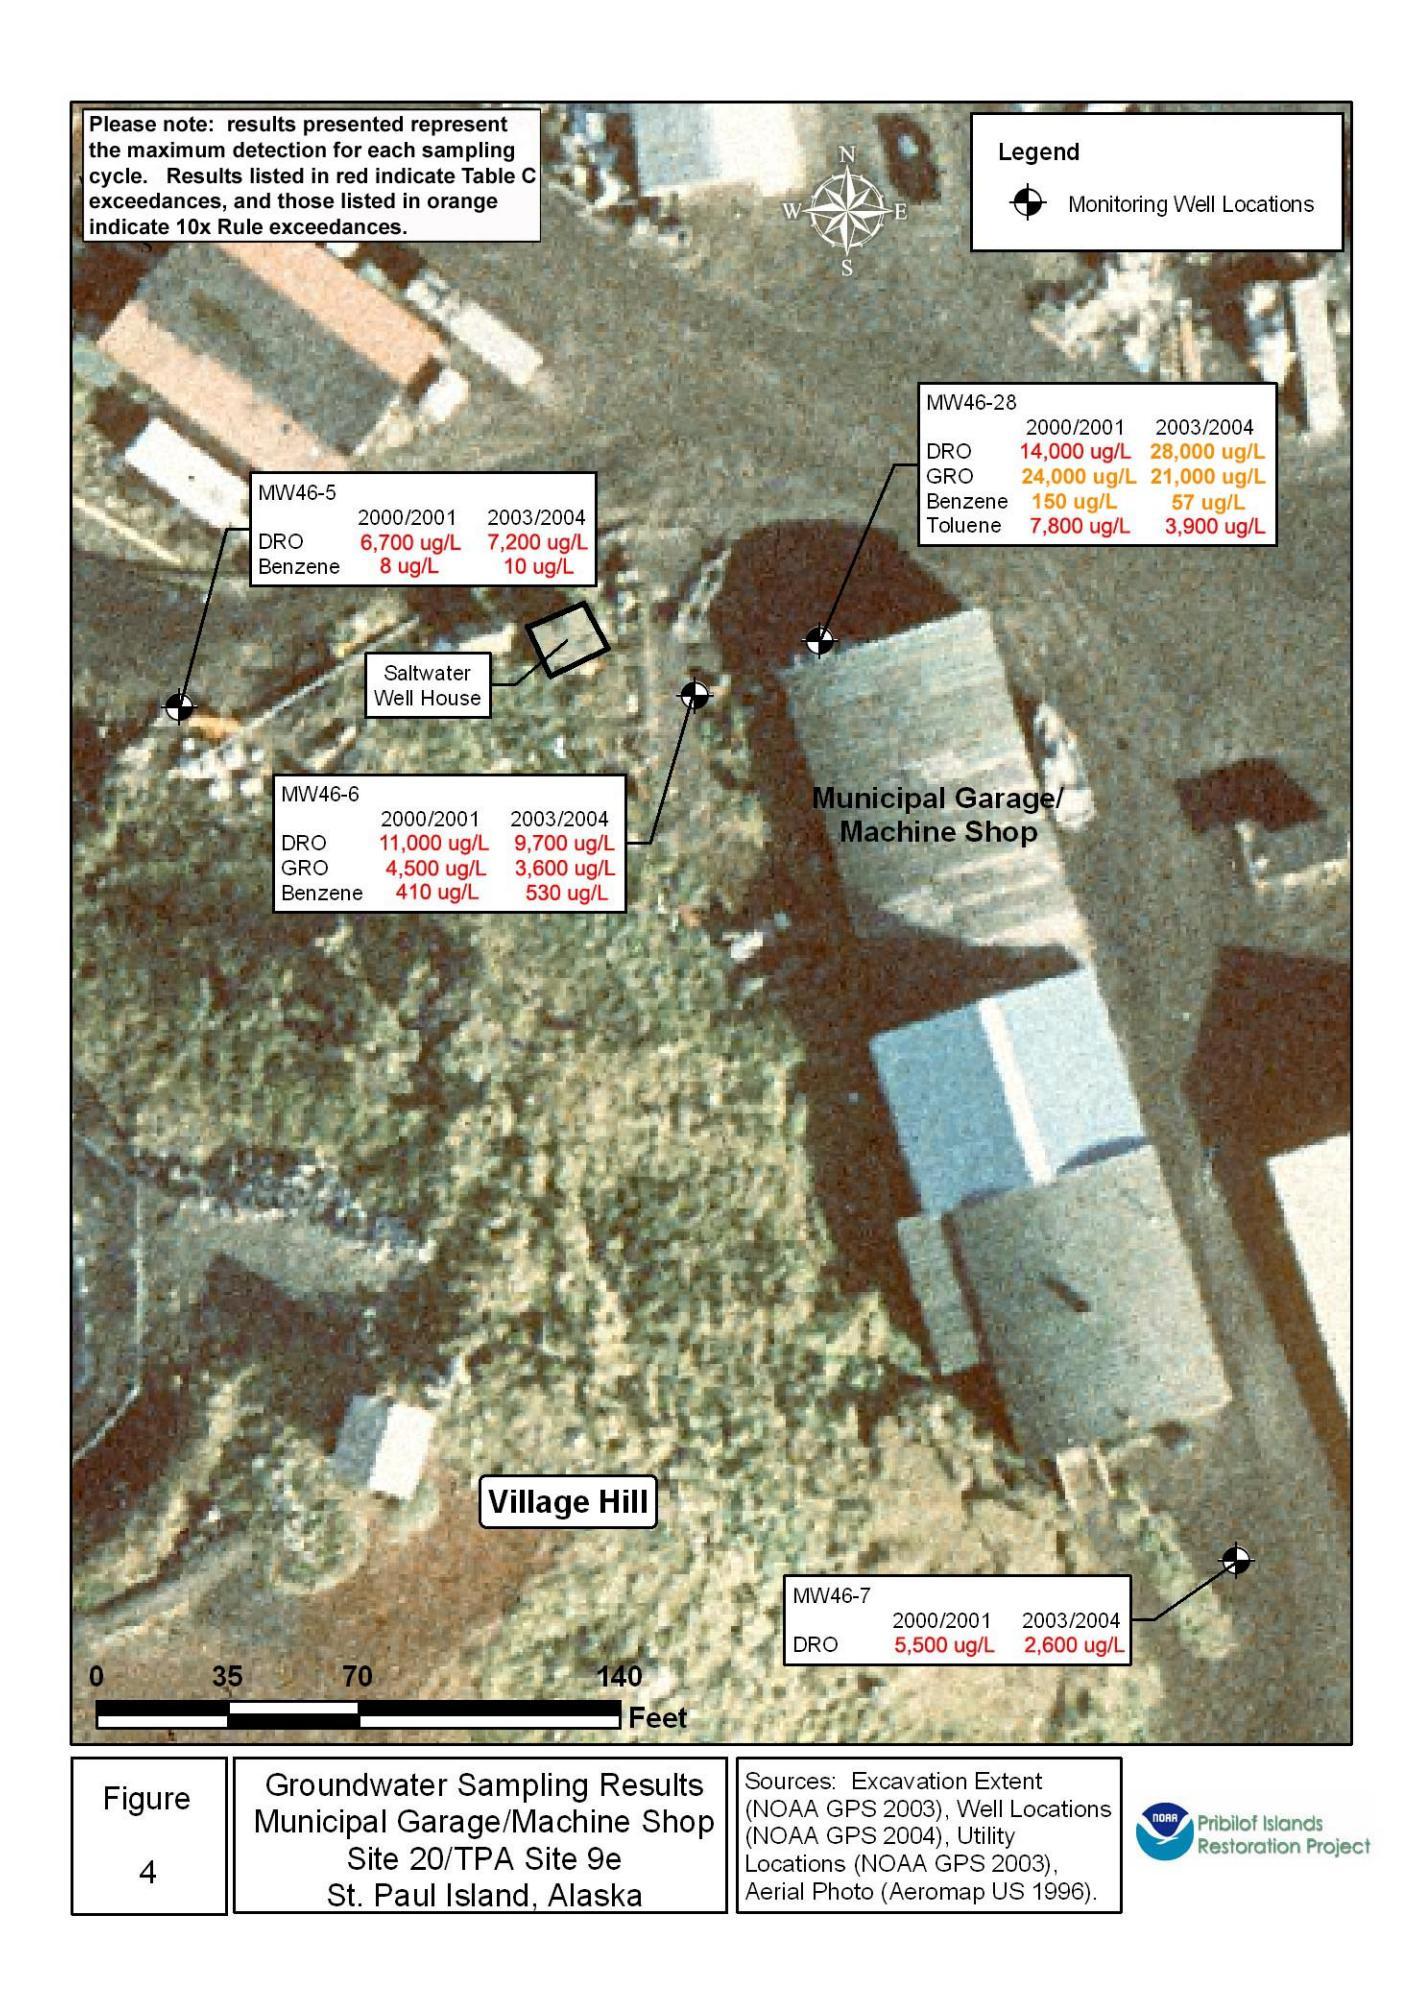
NOAA contractors conducted quarterly groundwater monitoring from June 2000 to September 2001 and from October 2003 to July 2004 including 4 monitoring wells in the vicinity of the Municipal Garage (Figure 4). The results are summarized below.

During 2000-2001 sampling events, DRO were detected above their Alaska Department of Environmental Conservation (ADEC) Table C cleanup level of 1,500 ug/l in all 4 wells, with maximum detected concentrations of 14,000 ug/l, (Figure 4). Gasoline range organics (GRO) were detected above their ADEC Table C cleanup level of 1,300 ug/l in two wells, with maximum detected concentrations of 24,000 ug/l, with this same well also exceeding the alternative Ten Times Rule (10x Rule) cleanup level for GRO of 13,000 ug/l, Figure 4. Benzene was detected above its ADEC Table C cleanup level of 5 ug/l in 3 of the 4 wells, with maximum detected concentrations of 410 ug/l, Figure 4. The two wells with the highest benzene concentrations also exceeded the 10x Rule cleanup level for benzene of 50 ug/l. Finally, analysis detected toluene above its ADEC Table C cleanup level of 1,000 ug/l in one well, at a concentration of 7,800 ug/l, (IT Alaska Inc. 2002), Figure 4.

During the first two quarters of 2003-2004 sampling, the same compounds that had exceeded the ADEC Table C cleanup levels were detected in all the same wells at levels exceeding the Table C cleanup levels. All the wells that had exceeded cleanup levels under the 10x Rule in 2000/2001 still did so, and one additional well exceeded the 10x Rule (for DRO) that had not in the previous sampling round. This well, MW46-28, went from 14,000 ug/l DRO in 2000/2001 to 28,000 ug/l DRO in 2003/2004, (Figure 4).

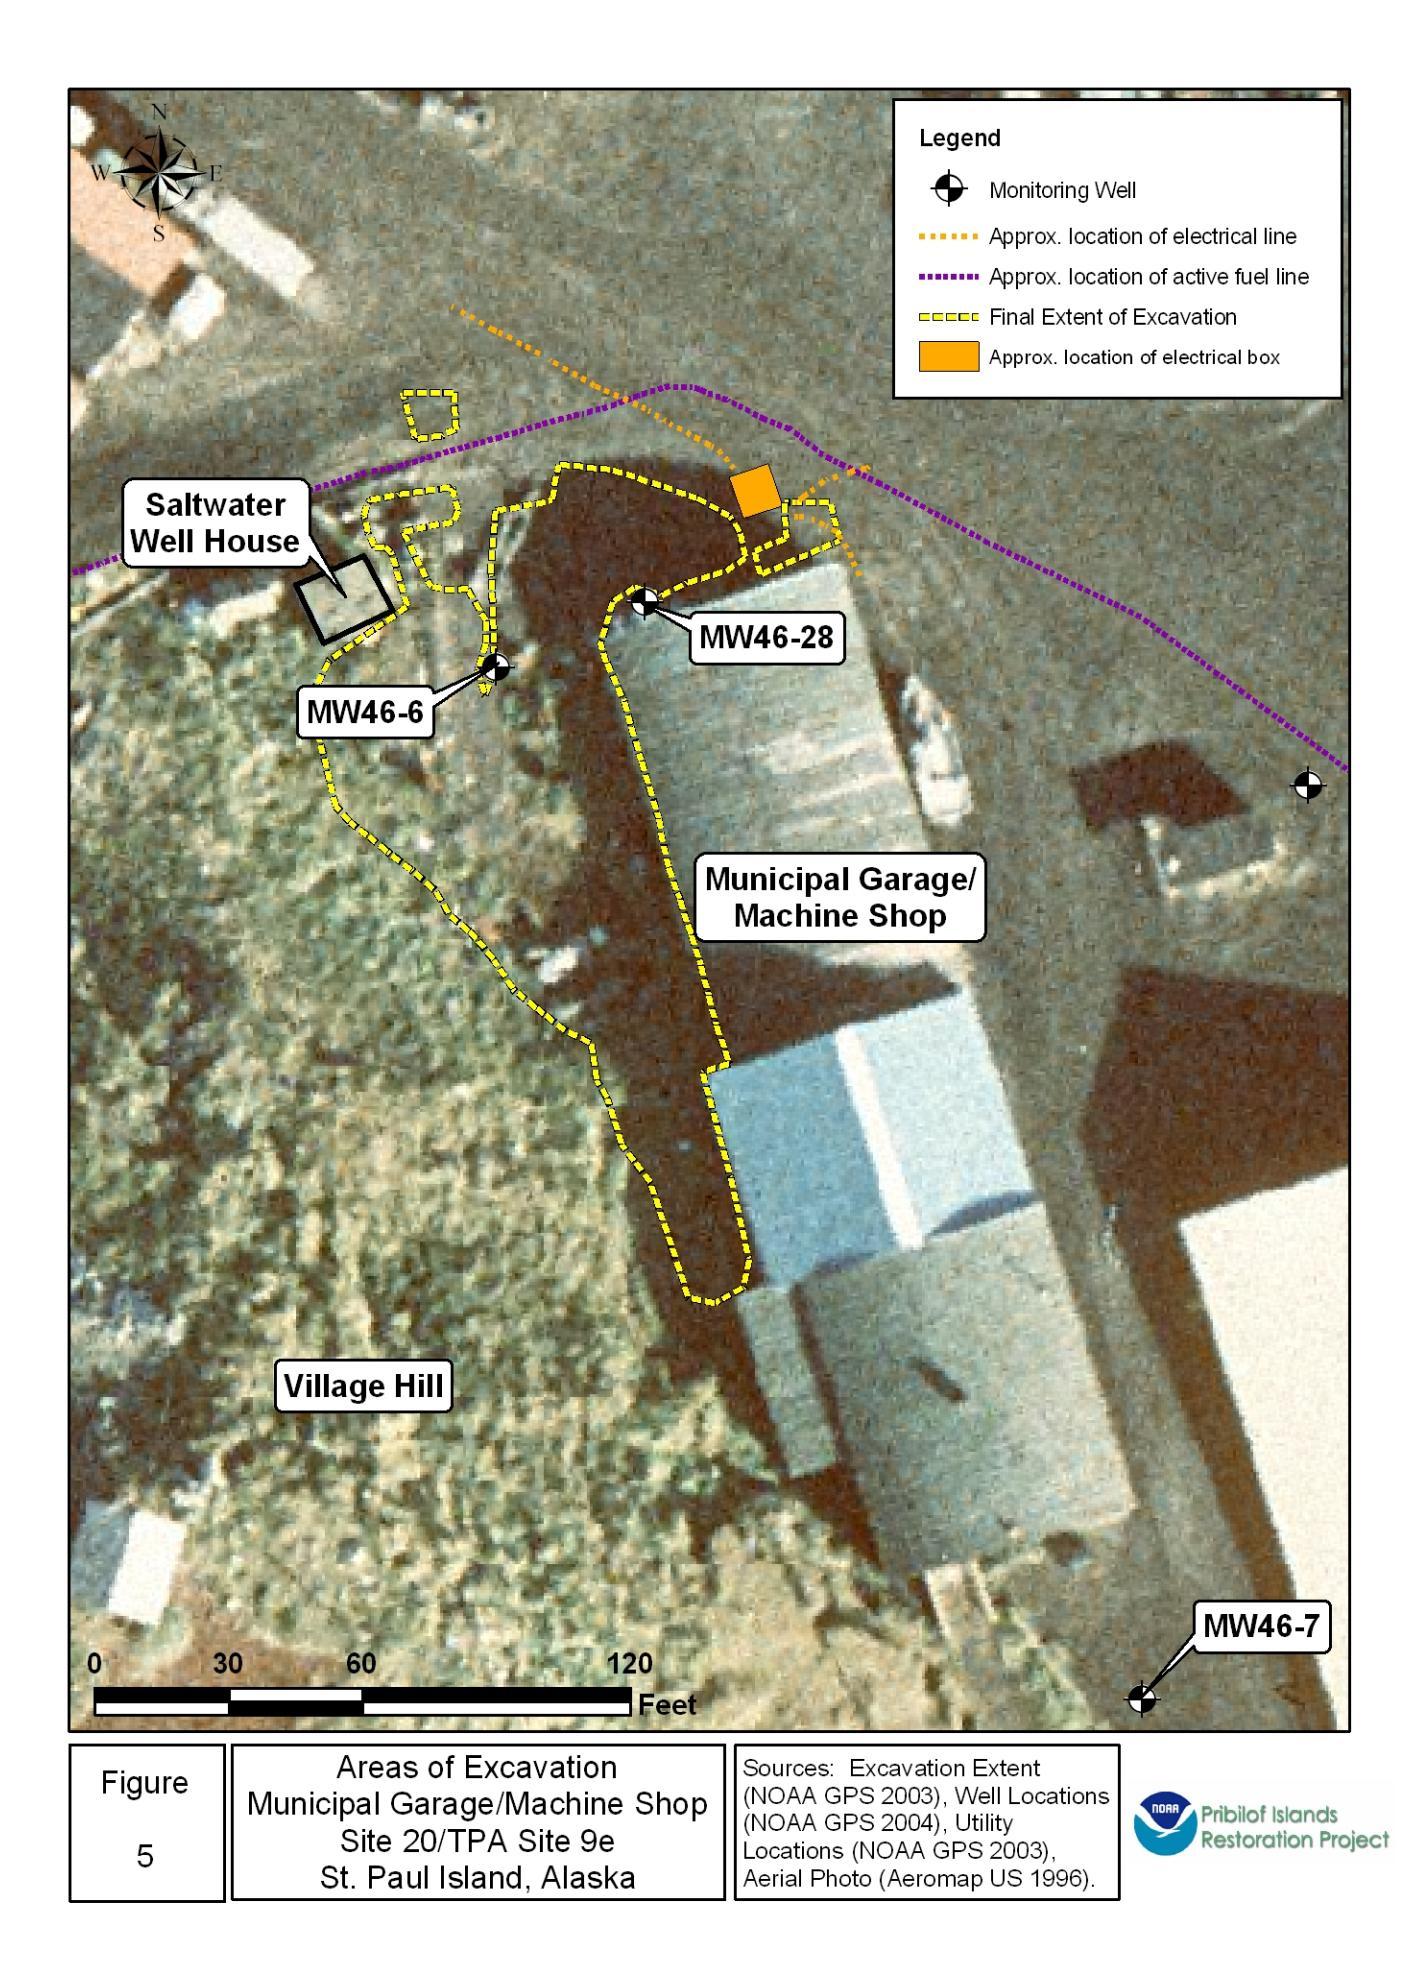
Excavation activities for the Municipal Garage commenced on August 4, 2003, and were completed on September 4, 2003. Initial areas of excavation were selected based on contamination identified during previous investigations, while the extent of excavation was determined based on thin layer chromatography (TLC) screening sample analyses as well as visual and olfactory observations (Figure 5) NOAA 2004.

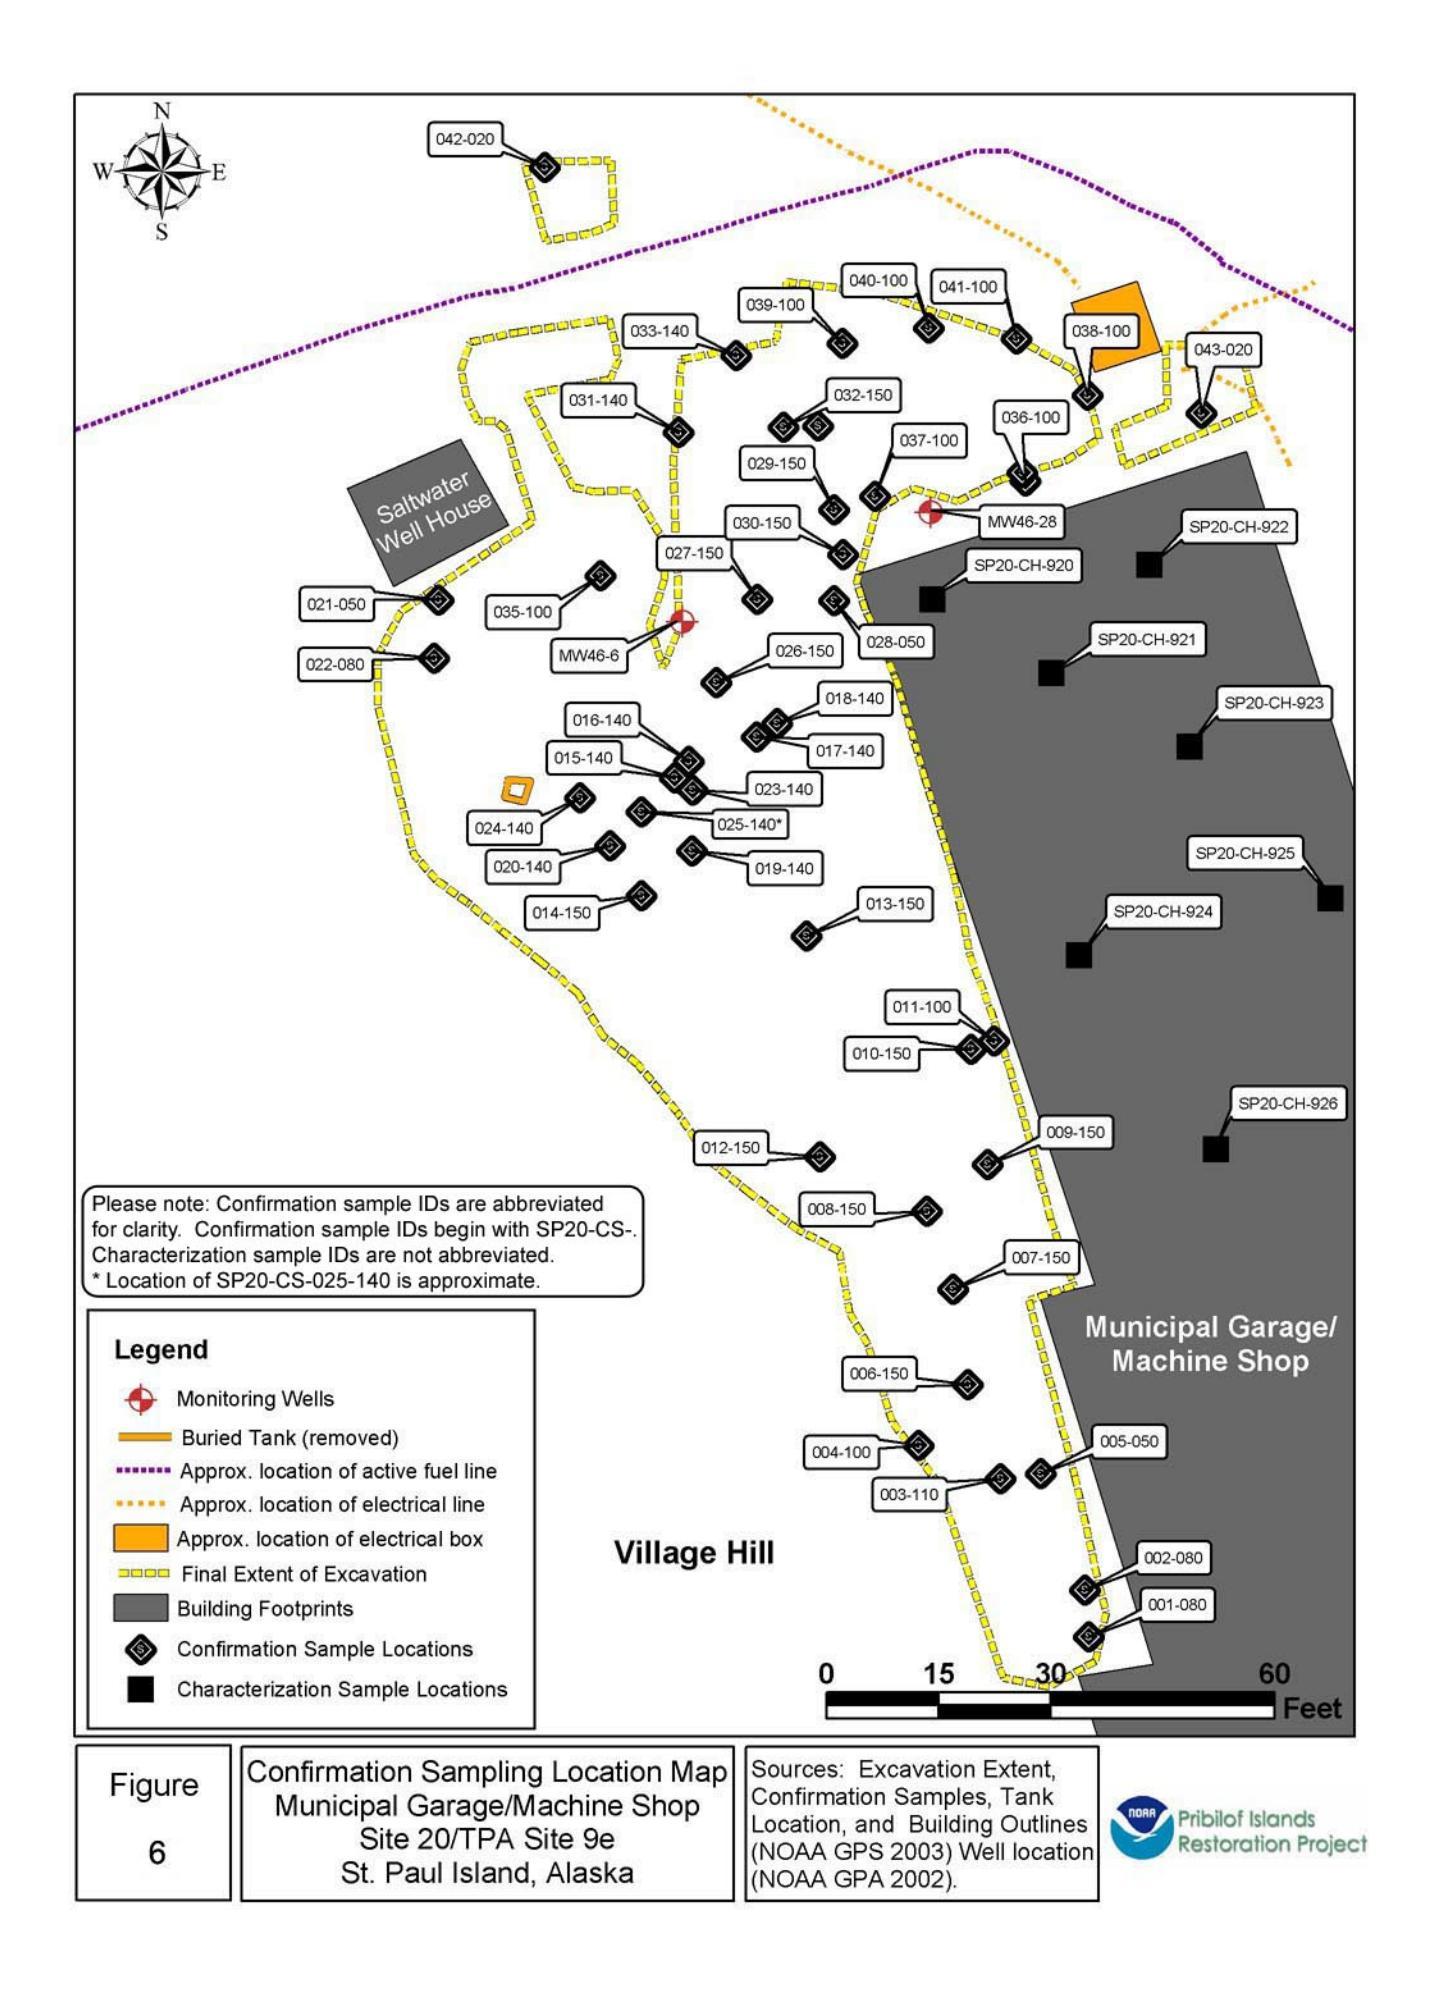
Forty-two confirmation samples and three field duplicate samples were collected during corrective action activities at the Municipal Garage. Tables 1 and 2 provide a summary of the confirmation samples collected during this corrective action. Figure 6 illustrates the sampling locations. All samples were analyzed for the following constituents:

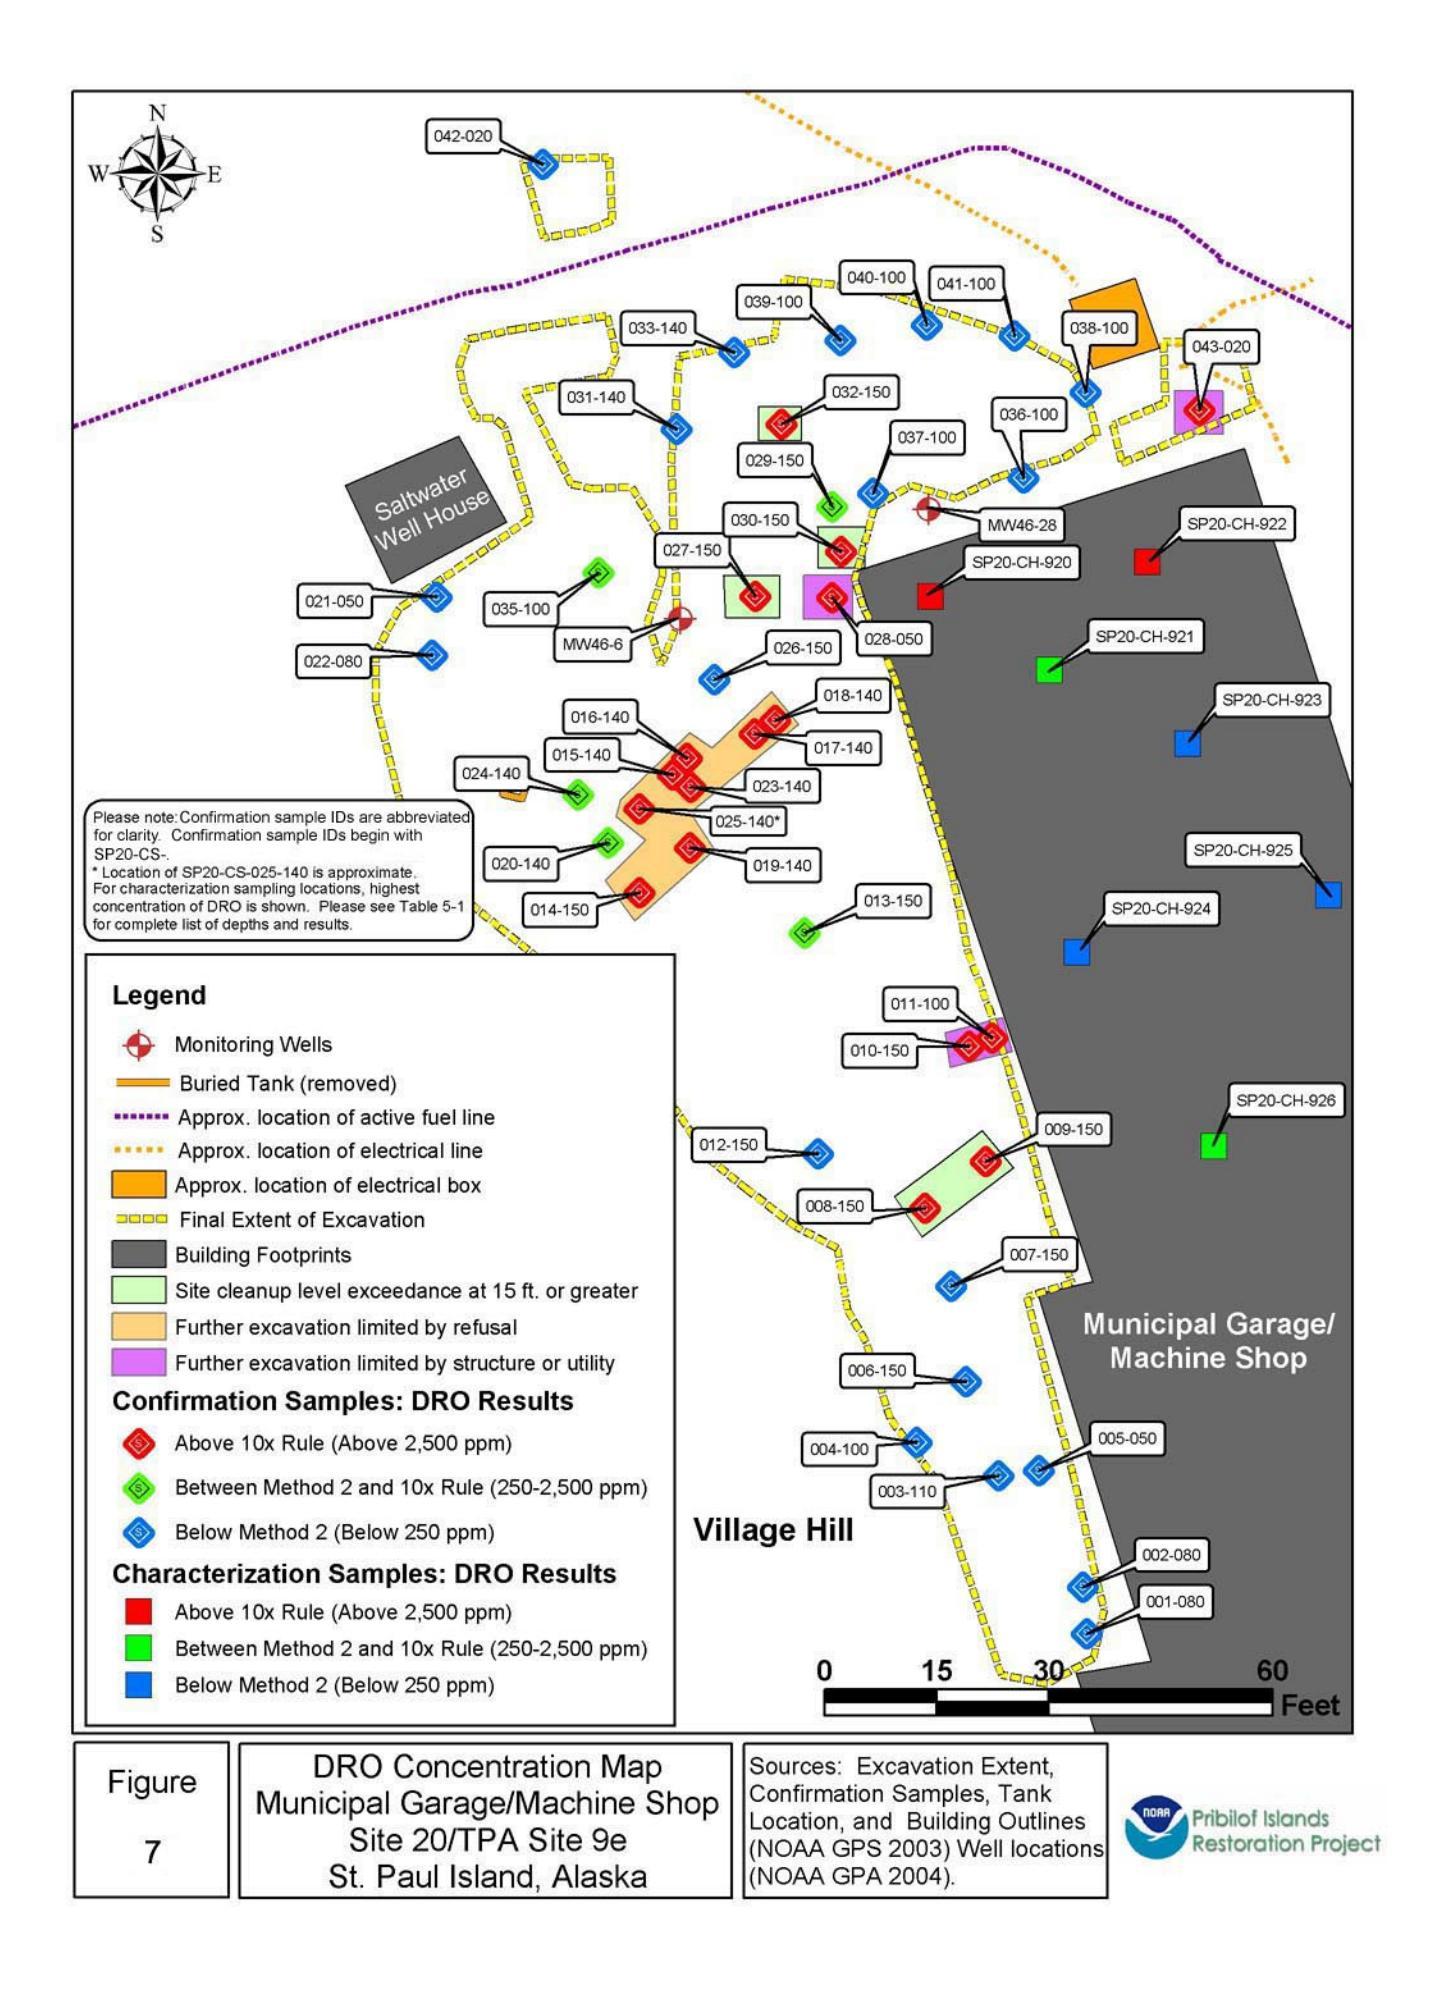
Confirmation samples collected from the excavation at the Municipal Garage indicated DRO concentrations varying from not detected to 19,000 mg/kg. Twenty-two of the 42 samples collected from this area contained concentrations of DRO above the ADEC Method Two cleanup level of 250 mg/kg, and 17 of the 42 samples exceeded the alternative cleanup level of 2,500 mg/kg. Figure 7 illustrates the distribution of DRO concentrations.

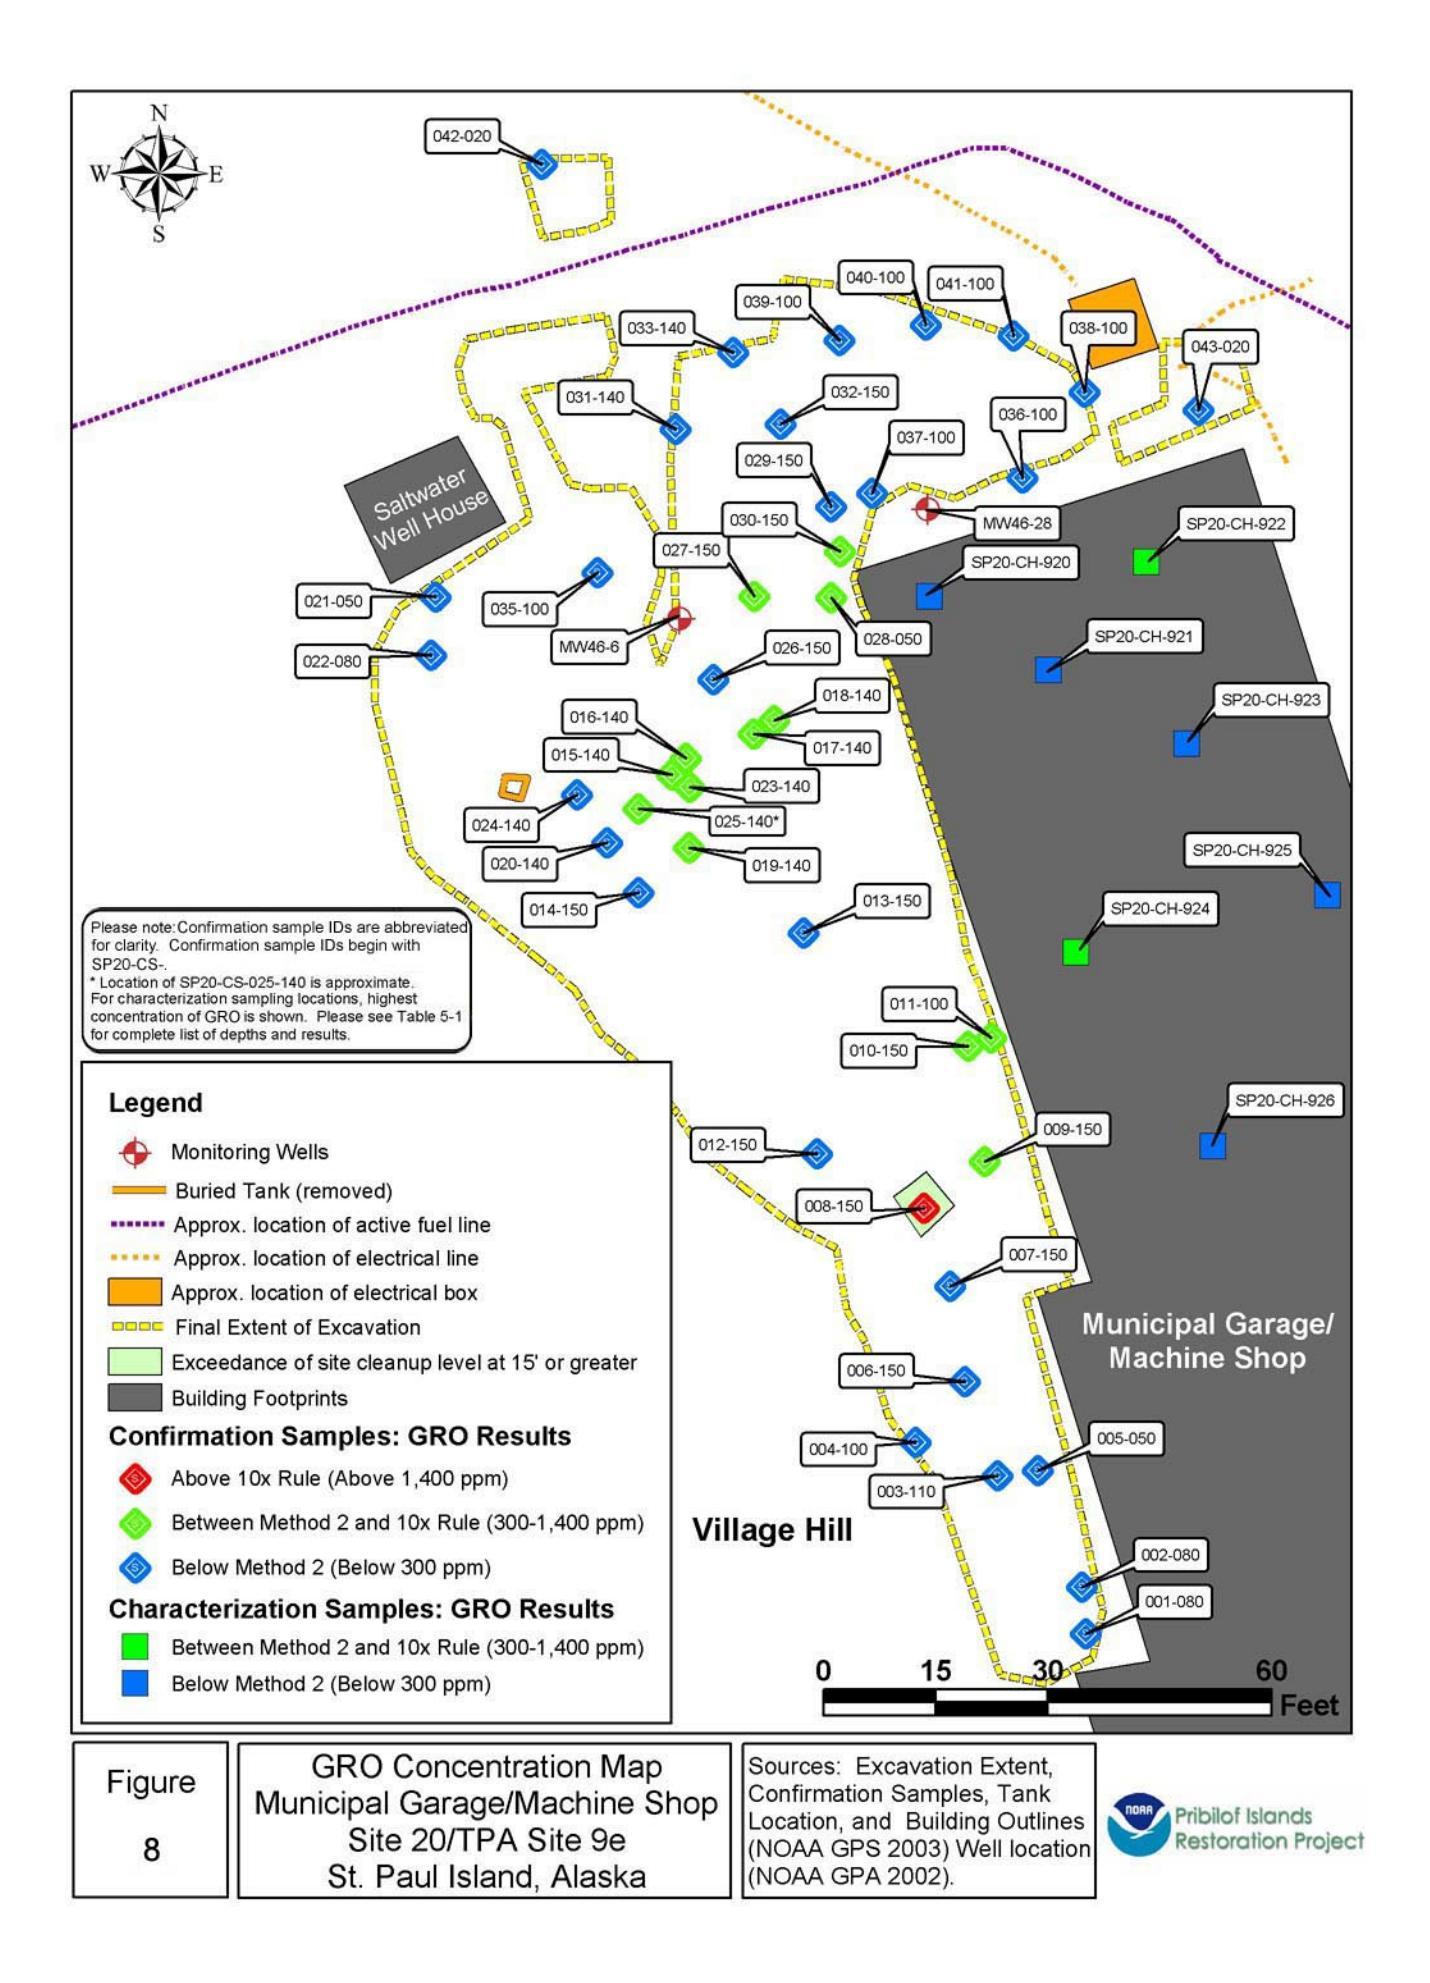
Confirmation samples indicated GRO concentrations varying from not detected to 1,500 mg/kg. Fourteen of the 42 samples collected from this area contained concentrations of GRO above the ADEC Method Two cleanup level of 300 mg/kg, and 1 of the 42 samples exceeded the alternative cleanup level of 1,400 mg/kg. Figure 8 illustrates the distribution of GRO concentrations.

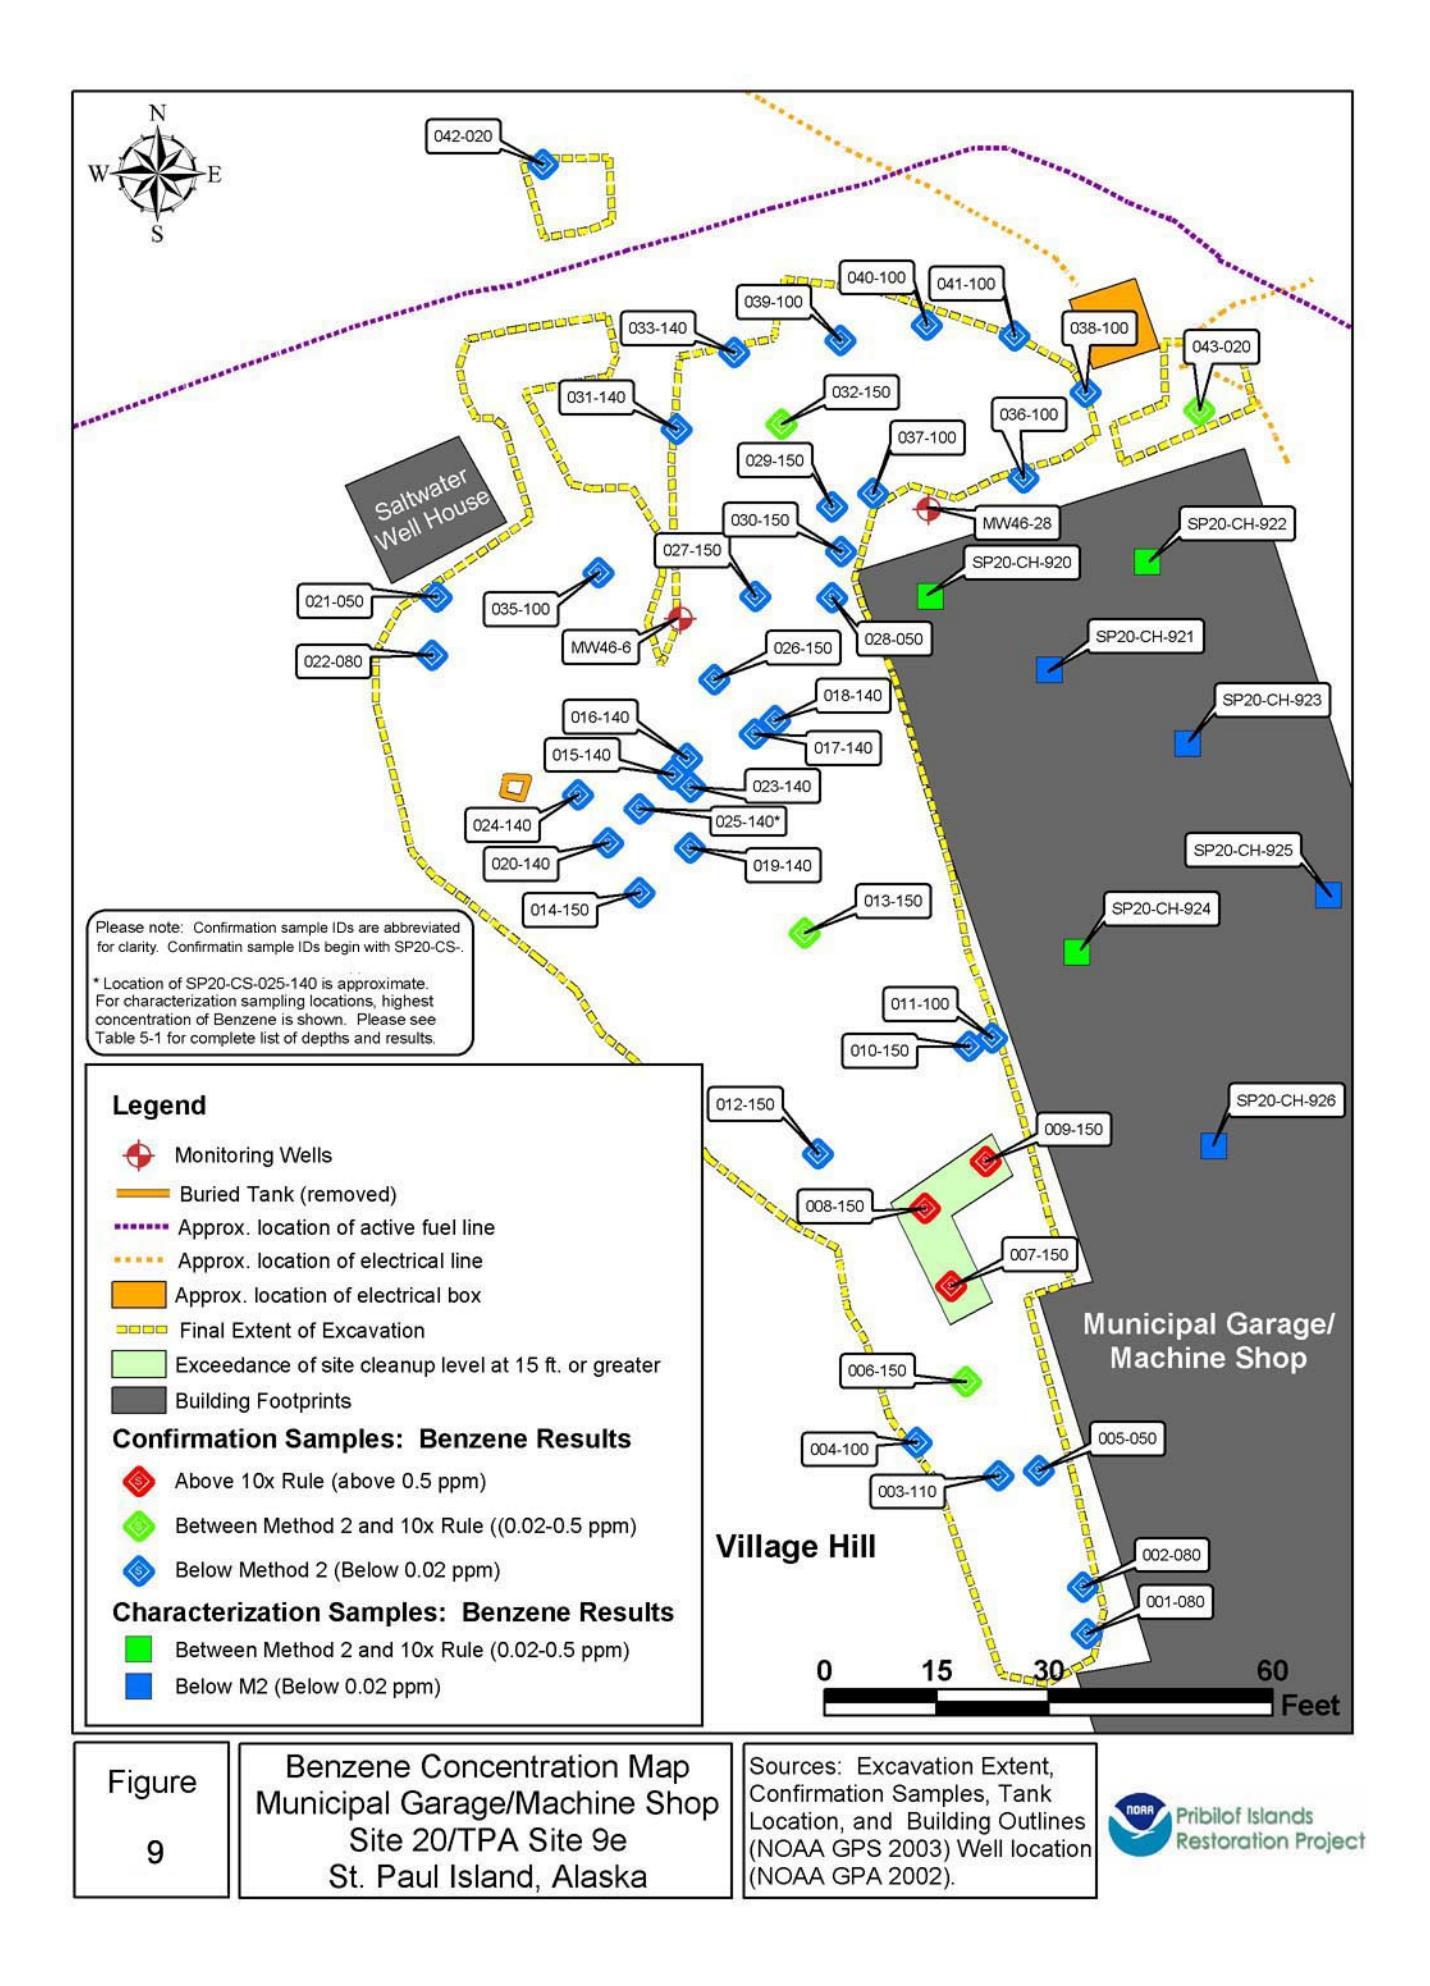
Confirmation samples indicated benzene concentrations varying from not detected to 1.2 mg/kg. Six of the 42 samples collected from this area contained concentrations of benzene above the ADEC Method Two cleanup level of 0.02 mg/kg, and 3 of the 42 samples exceeded the alternative cleanup level of 0.5 mg/kg. Figure 9 illustrates the distribution of benzene concentrations.

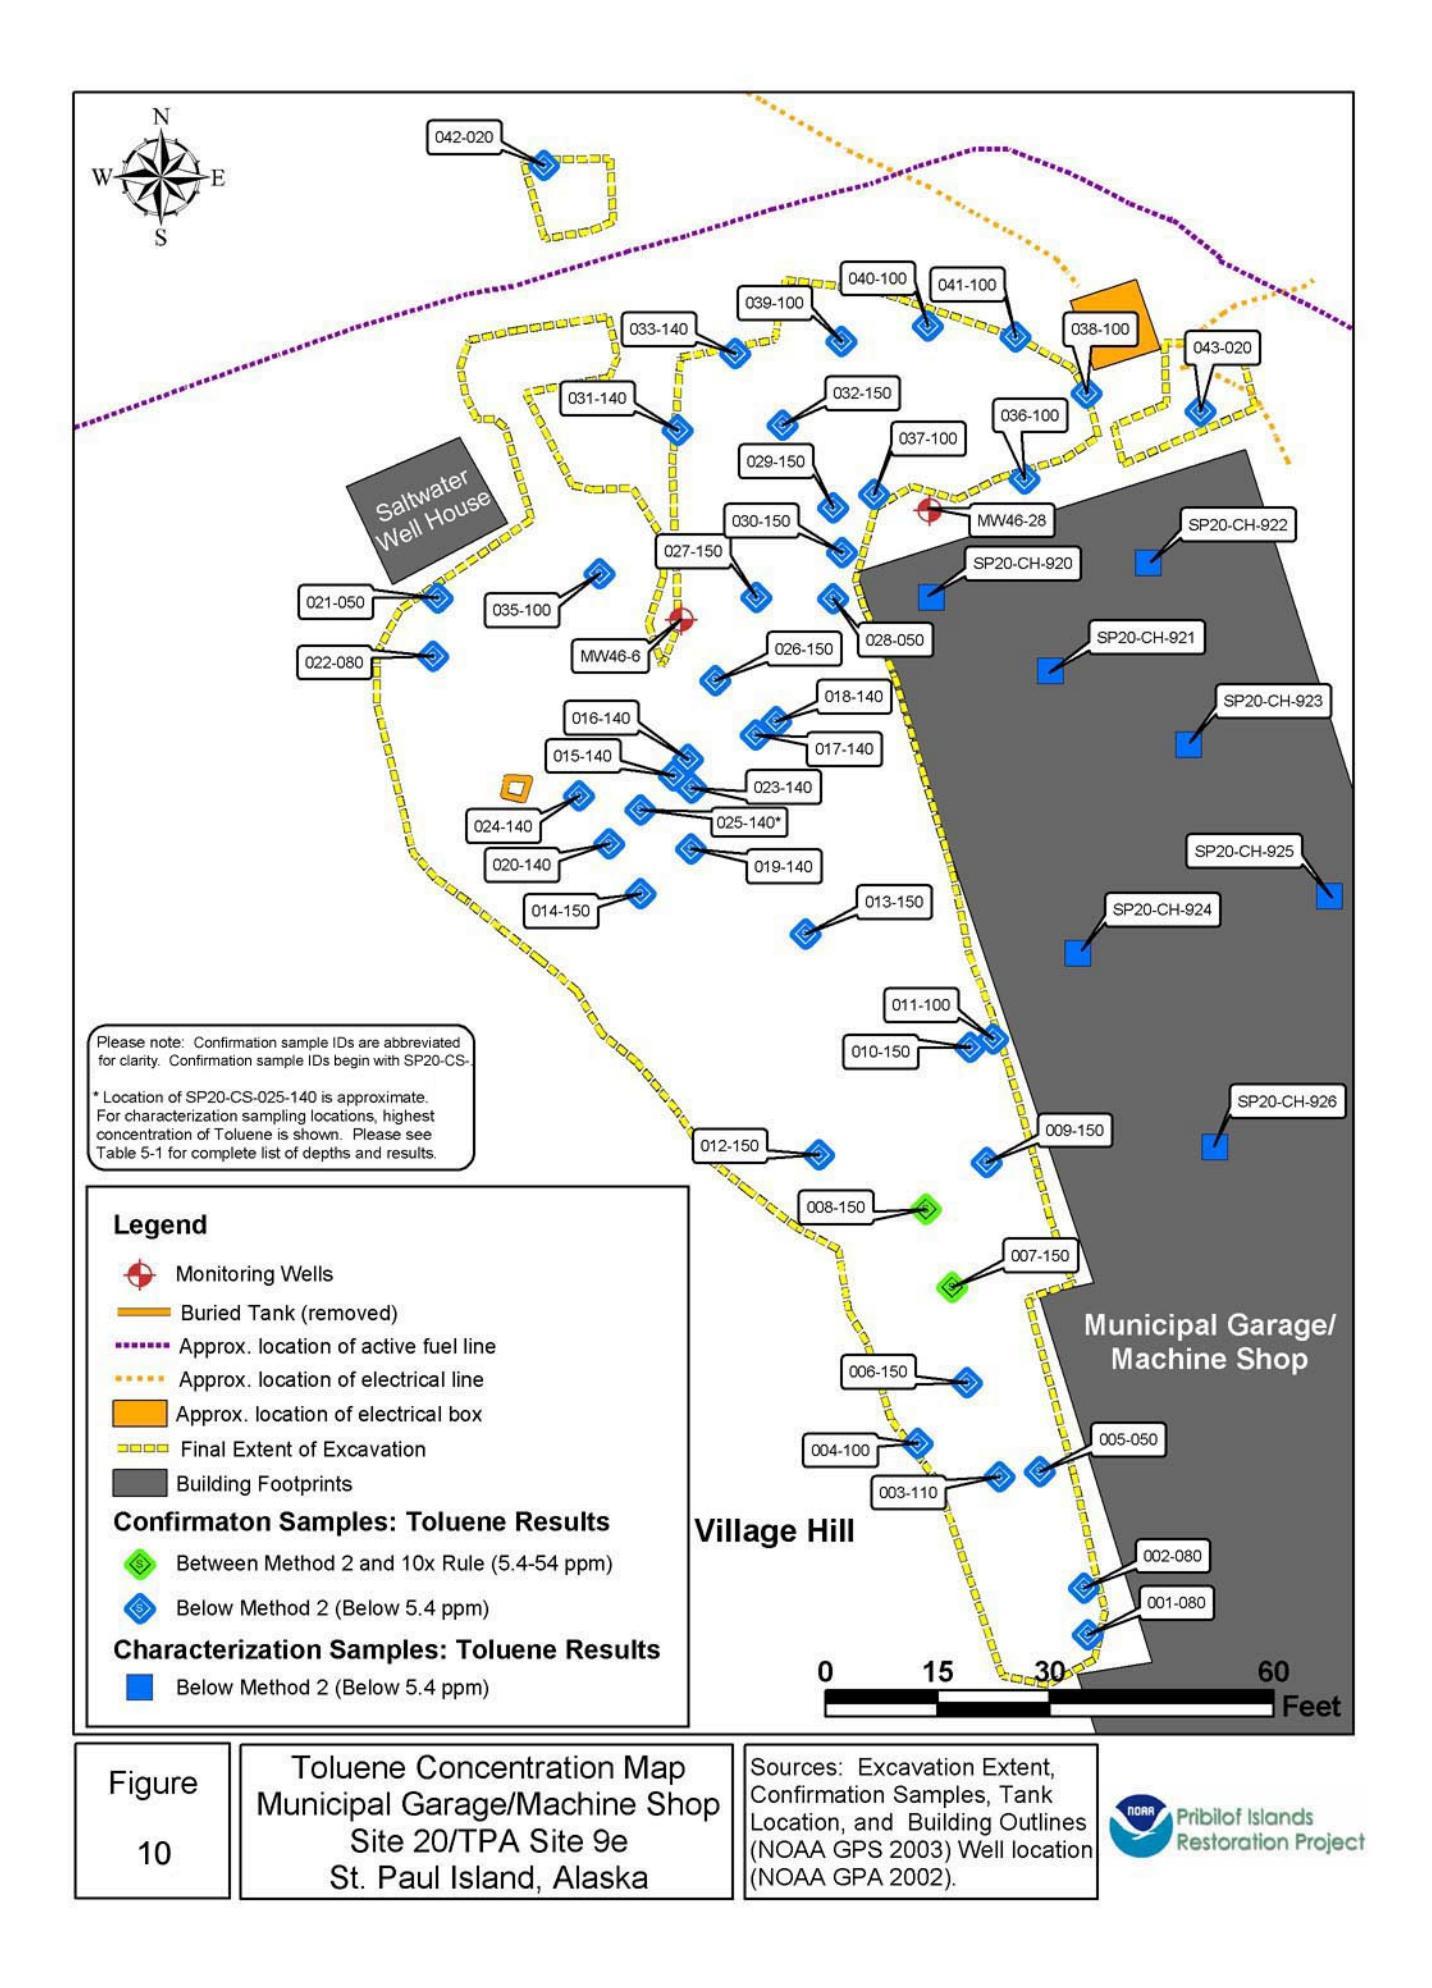
Confirmation samples indicated toluene concentrations varying from not detected to 25 mg/kg. Two of the 42 samples collected from this area contained concentrations of toluene above the ADEC Method Two cleanup level of 5.4 mg/kg, but none of the 42 samples exceeded the alternative cleanup level of 54 mg/kg. Figure 10 illustrates the distribution of toluene concentrations.
