Request for No Further Remedial Action Planned

The Municipal Garage/Machine Shop (Municipal Garage) site is known by several different names including the Equipment Shed, Community Garage, and Elephant Hut. It is formerly referred to as Two-Party Agreement [TPA] Site 9e, and as National Oceanographic and Atmospheric Administration (NOAA) site 20.

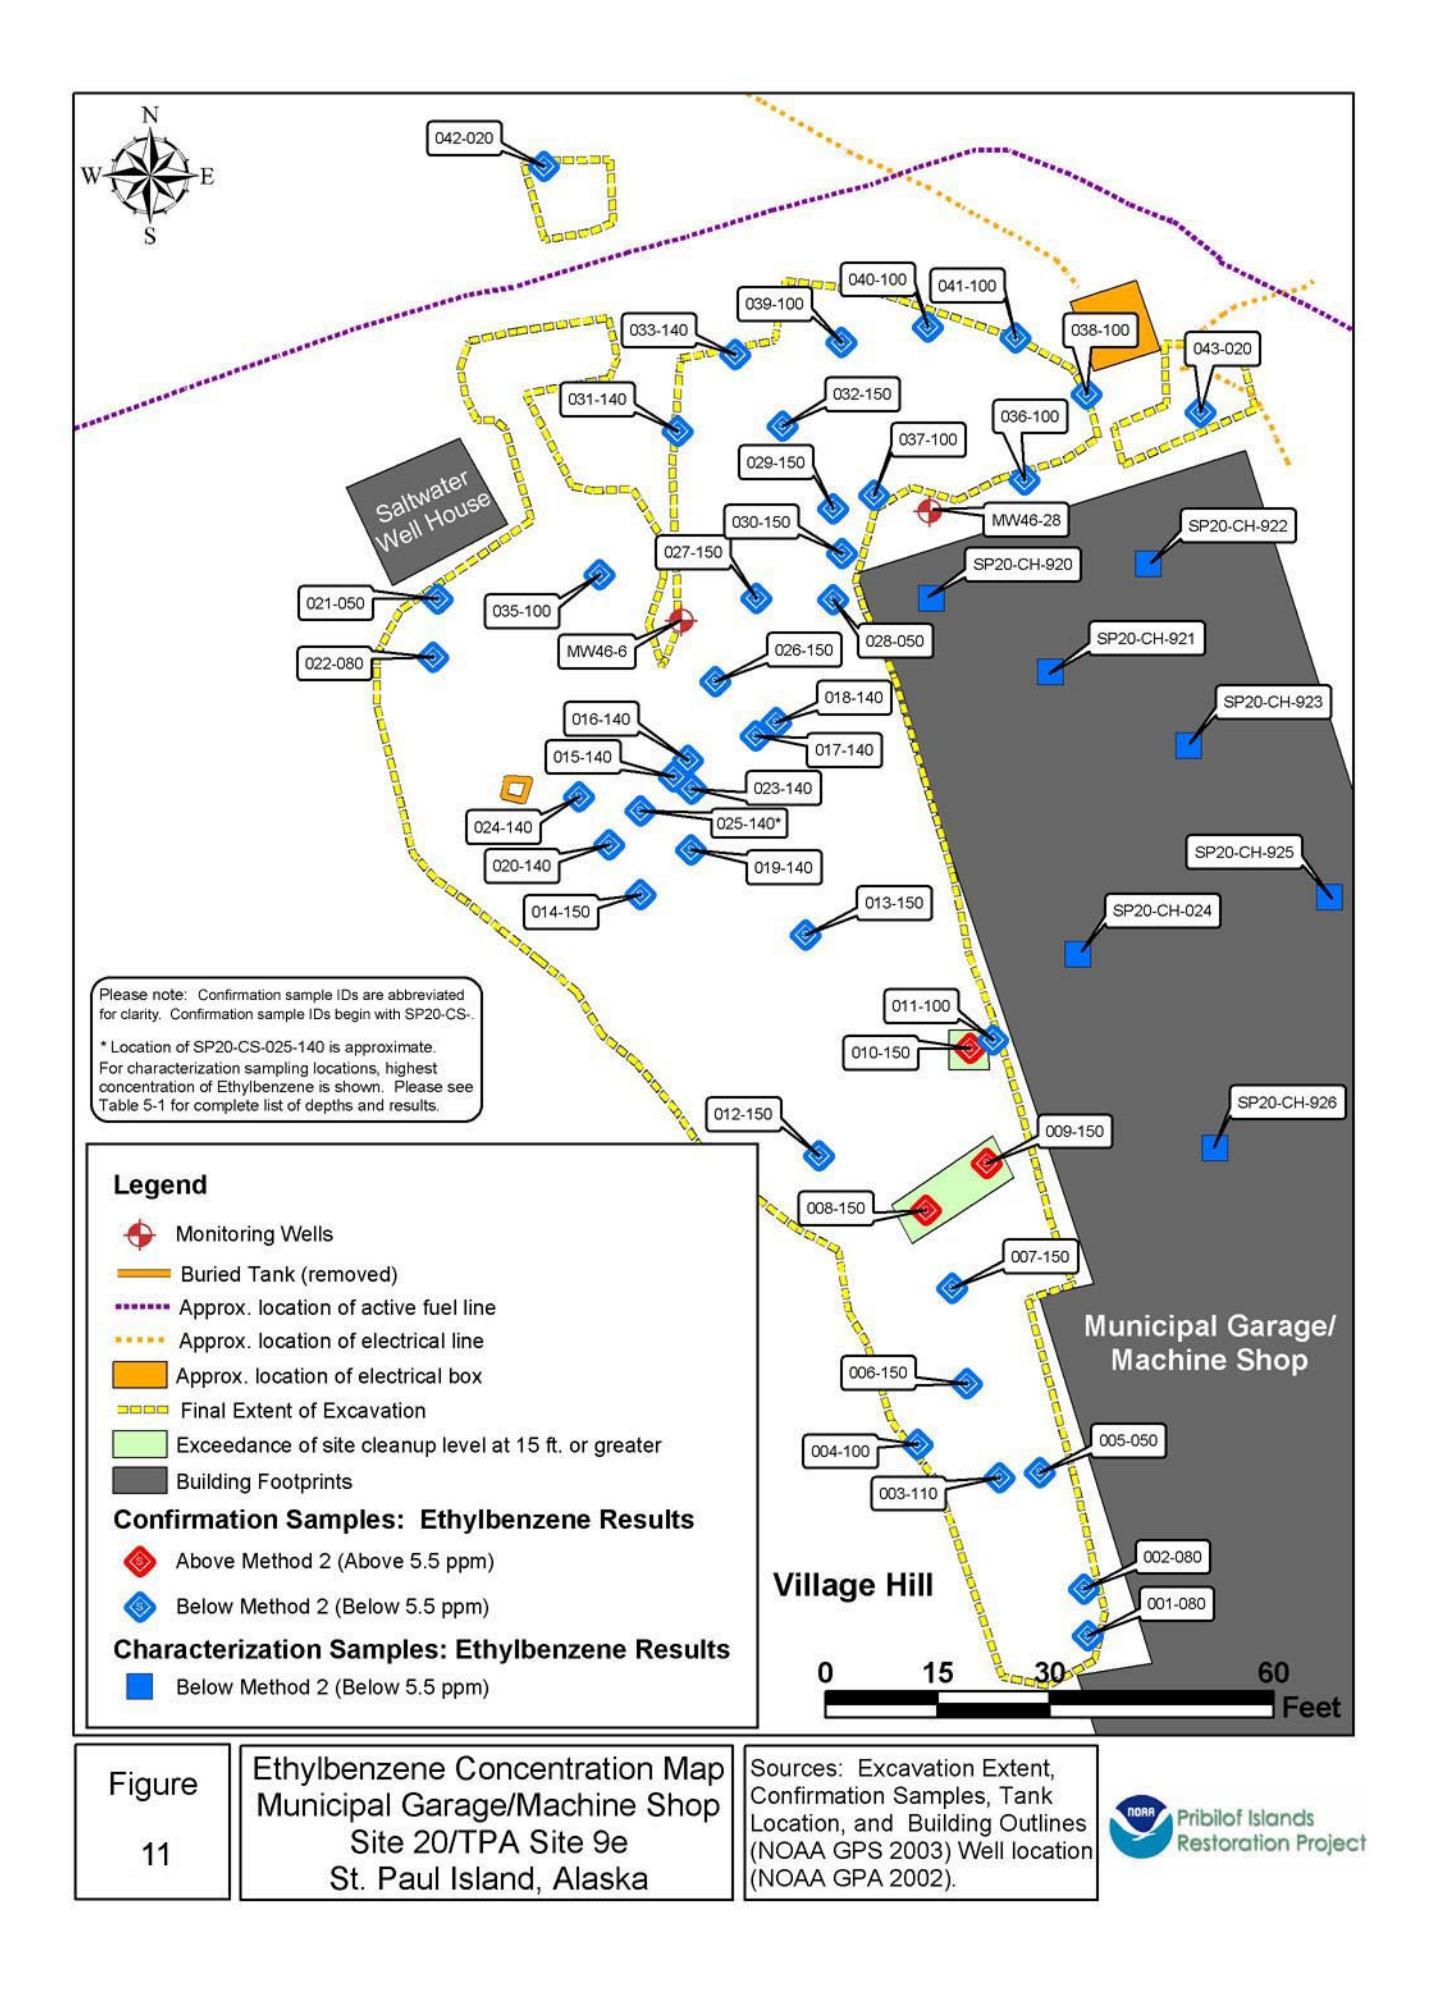
Confirmation samples indicated ethylbenzene concentrations varying from not detected to 23 mg/kg. Three of the 42 samples collected from this area contained concentrations of ethylbenzene above the ADEC Method Two cleanup level of 5.5 mg/kg. Since ethylbenzene was not detected in groundwater at this site, the 10x Rule does not apply to the ethylbenzene soil cleanup level. Figure 11 illustrates the distribution of ethylbenzene concentrations.

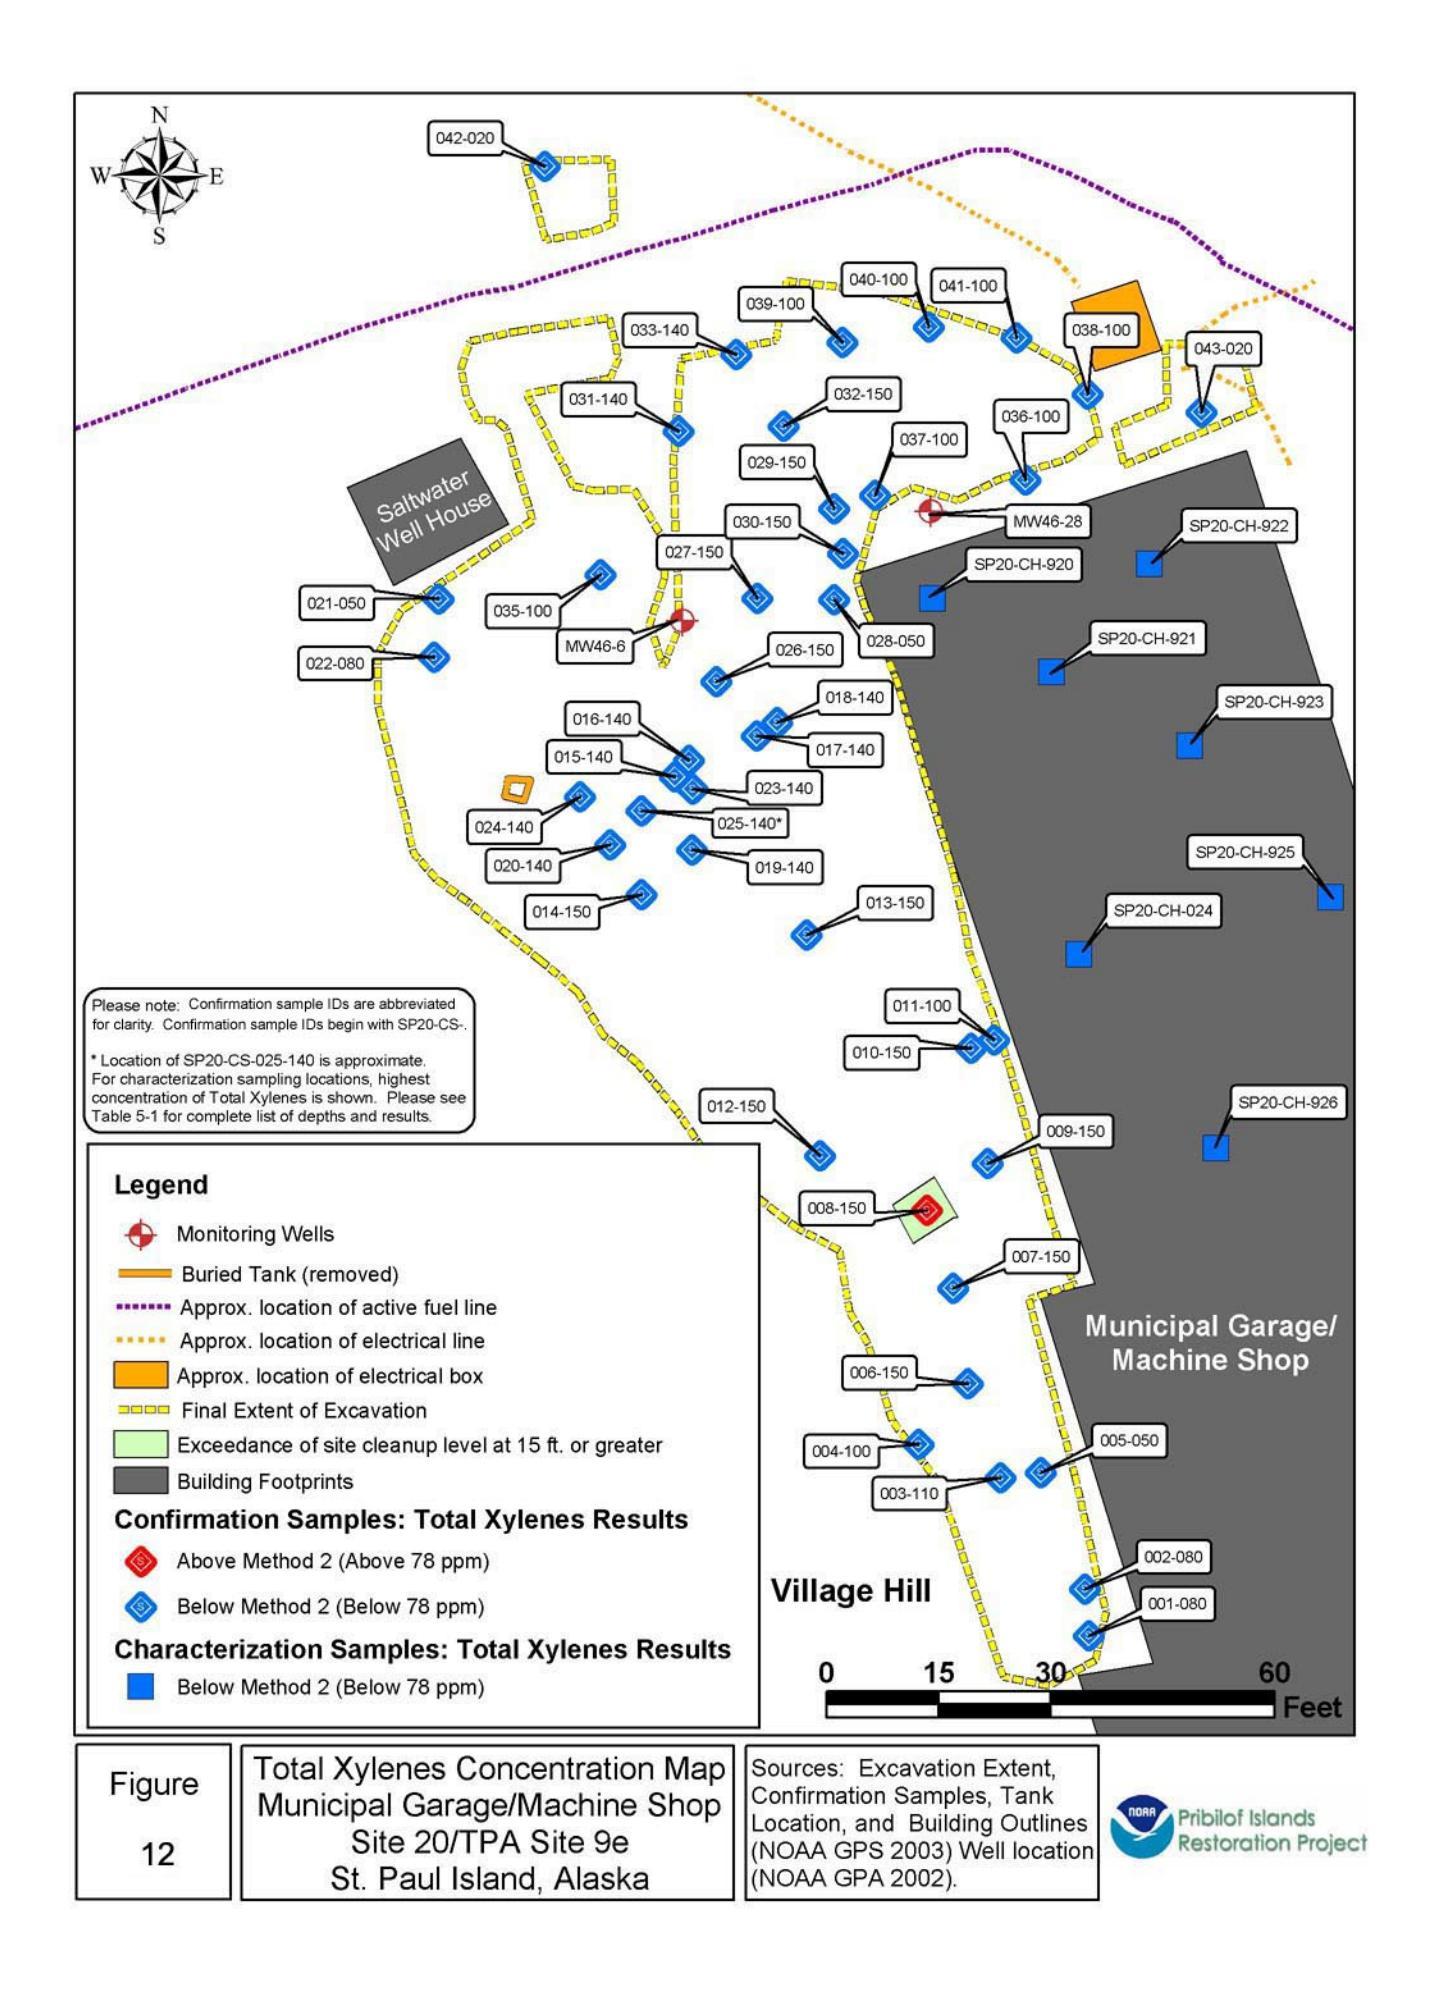
Confirmation samples indicated total xylenes concentrations varying from not detected to 105 mg/kg. One of the 42 samples collected from this area contained concentrations of total xylenes above the ADEC Method Two cleanup level of 78 mg/kg. Since xylenes were not detected in groundwater at this site, the 10x Rule does not apply to xylene soil cleanup levels. Figure 12 illustrates the distribution of total xylenes concentrations.
